Erosion Hazard Limit Study Report

Heritage Line Residential Development

**Lot 14, Concession 6, Otonabee-
South Monaghan, ON**

D.M. Wills Project Number 21-10985

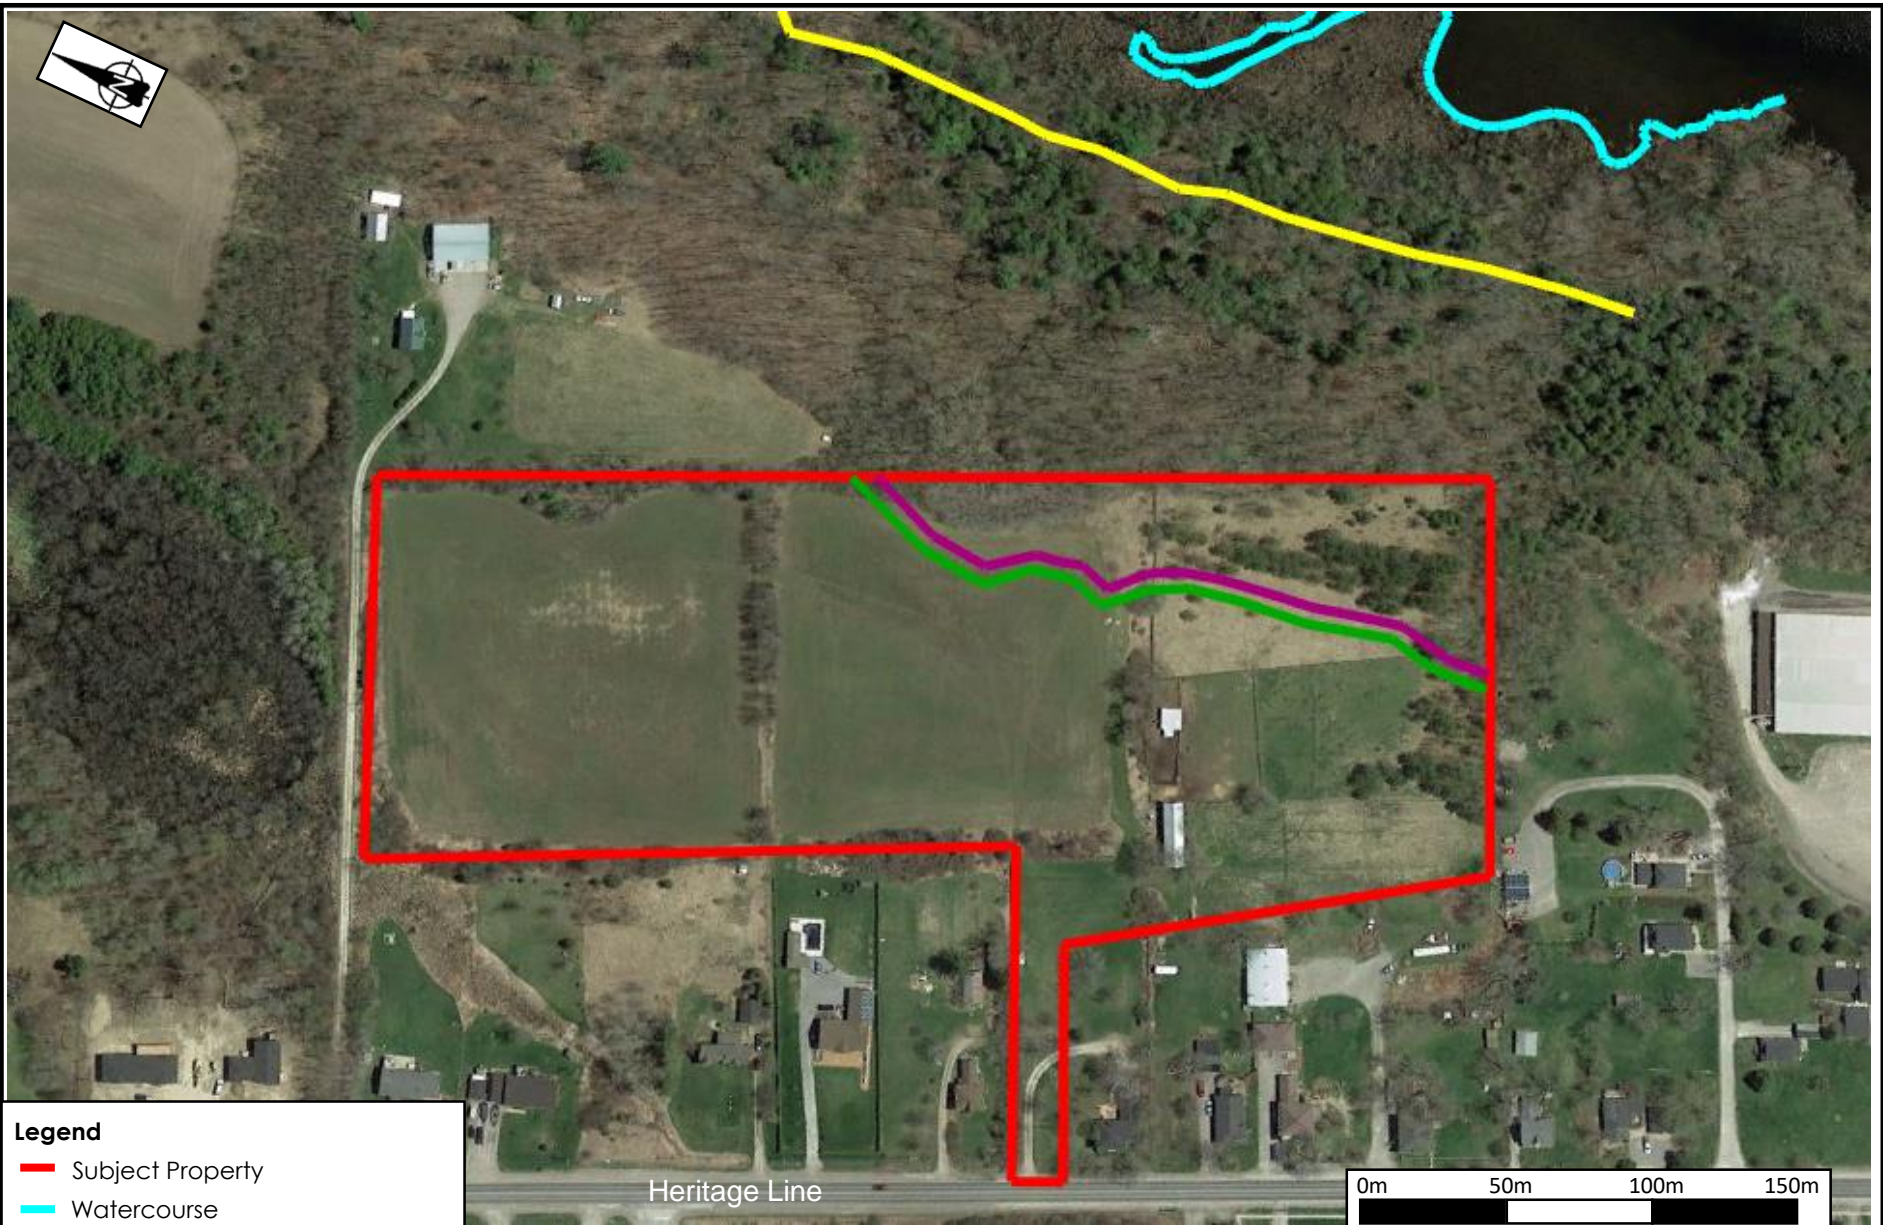
Slope Stability Setback Plan

- Existing topographic survey for the Subject Slope, and Wills' confirmatory slope measurements indicate the Subject Slope has an overall gradient that is shallower than 3H:1V (as projected from the toe of slope), and is considered stable on the basis of the Technical Guideline.

- A toe erosion allowance was not applied in view of the Indian River (watercourse) being in excess of 15 m away from the toe of slope.
- The long term stable top of slope (LTSTOS) was determined to be the existing top of slope, as determined by Wills staff during the site reconnaissance.

- Based on the Technical Guideline, a 6 m erosion access allowance was applied beyond the LTSTOS. Although this allowance will likely not be required to permit slope stabilization activities, the 6 m allowance also coincides with the 6 m development setback limit provided in ORCA's *Watershed Planning & Regulation Policy Manual* (updated December 4, 2015) for subdivisions, condominiums, and consents in the vicinity of a confined/apparent valley system.

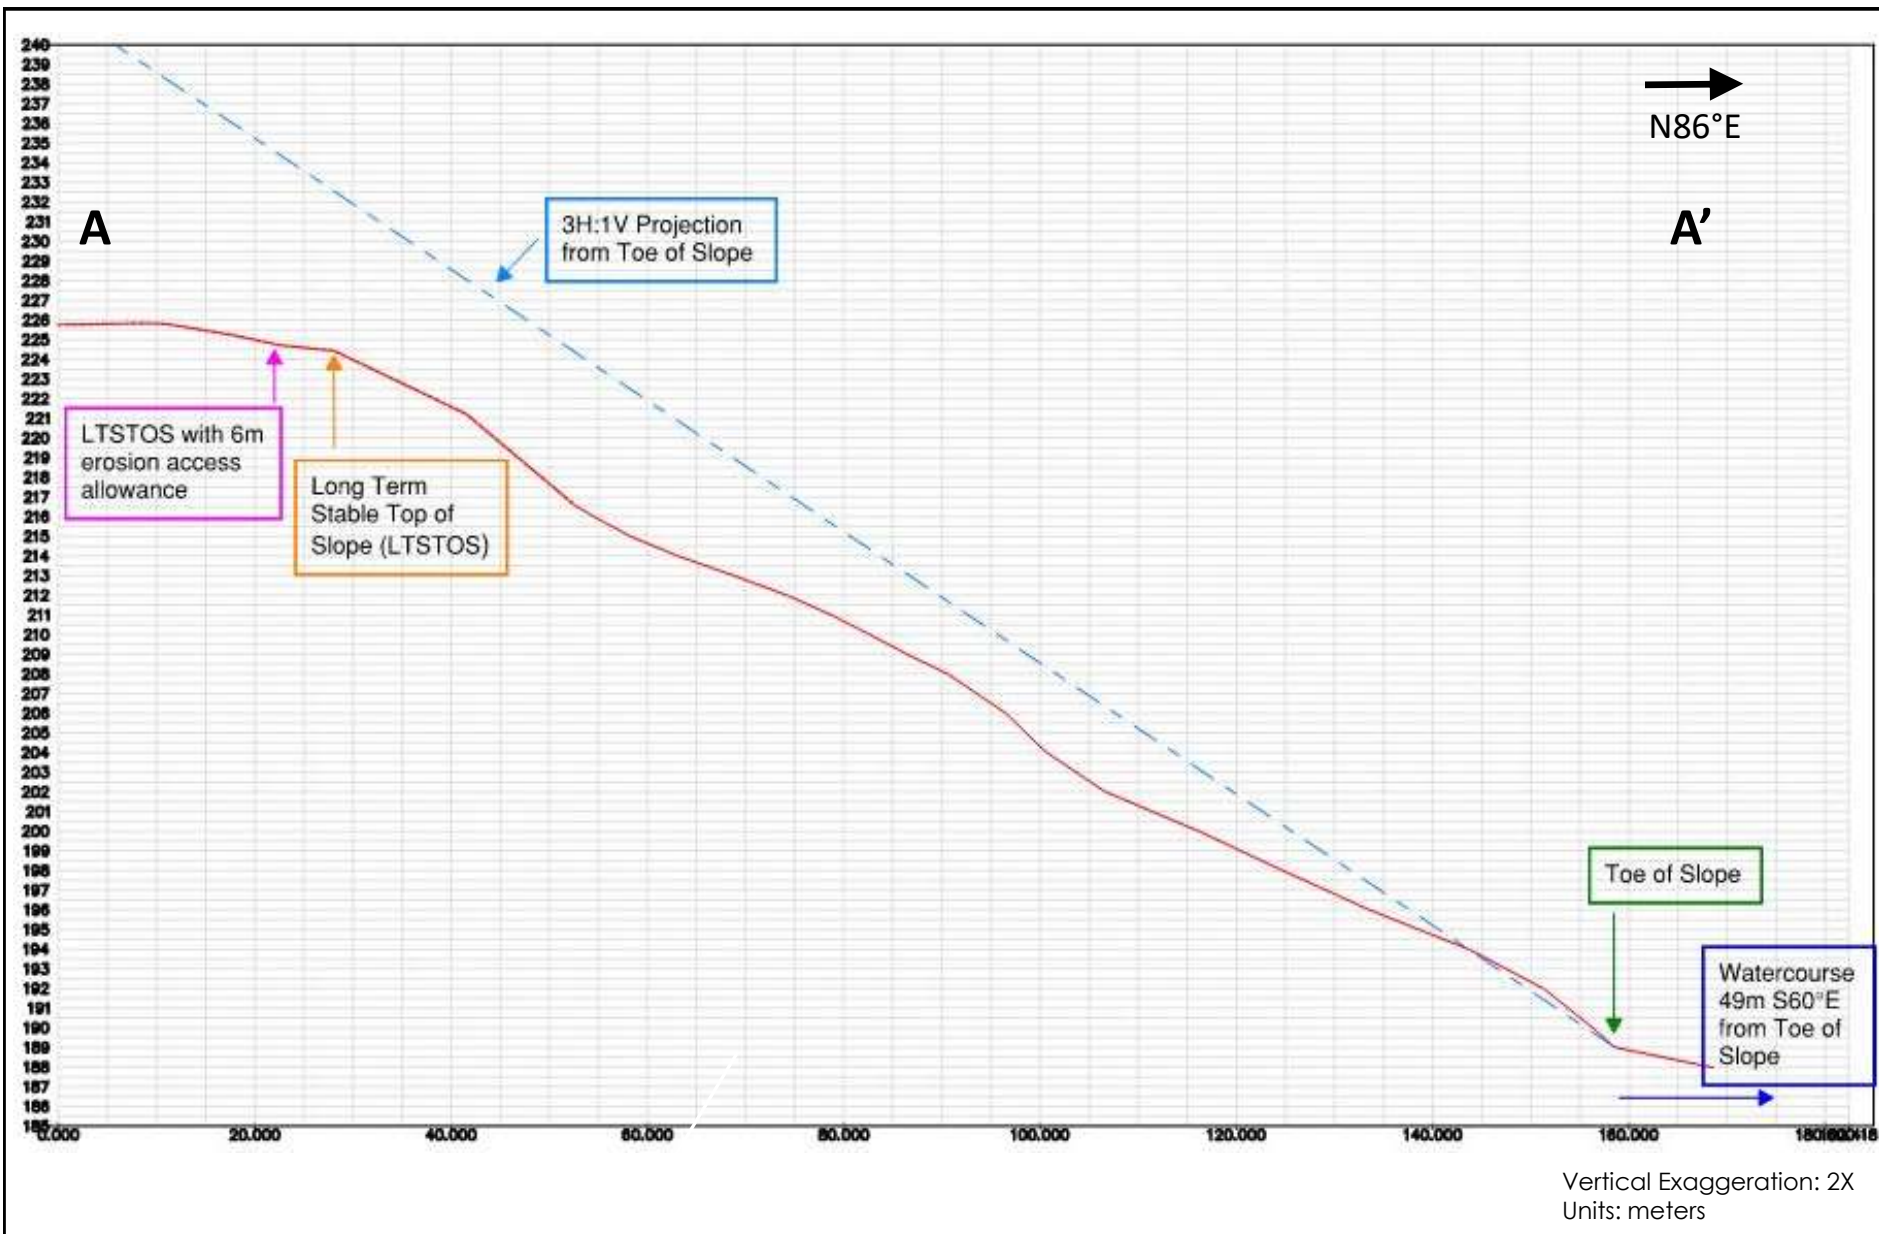
The slope sections surveyed by Wills are shown on **Figure 2** and were designated as section A-A' and section B-B'. In general, the Subject Slope ranges in height from approximately 30 to 35 meters, and maintains slope gradients from 3H:1V (horizontal:vertical) to shallower than 4H:1V. Isolated areas on the Subject Slope maintain gradients approaching 2H:1V, although these areas represent a small percentage of the slope profile and are not expected to affect the overall slope stability. Cross sections A-A' and B-B' are included in **Appendix A**, and are discussed in further detail in **Section 3.3**.

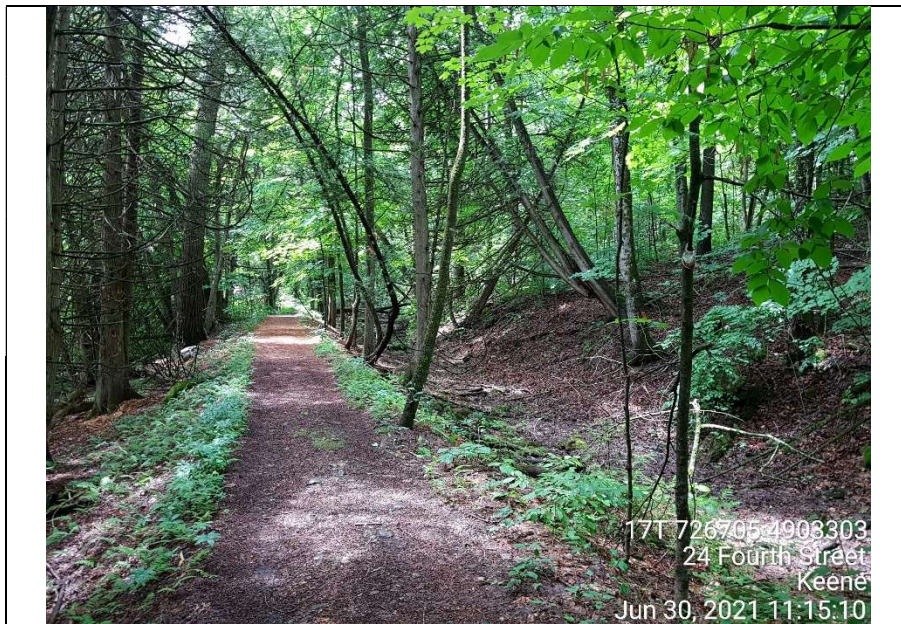
Photograph No.: 1
Date: June 30, 2021
Direction: South
Description: Trail adjacent to toe of slope.

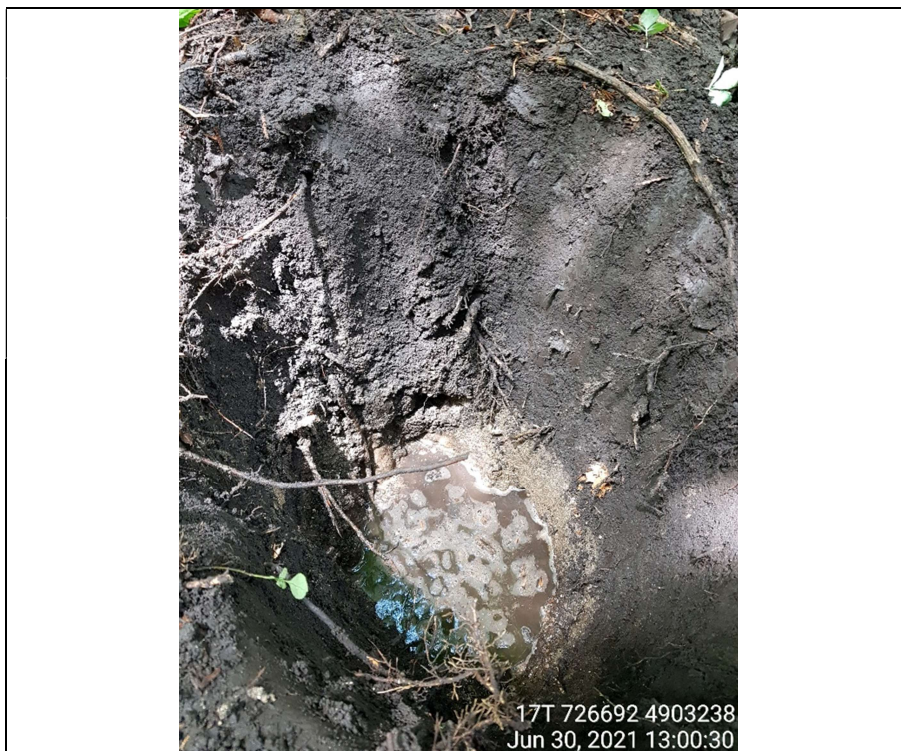
Photograph No.: 2
Date: June 30, 2021
Direction: West
Description: TP21-01 at toe of slope. Dark brown sandy silt topsoil overlying light brown sand material. Groundwater pooling in test pit.

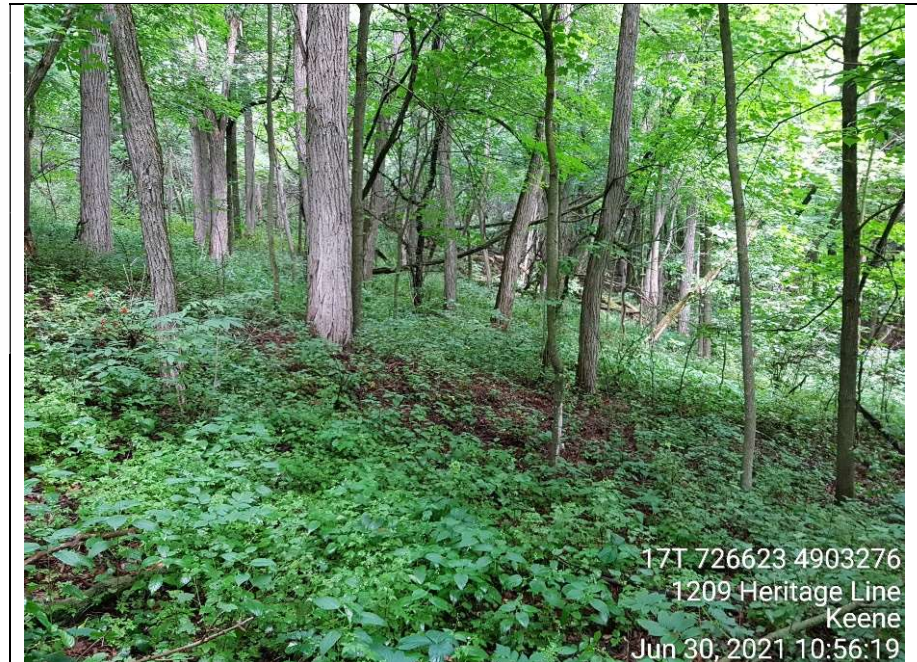
Photograph No.: 5
Date: June 30, 2021
Direction: North
Description: Mid-section of slope. Ground cover and hardwood growthq.

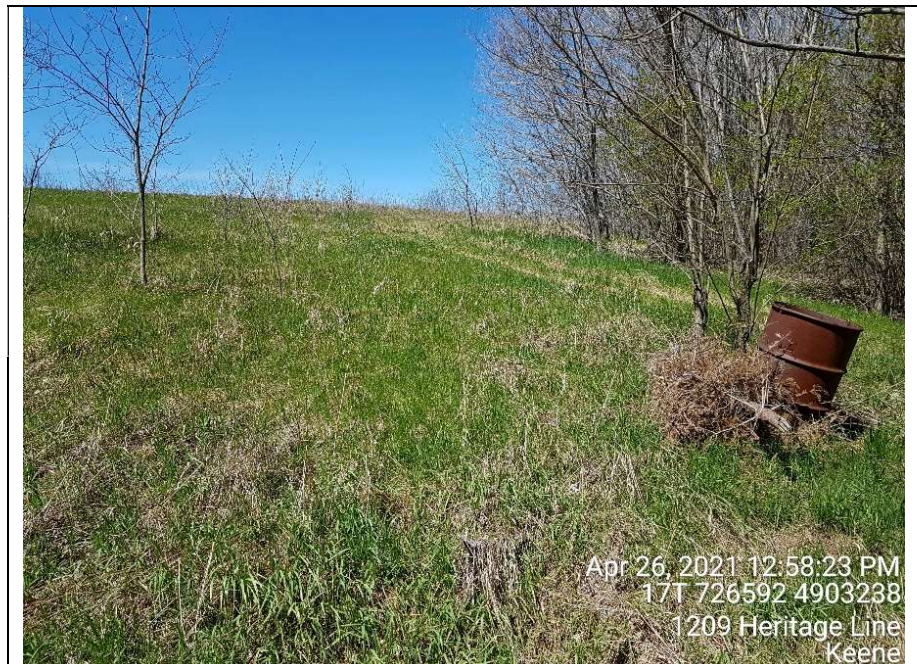
Photograph No.: 6
Date: June 30, 2021
Direction: Northwest
Description: Photo taken west of tree line, slope crest visible in background.

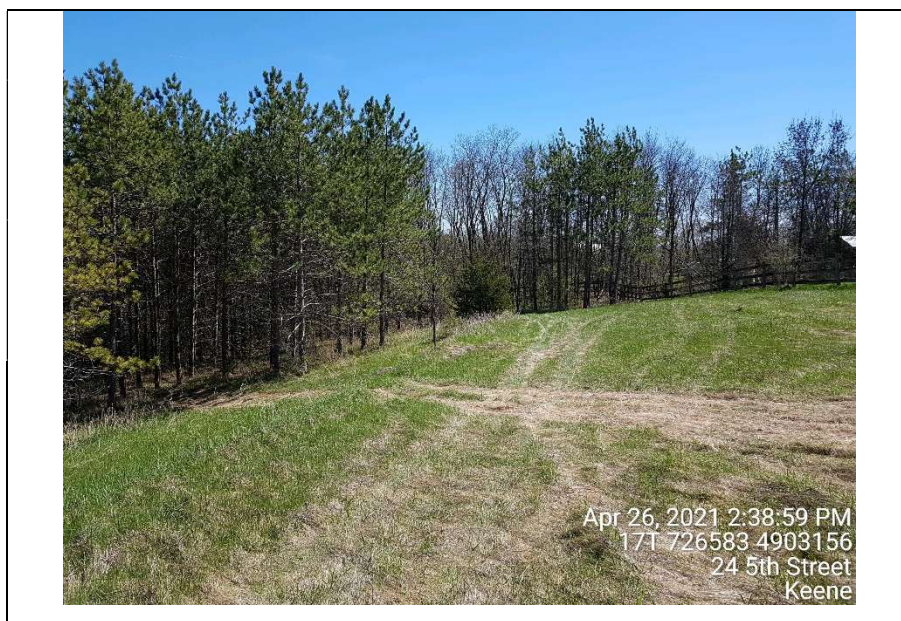
Photograph No.: 7
Date: June 30, 2021
Direction: South
Description: Southern end of Subject Property. Slope crest visible on left adjacent to tree line.
