Our Ref: 11224019-03  
TBG Ref: 20697

Re: Response to Comments – 787 & 825 Fallis Line, Millbrook ON  
County File 15T-21007

GHD Limited (GHD) is pleased to present the following responses to various agency comments received regarding the geotechnical and hydrogeologic investigation reports and environmental site assessment report completed for the above noted properties located on Fallis Line in Millbrook, Ontario. GHD responses follow the respective agency comments.

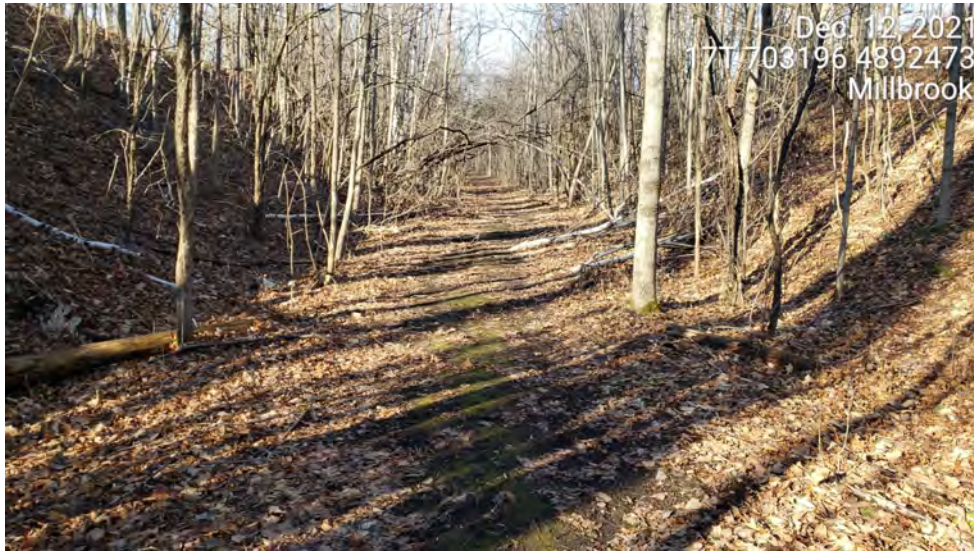
Photo 1 - View of the former rail line looking north.

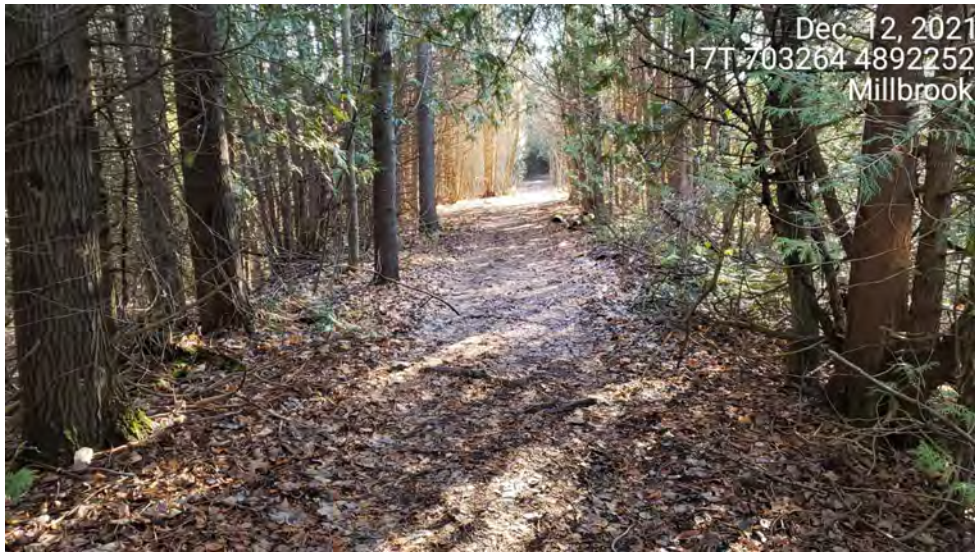
Photo 3 - View of former rail line looking south.

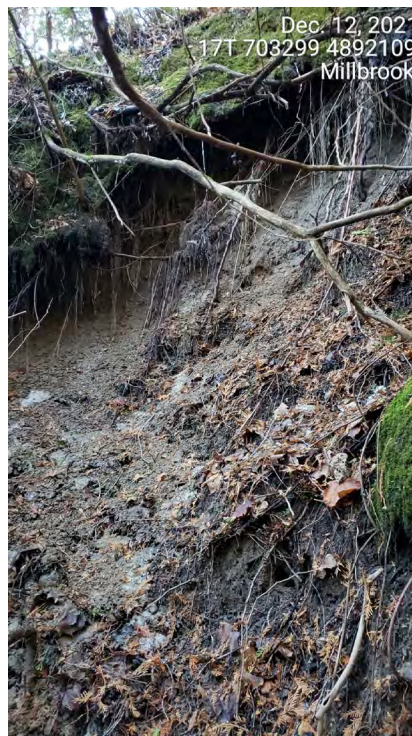
Where the rail bed was built up is within a heavily forested in this area. A number of areas of the rail bed area have been washed out and eroded over the years. The material observed was generally a brown silty sandy with gravel material. No deleterious fill, ballast or discoloured material was observed. Based upon our observations, the likelihood of significant impacts below the former rail line appears low.

Photo 4 - Area of erosion of former rail line (south of residential area). Light brown silty sand observed. No rail ballast or discoloured soils noted.

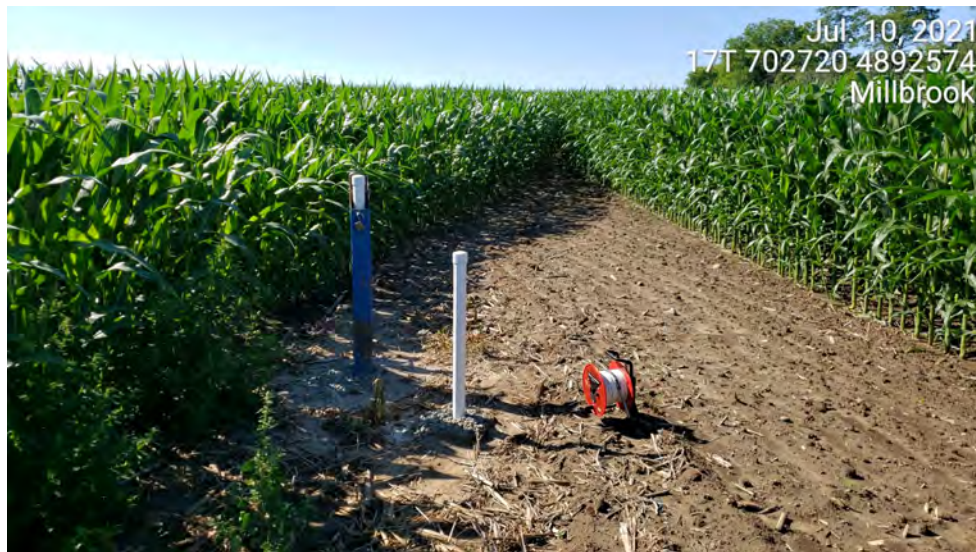
Photo 8 - View of BH11-21 monitoring well nested location looking south.
