Tree Inventory, Preservation & Protection Report

DPH Developments
Norwood Park Subdivision – Phase 4
Norwood, ON

May 14, 2022

Treescape Consulting Project TC348

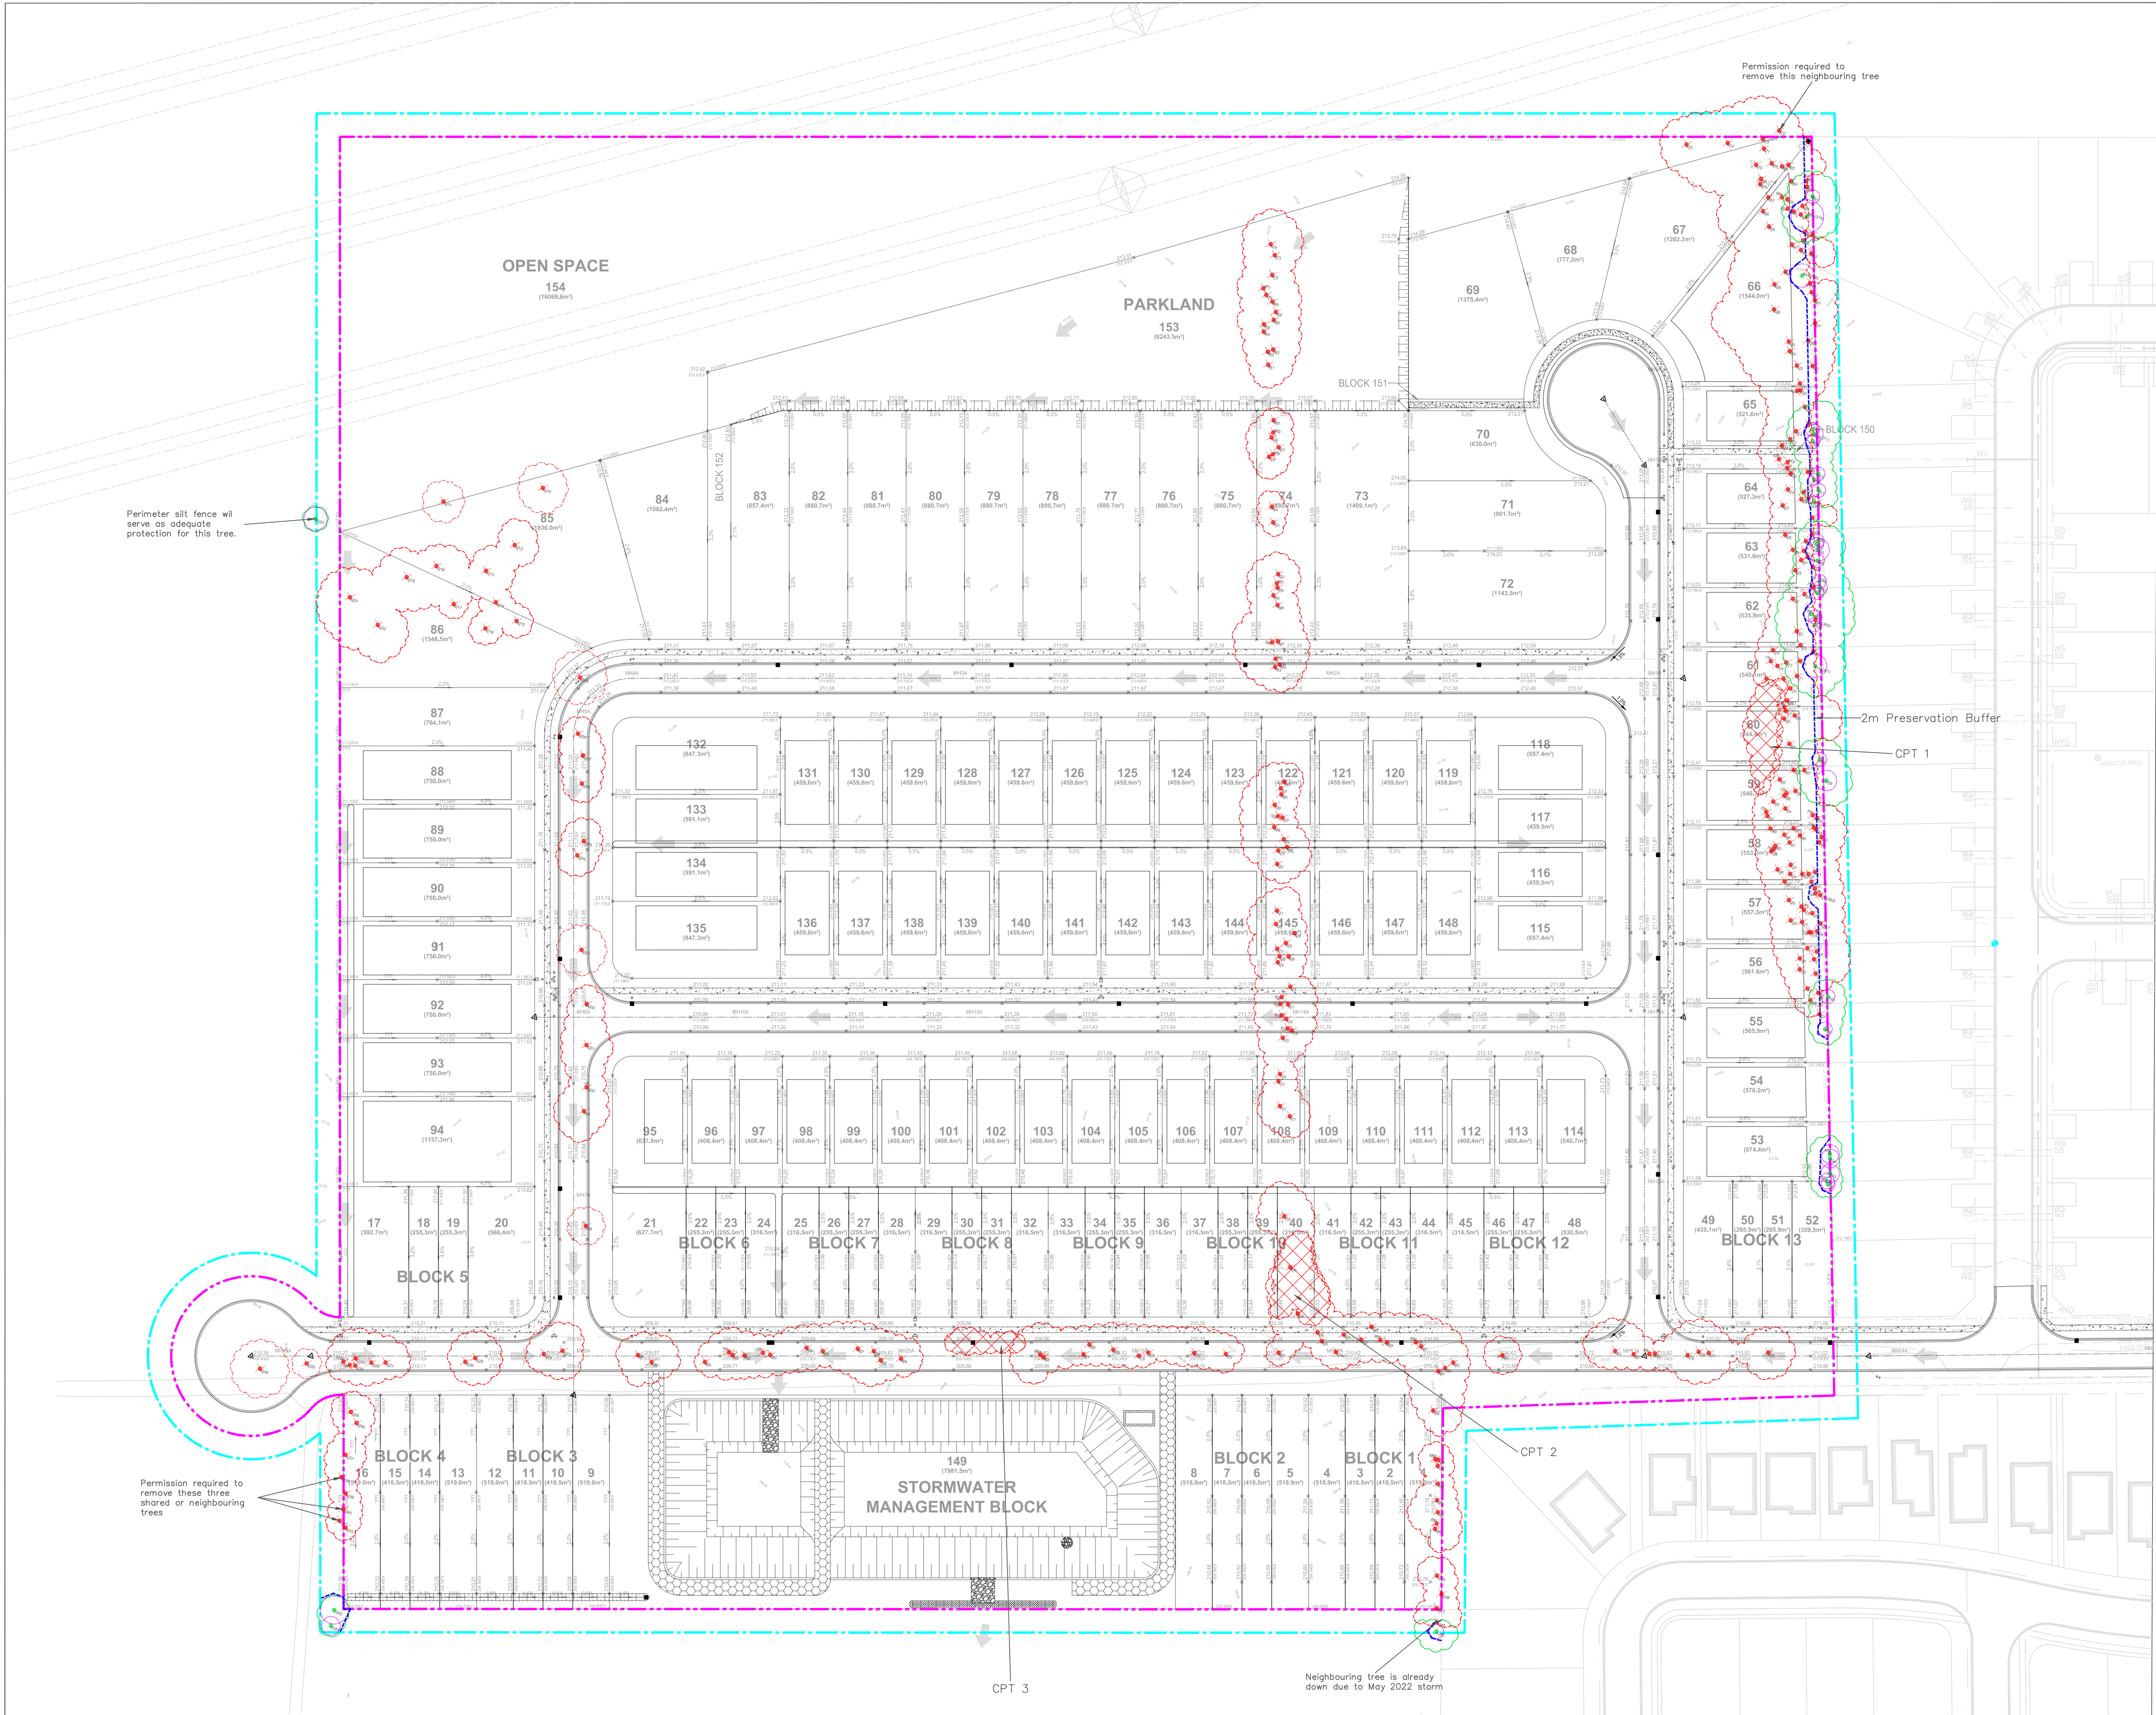
CLIENT	
Justin Cogan	
DPH Developments Inc.	
2345 Yonge Street	
Toronto, ON	
SHEET	
Tree Inventory & Protection Plan	
PROJECT	
TC348_Ptbo Homes-Norwood PH4_TIPP	
REVIEWED	
DRAWN	
AWS	
DATE	
May 4, 2022	
SCALE	
1:750 (ARCH D)	
SHEET	
TIPP-01

The appended plan TIPP-01 found in **Appendix B** identifies the locations of the inventoried trees and outlines the true canopy area of the wooded portions of the property. This drawing also illustrates the recommended removals and tree protection to be read in conjunction with the Tree Preservation & Removals Plan outlined in section 4.

The tree protection distances shown on the Tree Inventory & Protection Plan of this report are based upon a radius of protection measured from the edge of the tree trunk and are minimum protection distances. The recommended tree protection areas for this project are detailed on the appended drawing TIPP-01.

- All trees identified for retention within the Tree Preservation and Removals section shall be protected using the recommended tree protection methods. Tree protection barriers installed in the locations identified on the appended Tree Inventory and Protection Plan create tree protection zones which are subject to revision as required by final design.

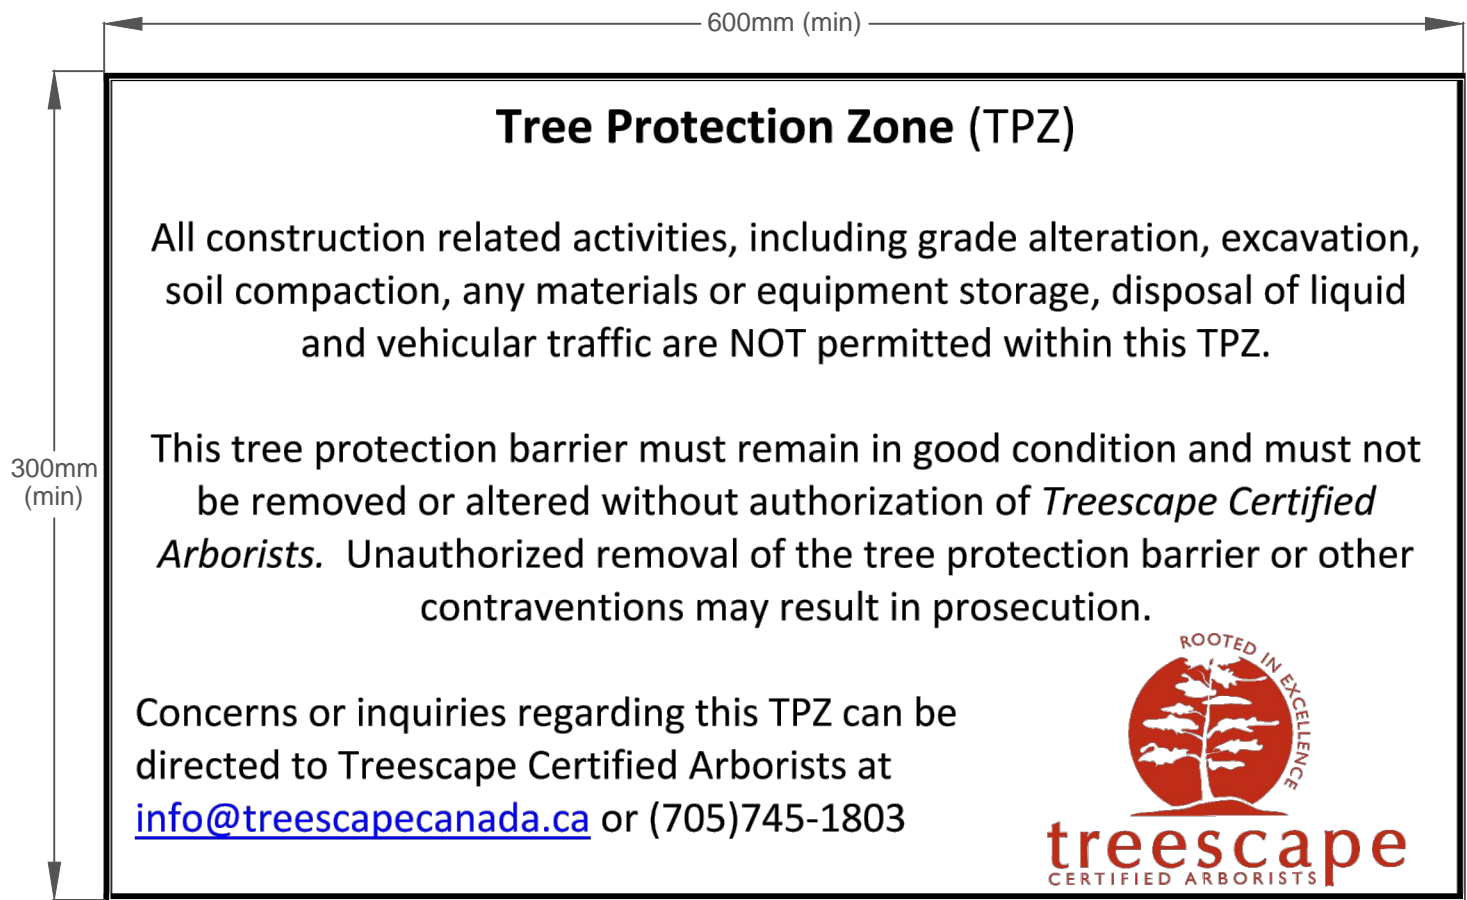
- All sections of tree protection fencing should be clearly marked with signs stating that the area within is a Tree Protection Zone and that no one is allowed to disturb this area. Signs should contain contact information for the contractor and/or the Arborist and clearly state any consequences that are associated with violations. Text on the signs should be in all languages commonly spoken on the site. Refer to detail #3 on drawing TIPP-02 for an example.
