**Re: Letter Report - Slope Stability Study**  
**74 Edwards Drive, Keene, ON**  
**Cambium Reference Number: 15831-001**

## GEOTECHNICAL INVESTIGATION - SLOPE STABILITY

YVETTE JOHNSTON  
74 Edwards Drive,  
Keene, Ontario

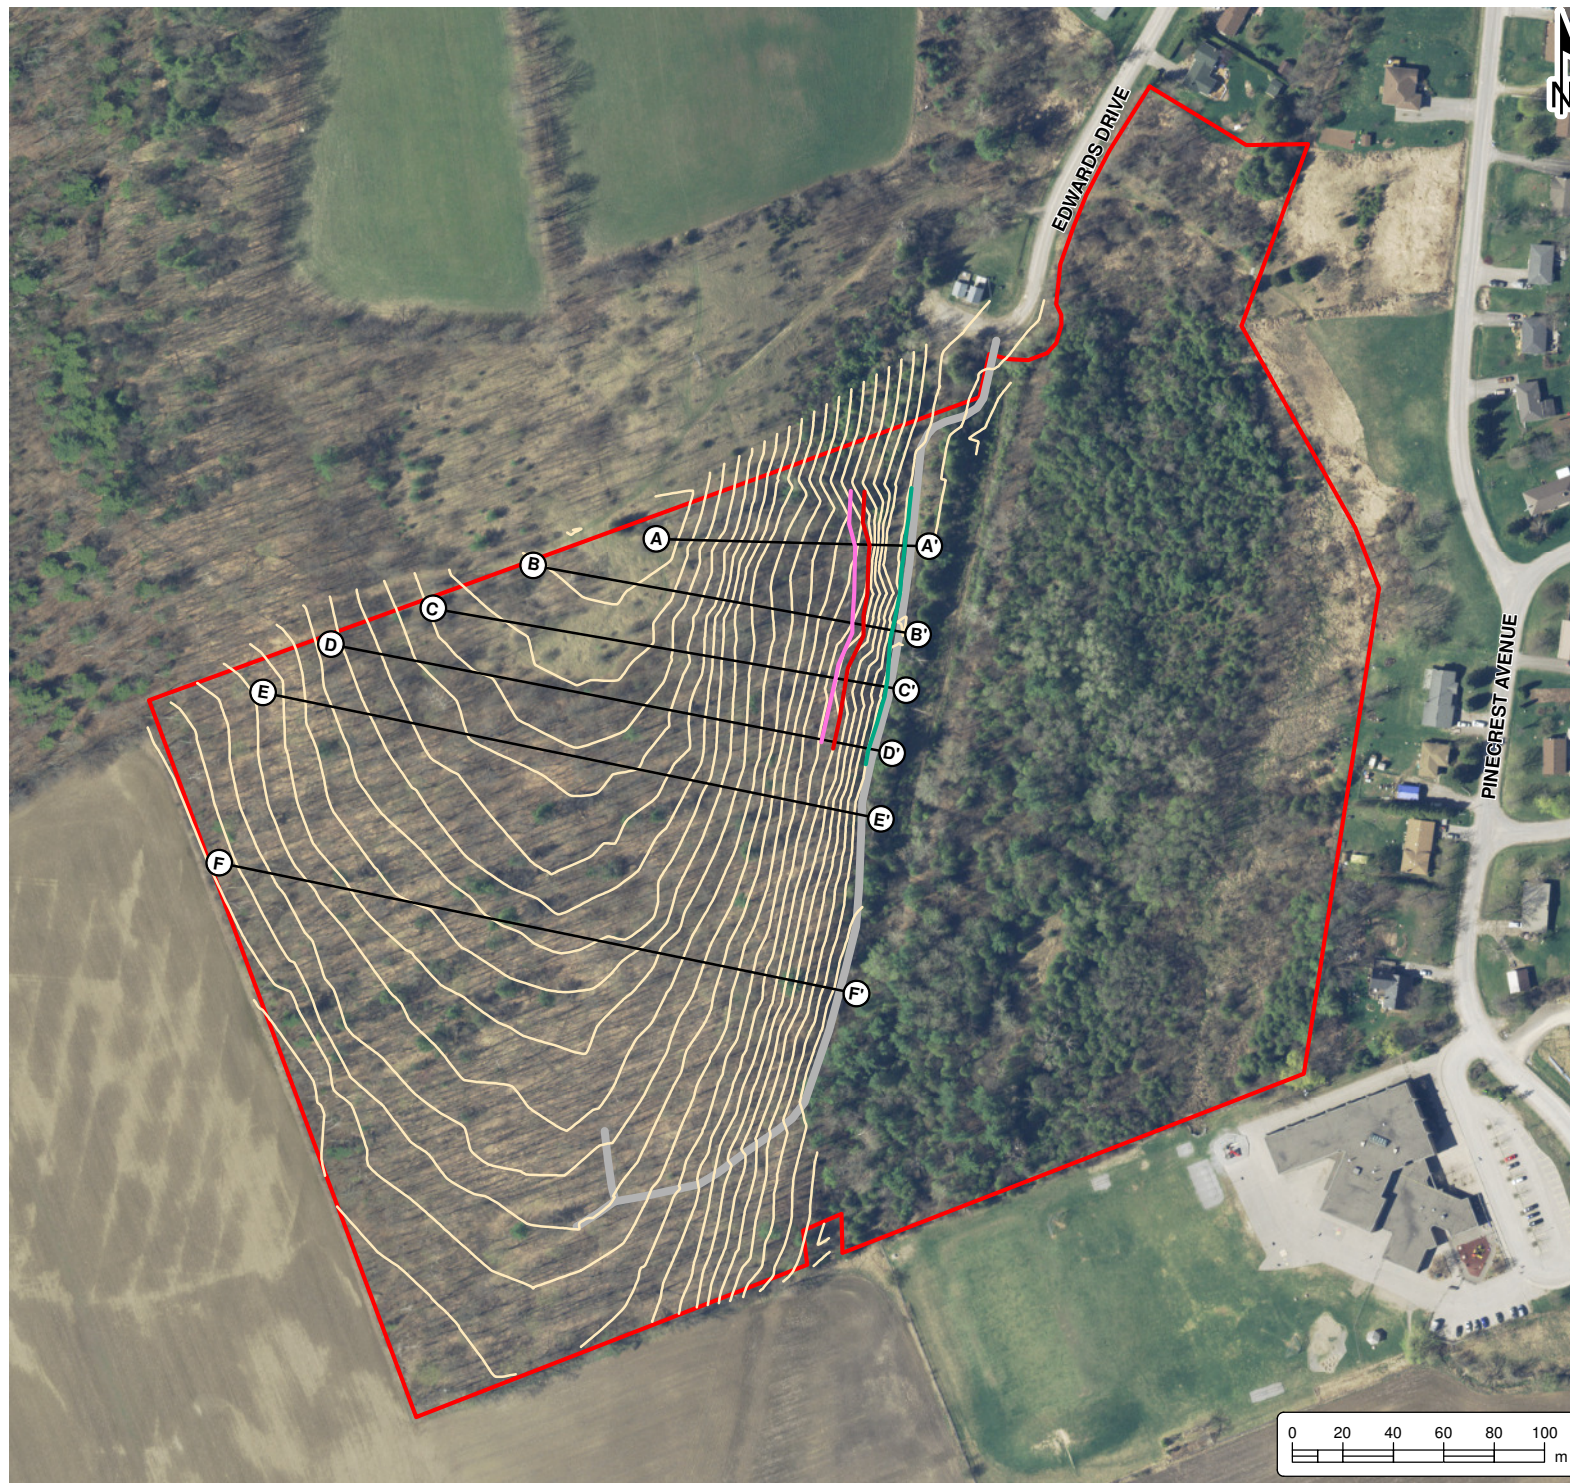
### SITE PLAN

The crest/top of slope has been identified as the top of any slope that is steeper than an inclination of 3H:1V. The identified top of slope is demonstrated in Figure 1. Any slope beyond the top of slope westward (gradual incline to the west) or southward is considered stable and of no concern for erosion, and any development in these areas will not impact the stability of the slope, with the

exception of the Development Setback line described below. As seen in Figure 1, the identified top of slope culminates at cross section D-D', as any slope beyond this point to the west or south becomes a non-hazard area (no steeper than 3H:1V).

Since the overall slope has a low potential for instability, the top of the existing slope can be considered the long-term stable top of slope, as long as no structures are developed within the slope height horizontal distance from the identified crest (top) of slope. This Development Setback limit is shown in Figures 1, 2 and 3. If development is proposed to be within this limit from the top of slope, then further investigations/studies will be required such as modelling, advancing boreholes/piezometer(s) or test pits, physical laboratory tests of the soil samples and a detailed report to support development through the slope and/or closer to the top of slope. This development limit does not apply for any "slope" beyond cross section D-D' to the south.

During construction, care should be taken to retain as much of the vegetation as possible and erosion control measures should be put in place to maintain the stable slope, including revegetation of the slope if any bushes or trees are removed and ensuring that there is no concentration of runoff from downspouts down the slope.

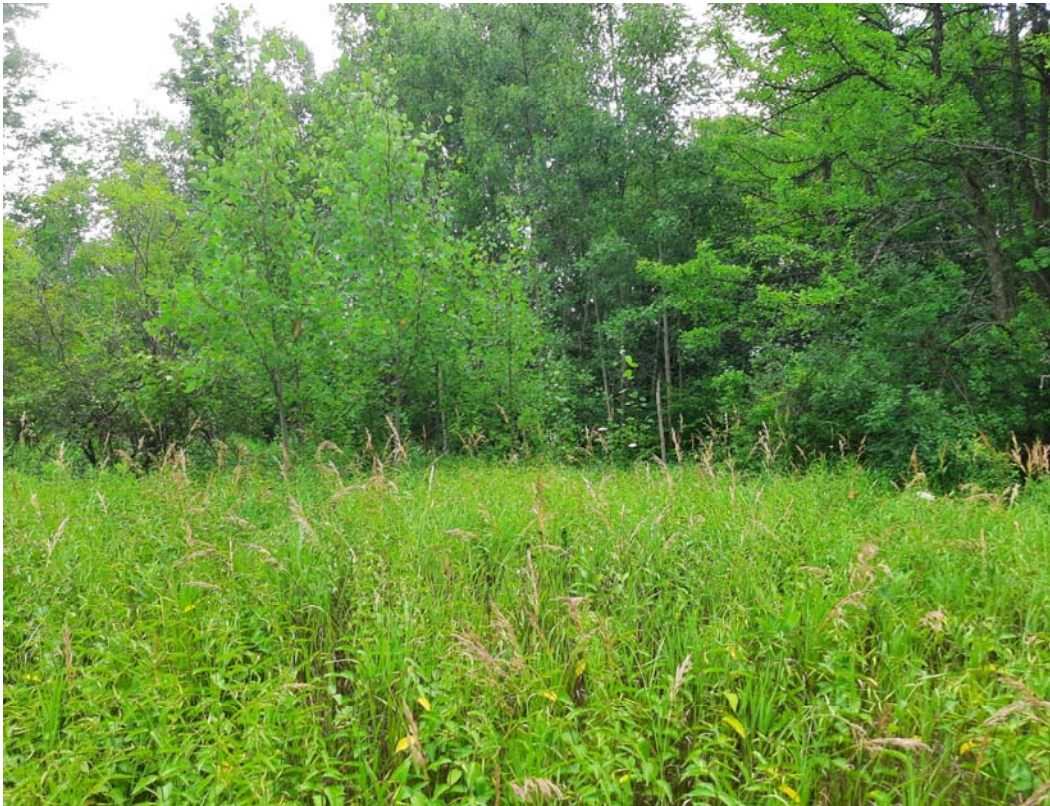
Photo 1: View from near the top of slope, looking east. Mix of trees, shrubs, grasses.

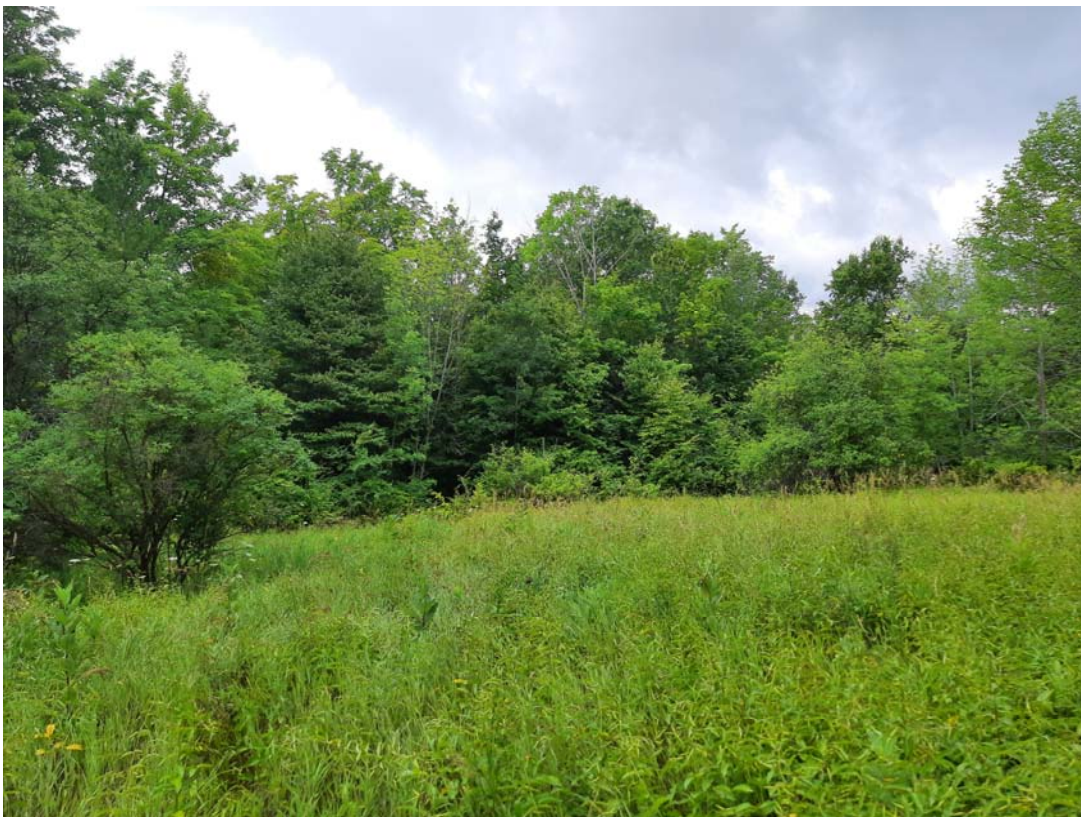
Photo 2: View from near the top of slope, looking south. Mix of vegetation; trees, shrubs and grasses.

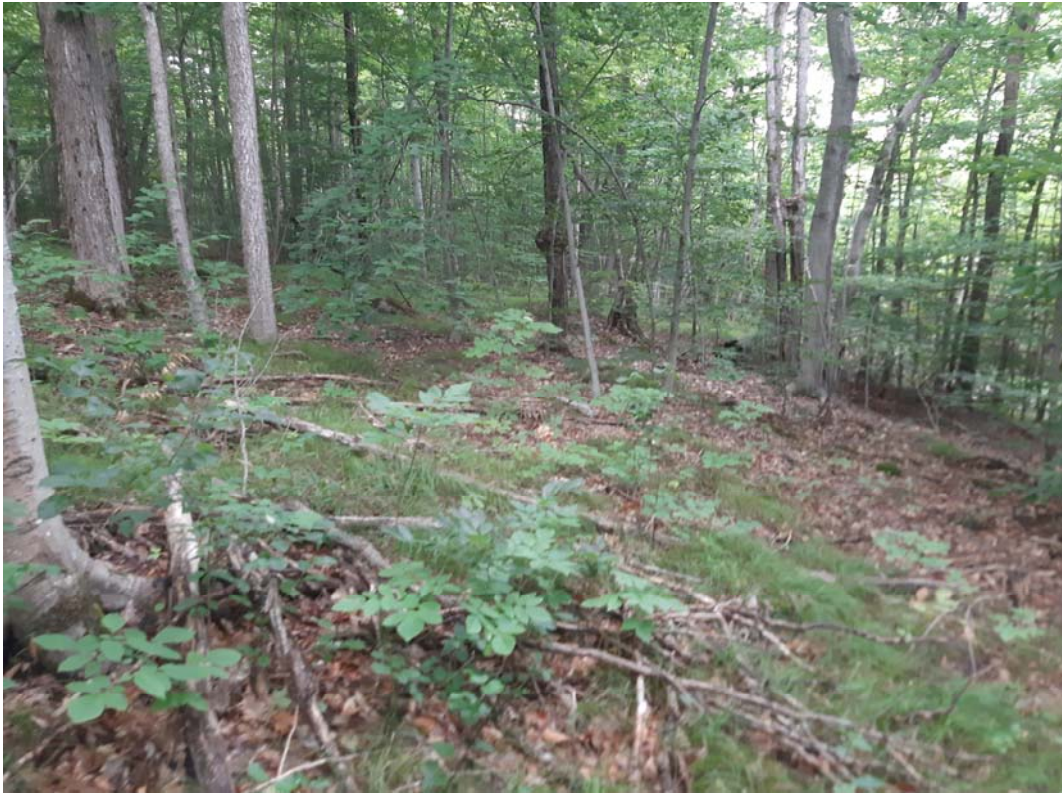
Photo 3: Image of middle of slope, looking north. Mix of vegetation on mid-slope.

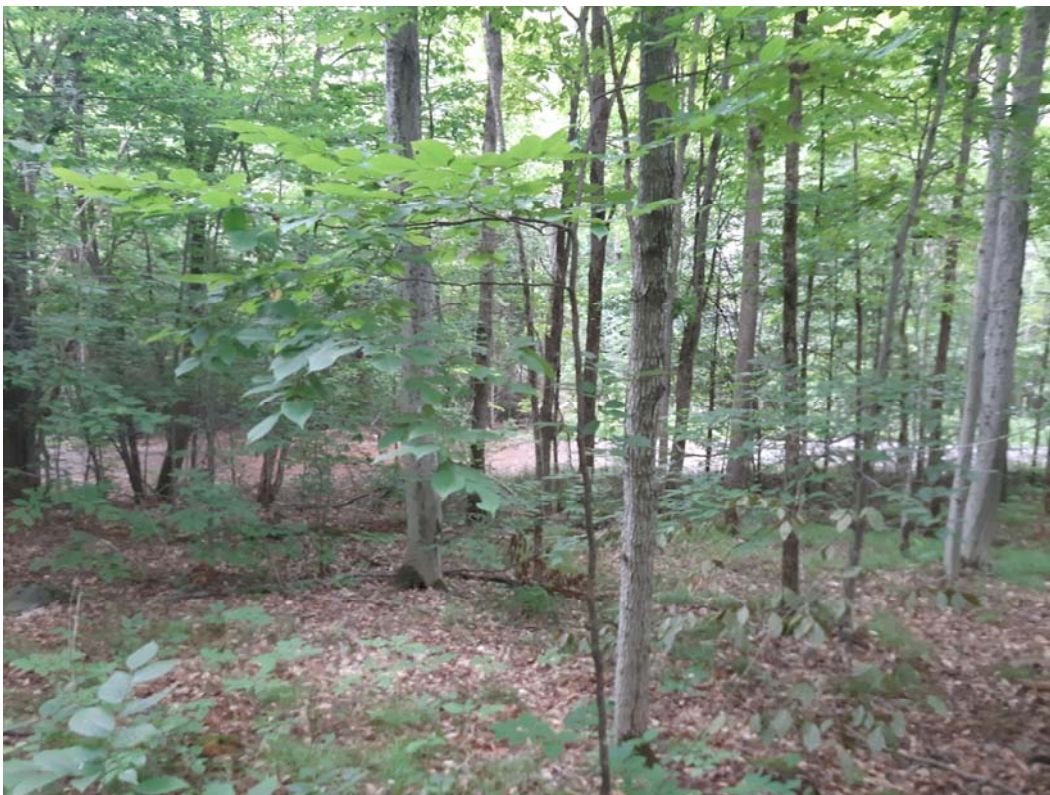
Photo 4: Image of middle of slope, looking east towards bottom of slope

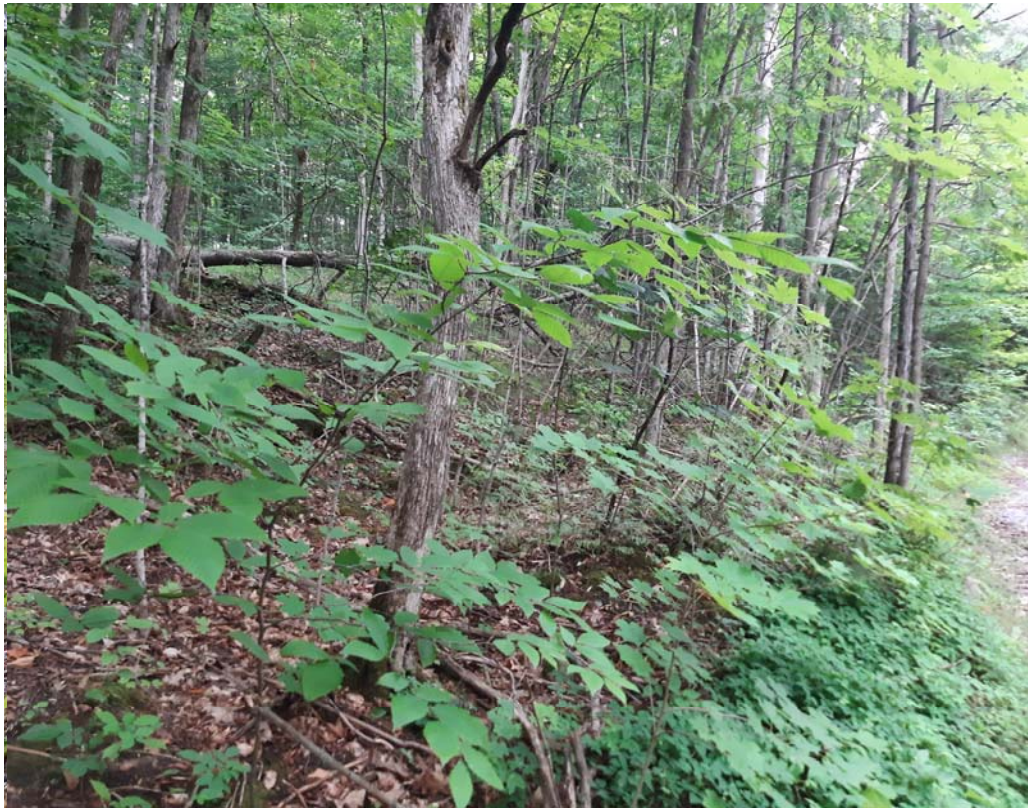
Photo 5: View of bottom of slope, with a mix of vegetation right up to the gravel road/bottom of slope.

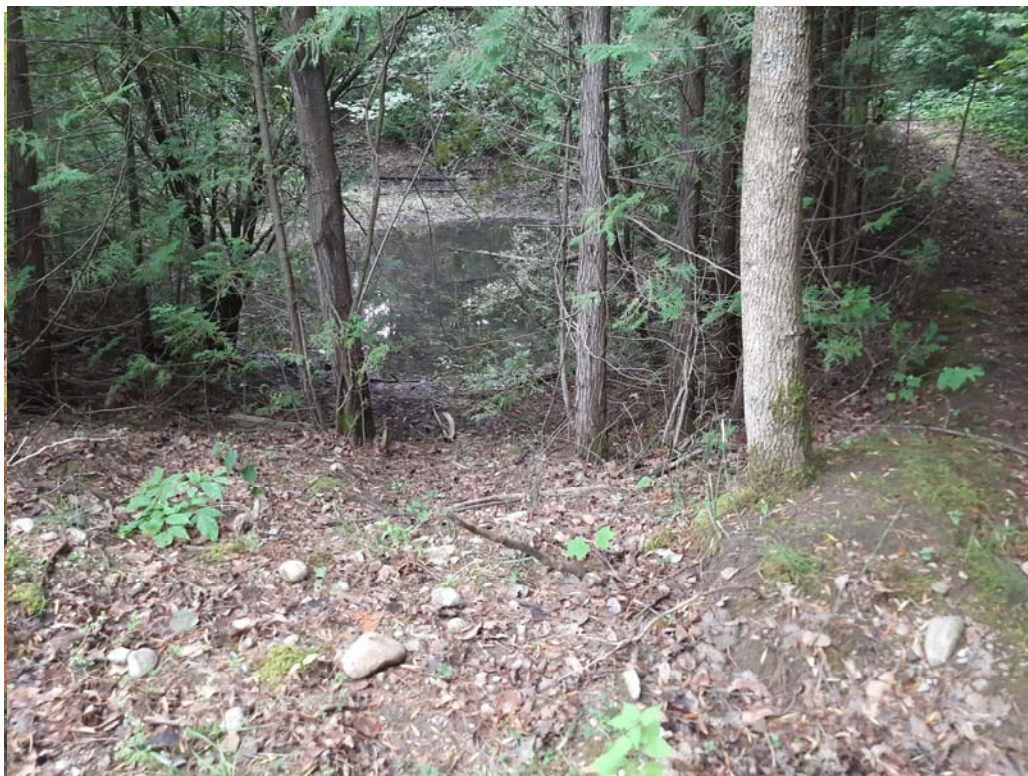
MARSHY GROUND: Small patches of marshy ground observed ranging from 300mm in width to approximately 3m in width, more than 15 m from bottom of slope

Photo 6: Portion of marsh area, near the bottom of slope/gravel road.
