27 February 2026

**Re: Erosion Hazard Limit Assessment – 963 County Road 10, Cavan-Monaghan, Ontario**

GHD Limited (GHD) was retained by Vargas P Inc. (the Client), represented by you, to conduct an Erosion Hazard Limit Assessment (EHLA) at the property located at 963 County Road 10, Cavan-Monaghan, Ontario (the Site). The Site location is illustrated on the attached **Site Location Plan, Figure 1**. GHD previously completed the following reports for proposed residential and commercial development at this Site:

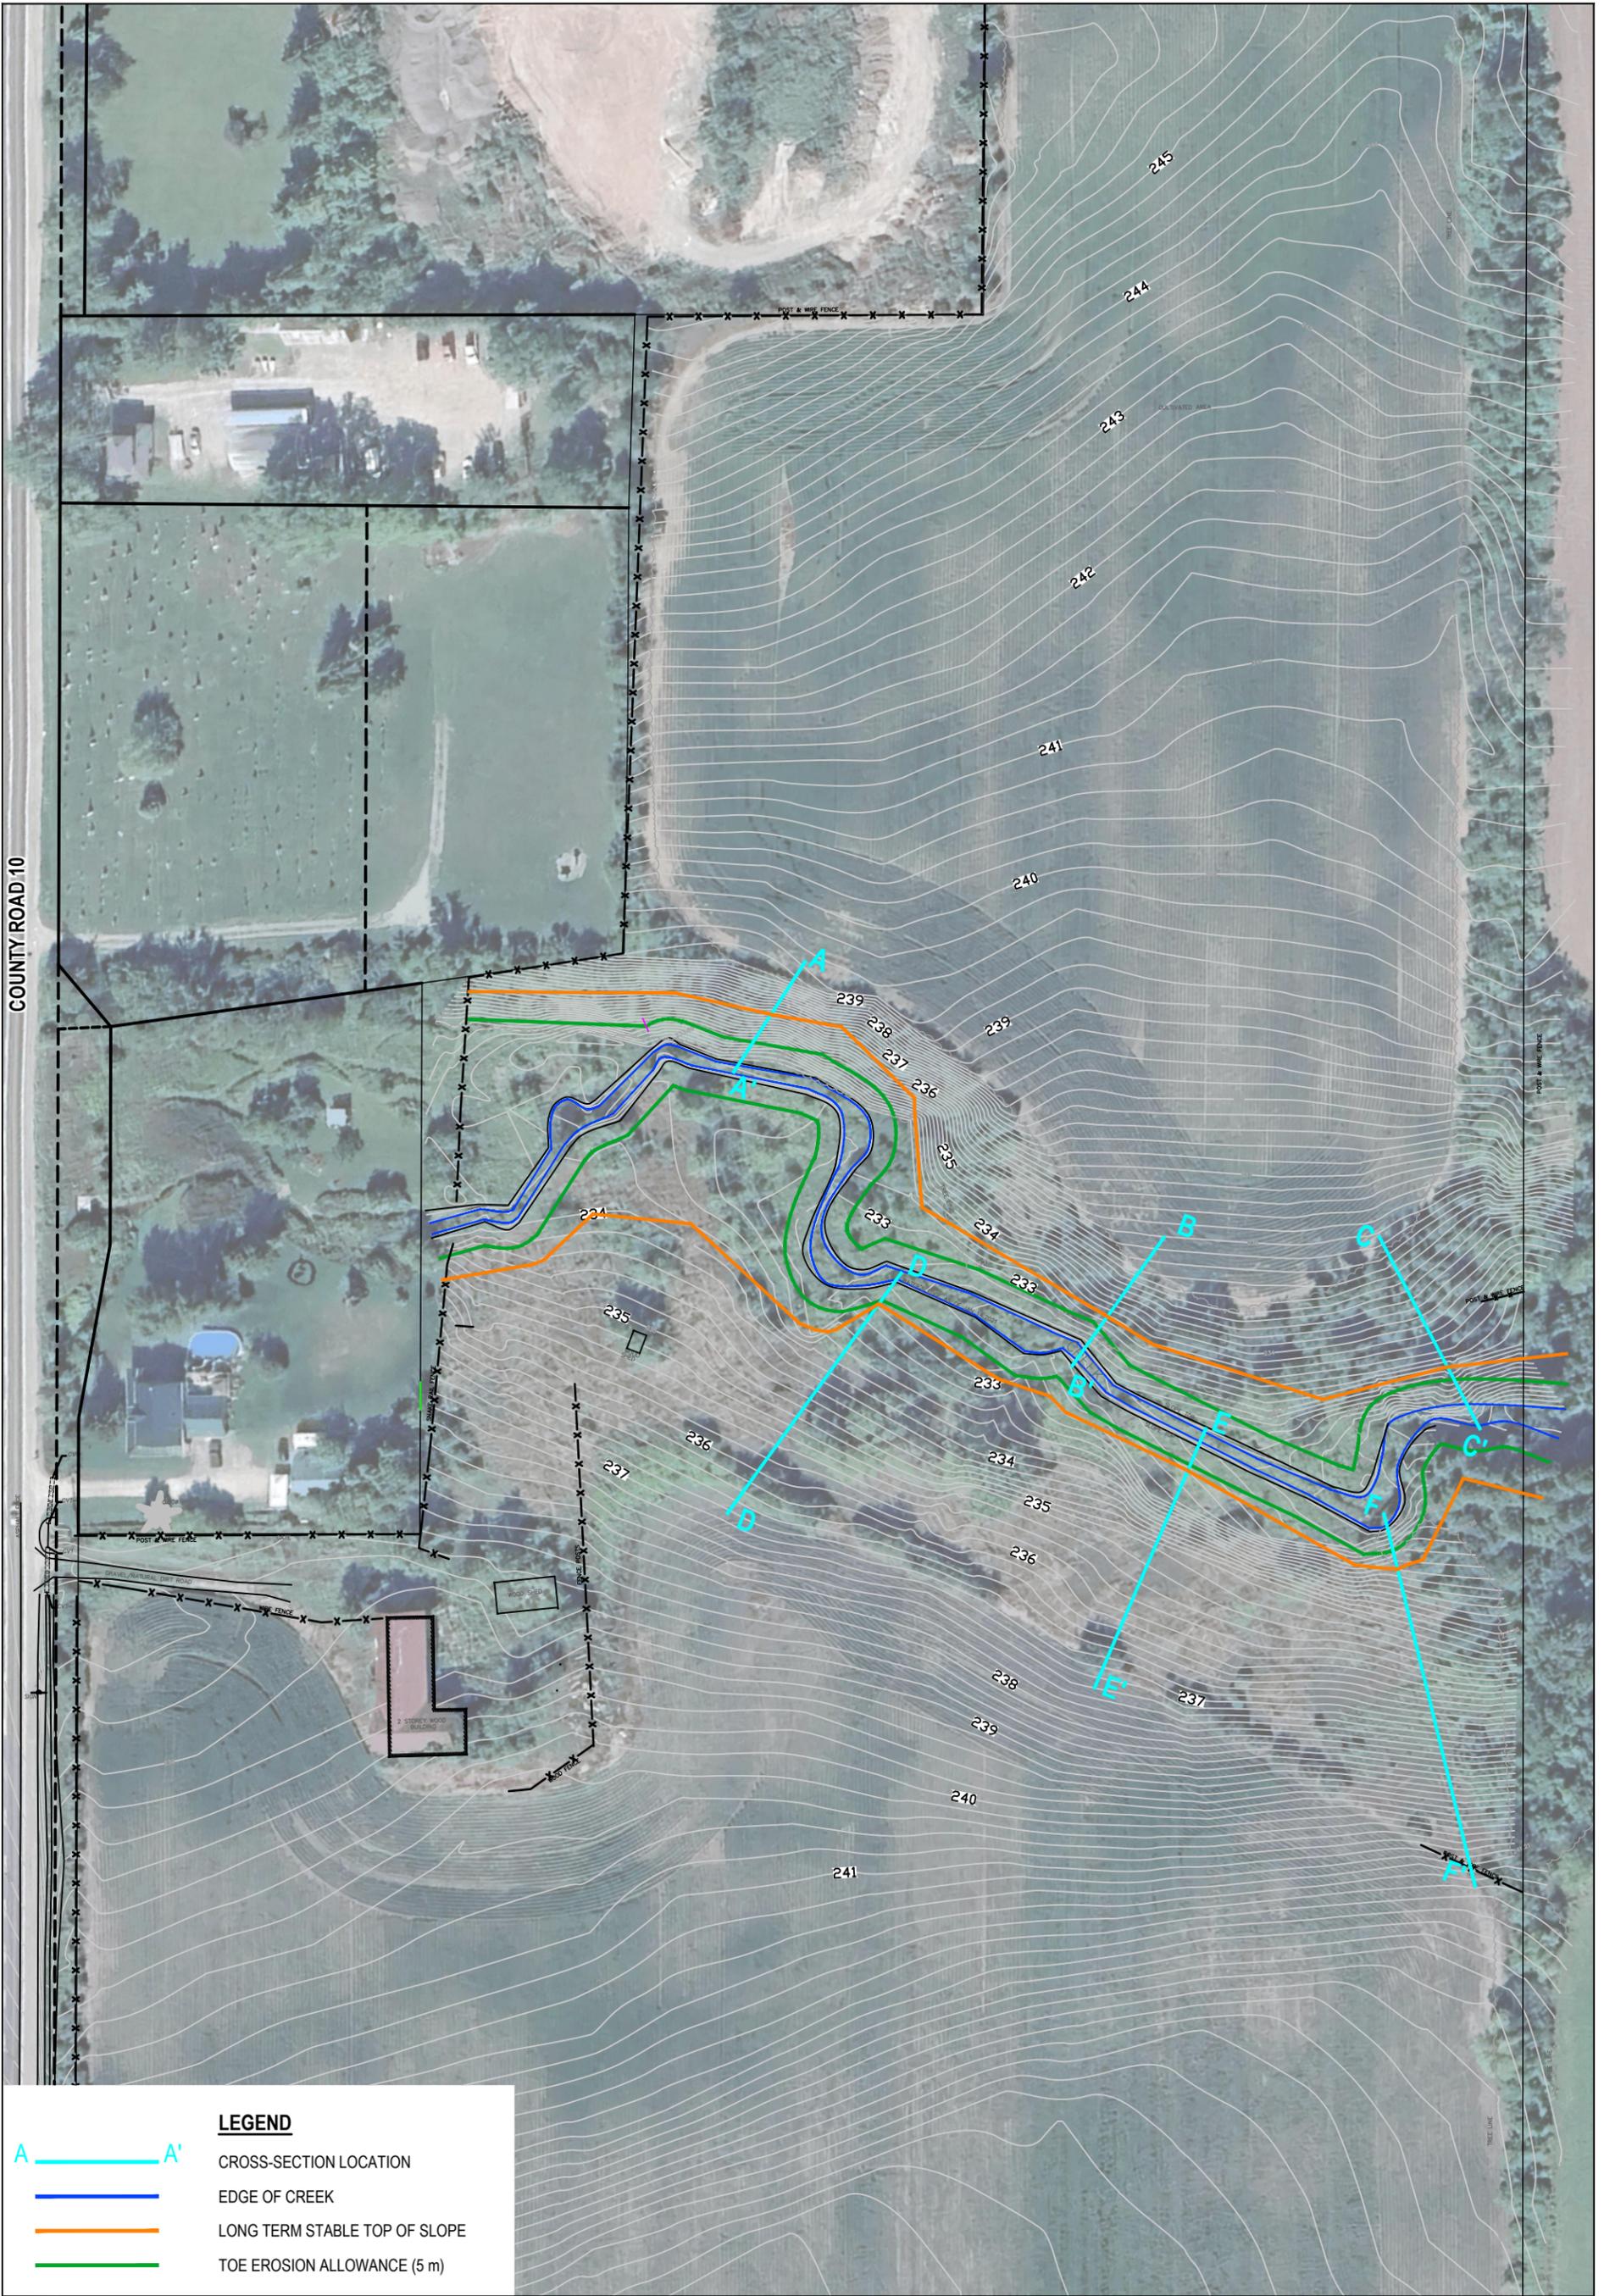
FIGURE 2

A total of six locations were inspected as part of the Site inspection. The locations are identified as Section A-A', Section B-B', Section C-C', Section D-D', Section E-E', and Section F-F'. The locations of these sections are identified on the attached **Cross-Section Location Plan, Figure 2**.

4. A toe erosion allowance of 5 m is recommended based on information available.
5. Using the erosion allowance of 5 m and the stable slope inclination of 2H:1V, the LTSTOS along the cross-sections are illustrated on **Figure 3** and **Figure 4**. The corresponding LTSTOS setback is plotted on the Cross Section Location Plan, **Figure 2**.

In accordance with the Guidelines, an erosion access allowance of 6 m *could* be applied in addition to the toe erosion and the stable top of slope allowances. A 6 m emergency access allowance can be added to the line identified as the LTSTOS on **Figure 2** should this be required by ORCA.

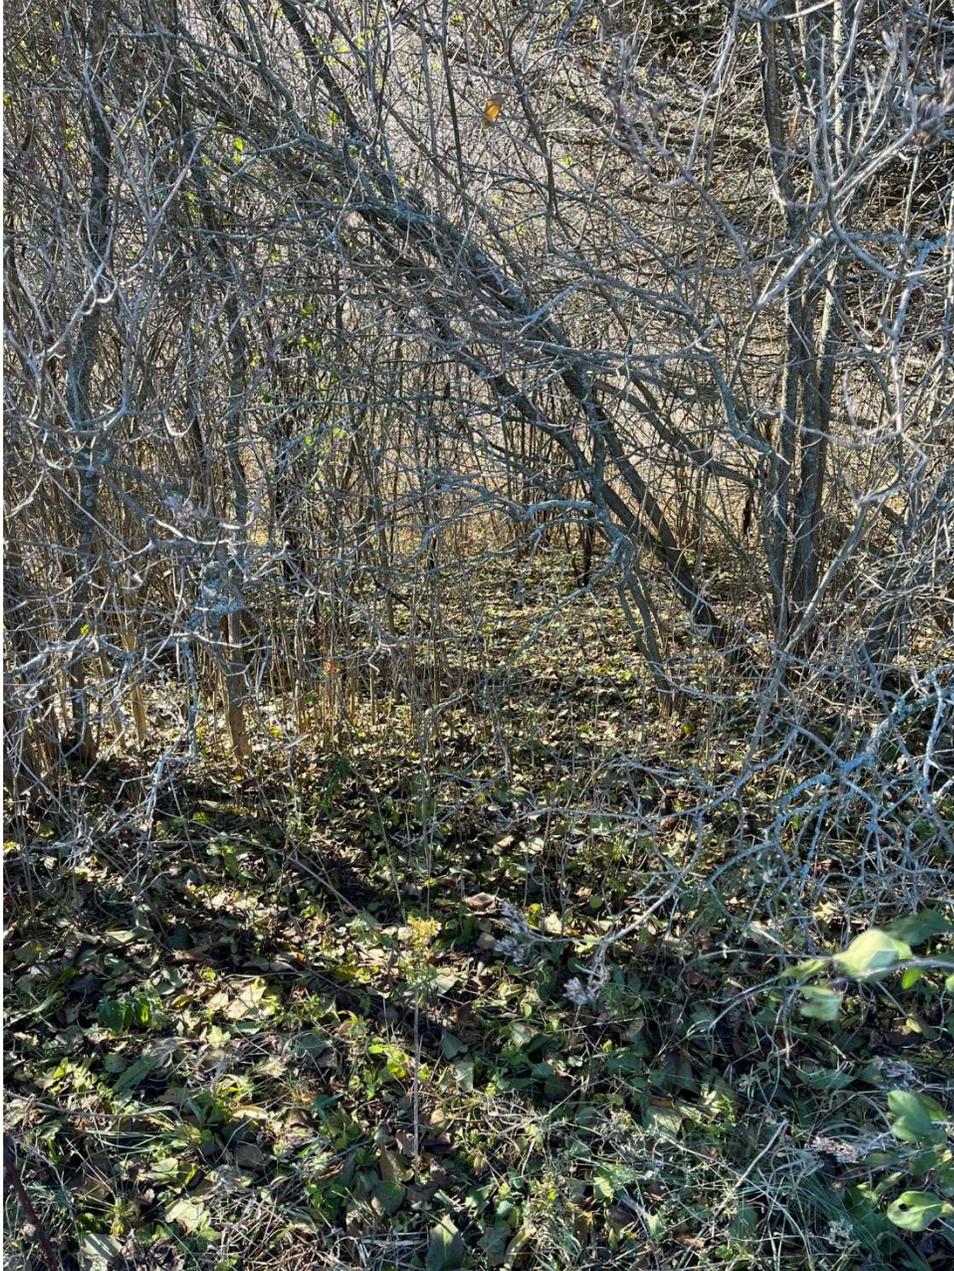
*Figure 1 Section A-A', top of slope, facing south*

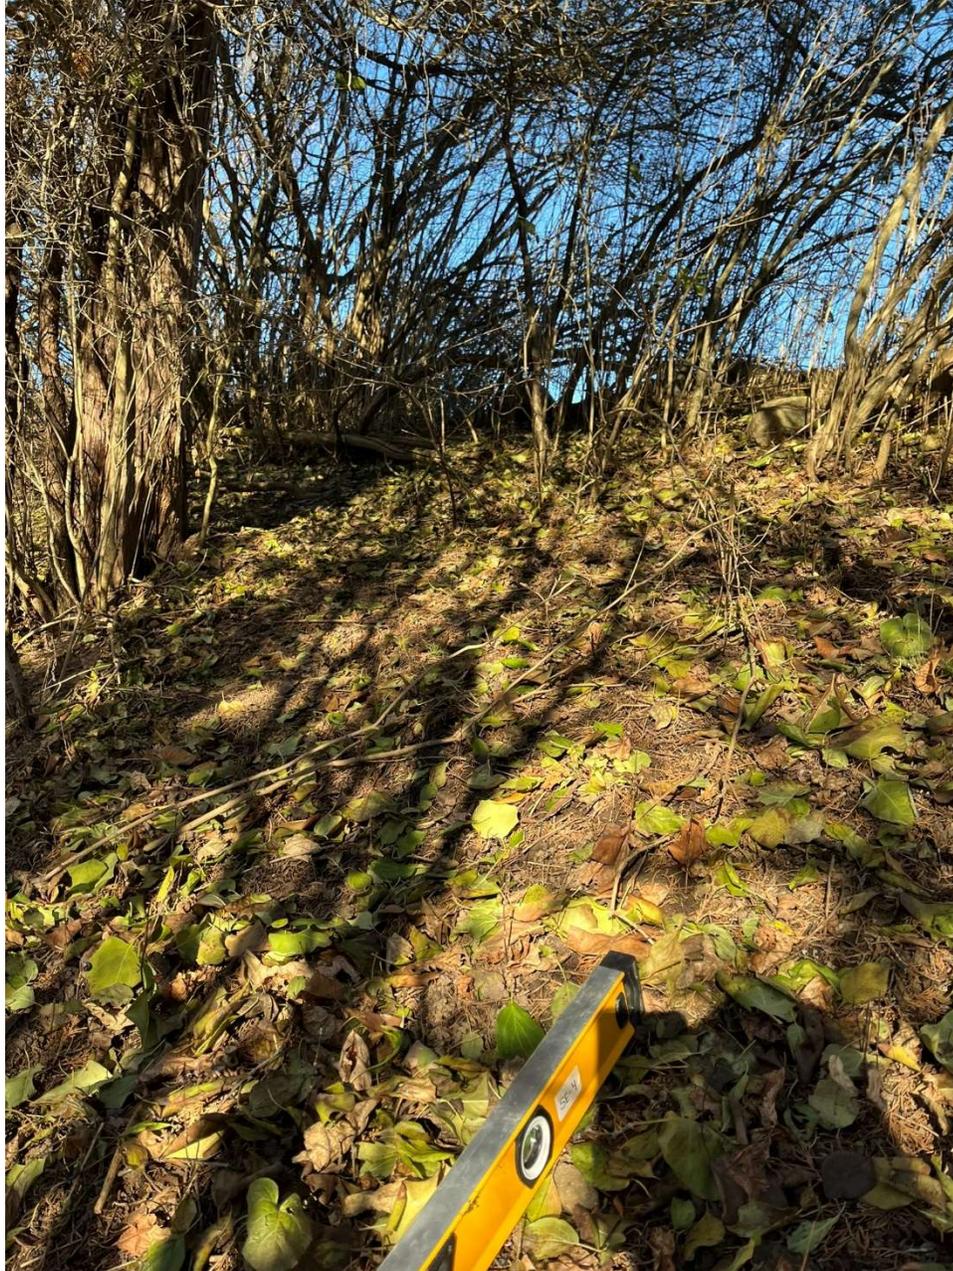
*Figure 2 Section A-A', top portion of slope face, facing north*

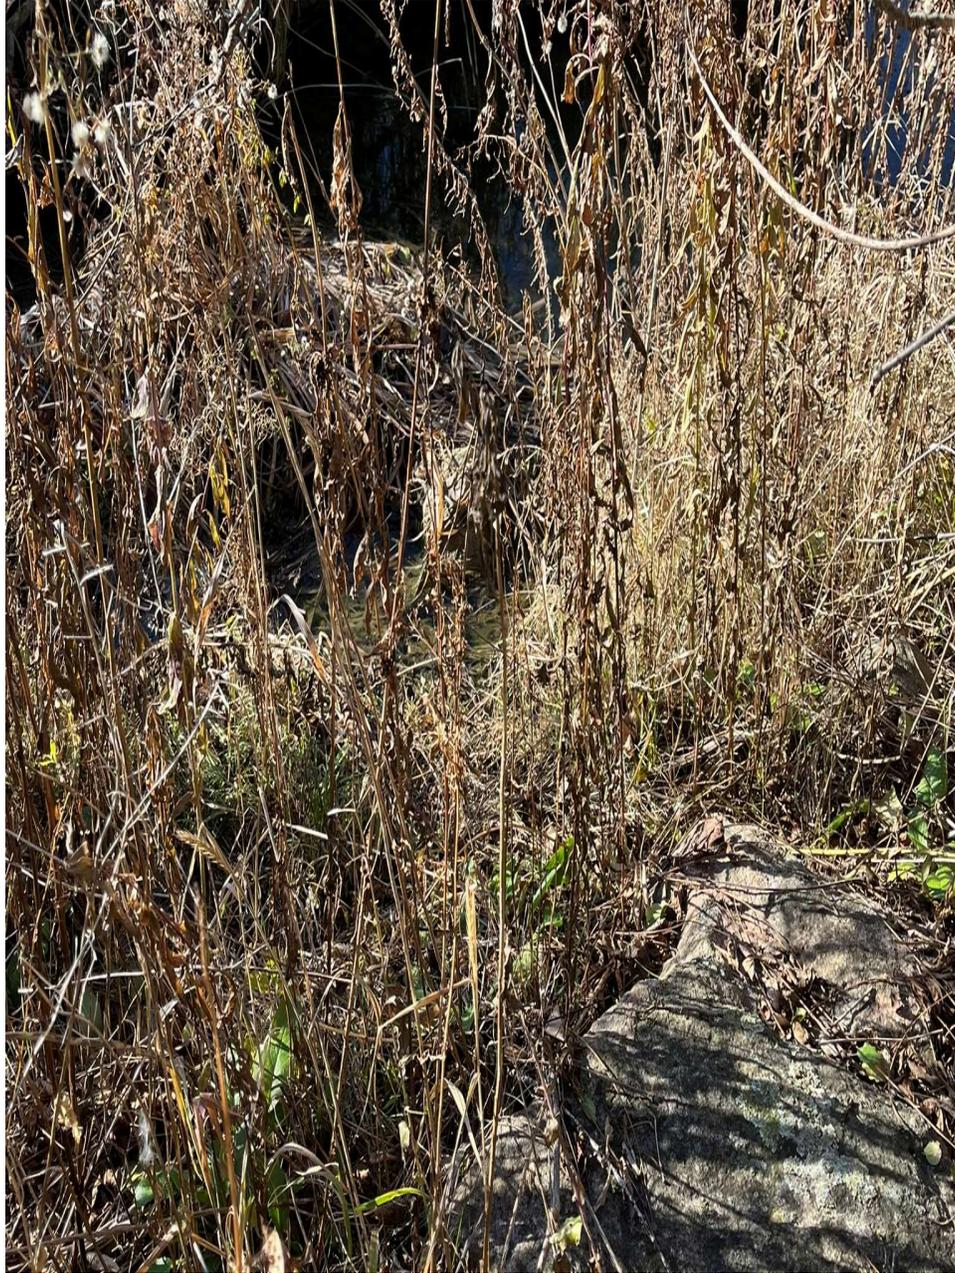
*Figure 3 Section A-A', toe of slope, facing south*

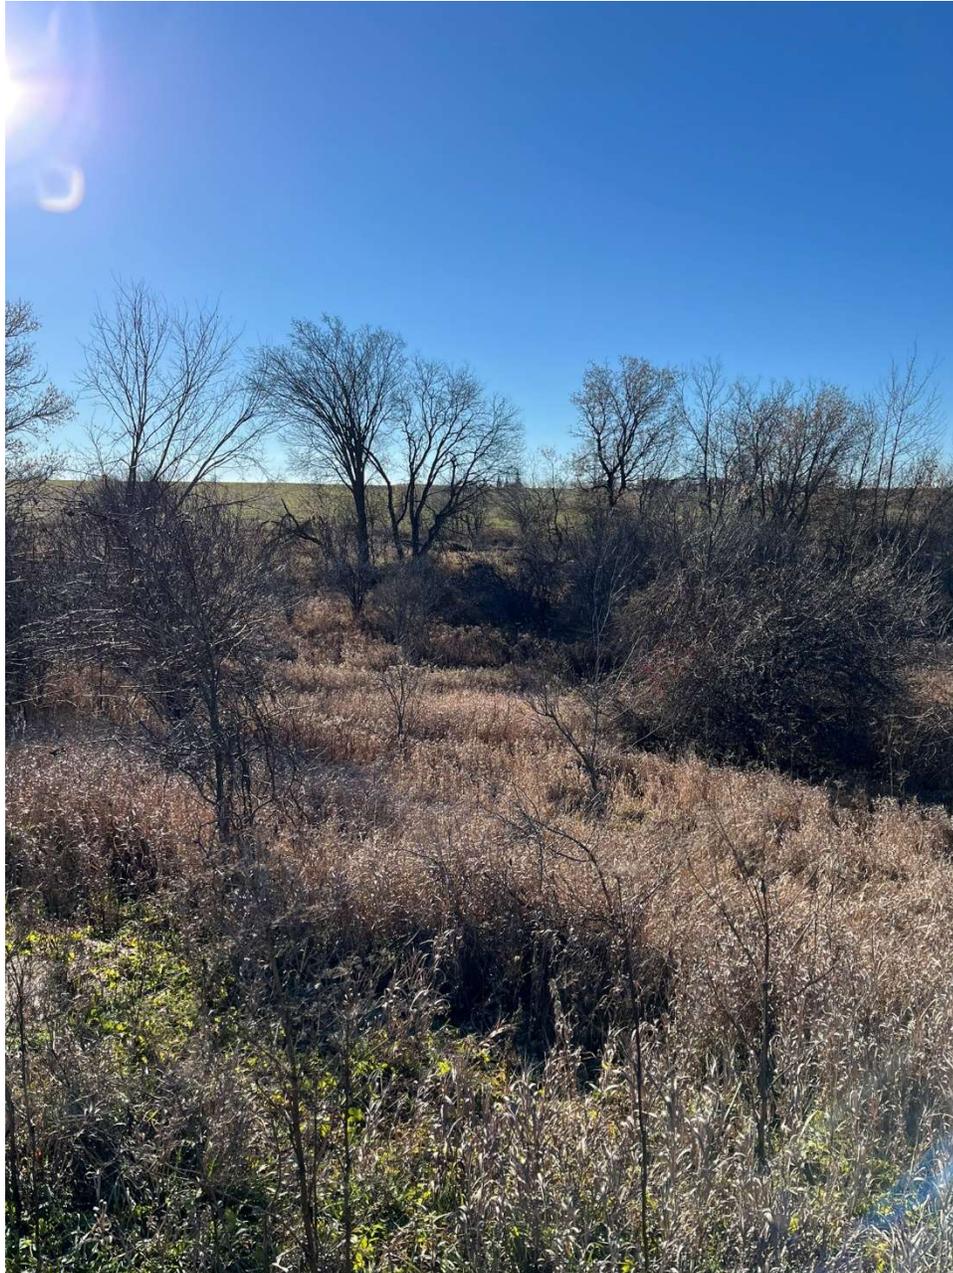
*Figure 4 Section B-B', top of slope, facing south*

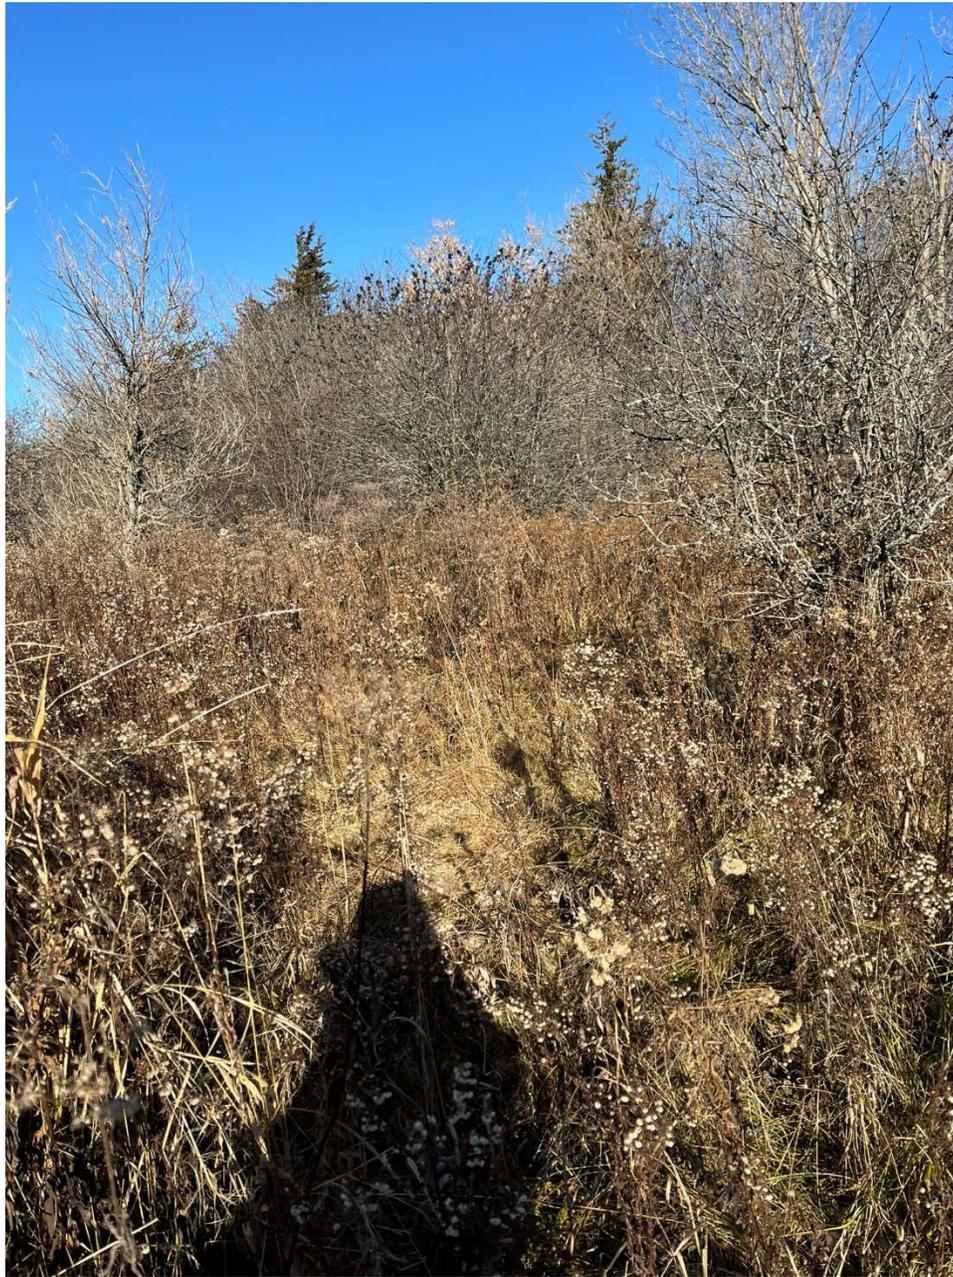
*Figure 5 Section B-B', looking up slope, facing north*

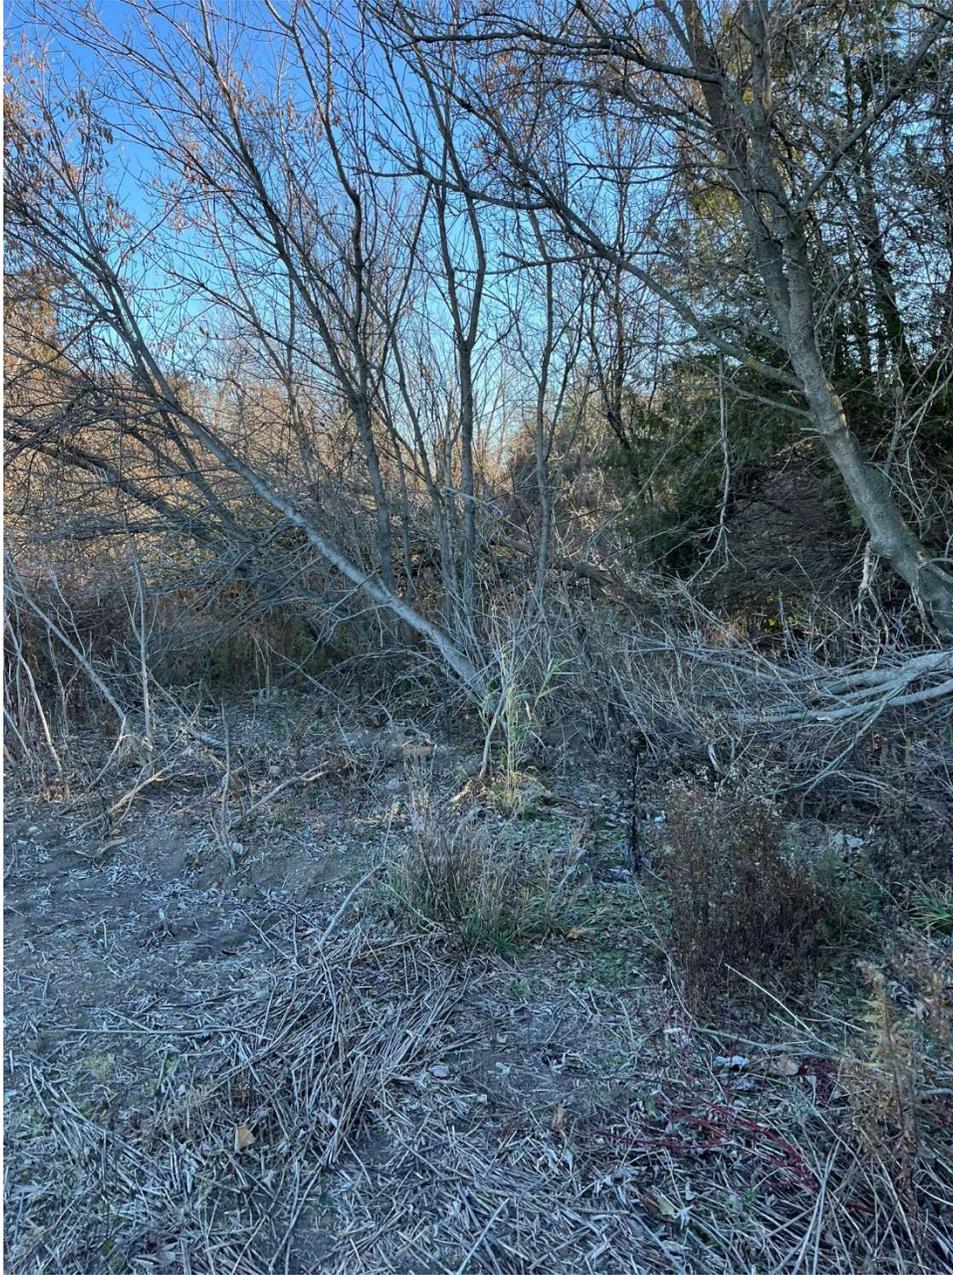
*Figure 6 Section C-C', looking up slope, facing north*

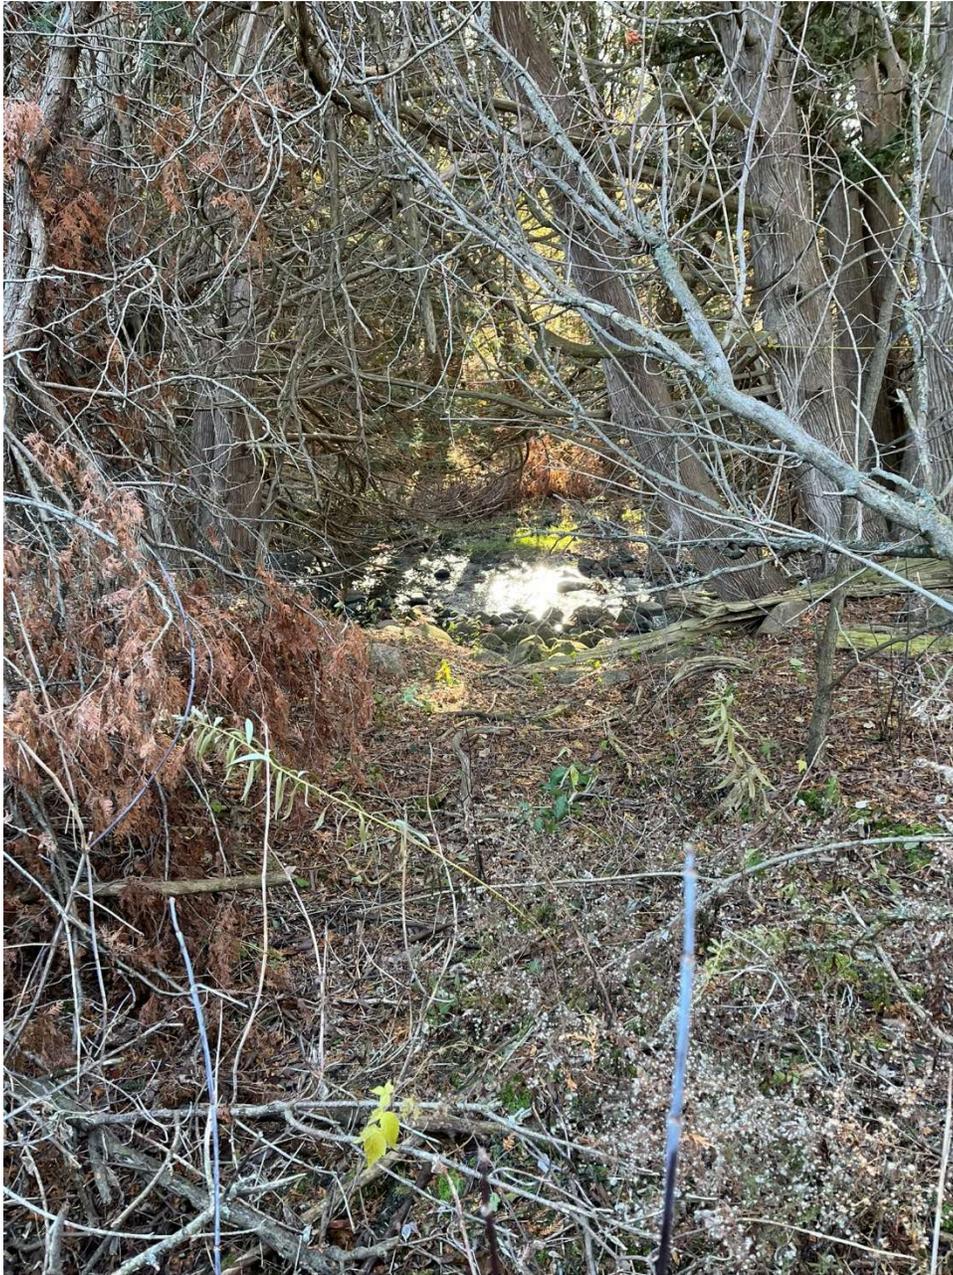
*Figure 7 Section C-C', looking down slope, facing south*

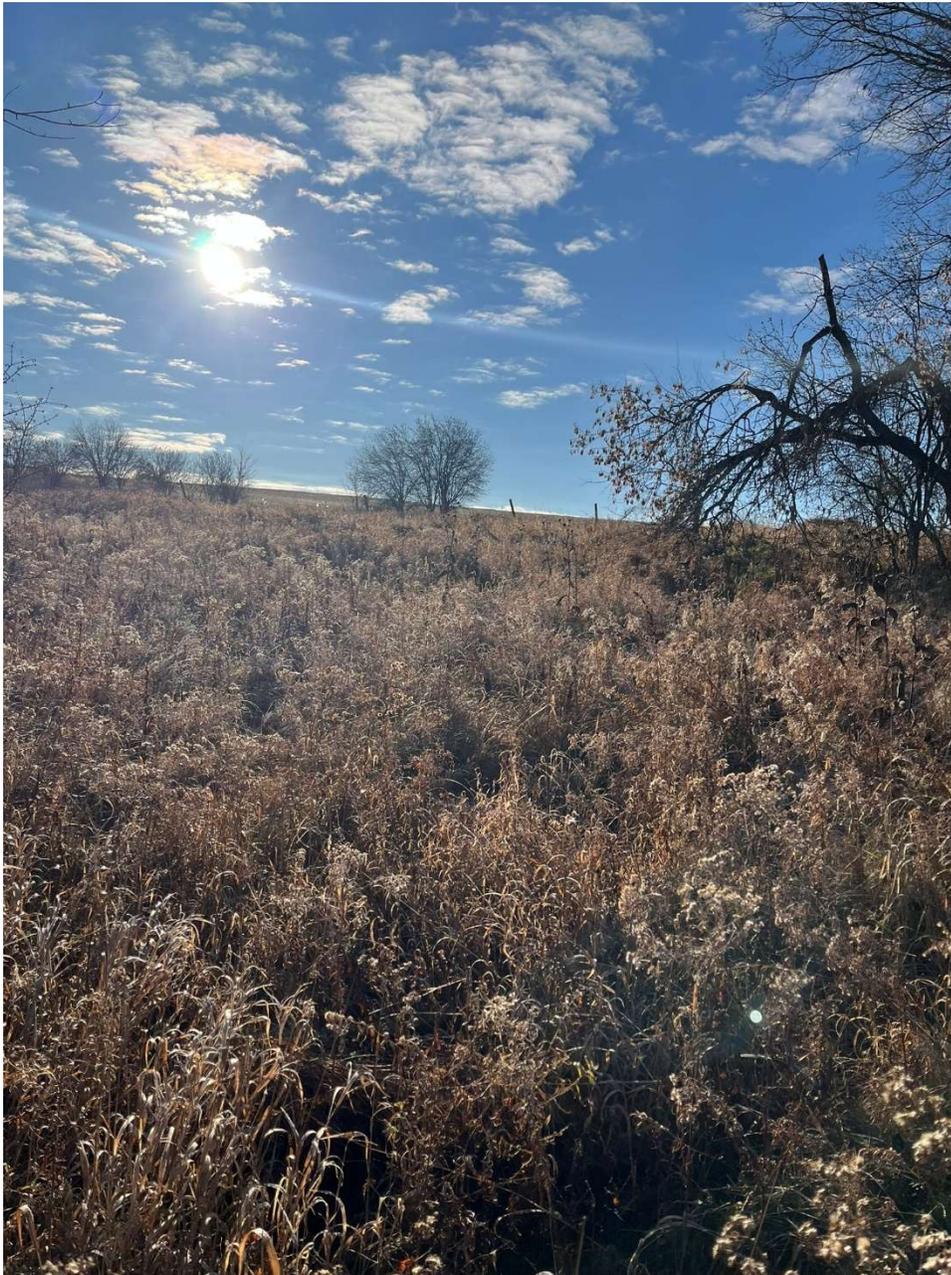
*Figure 8 Section D-D', looking up slope, facing south*

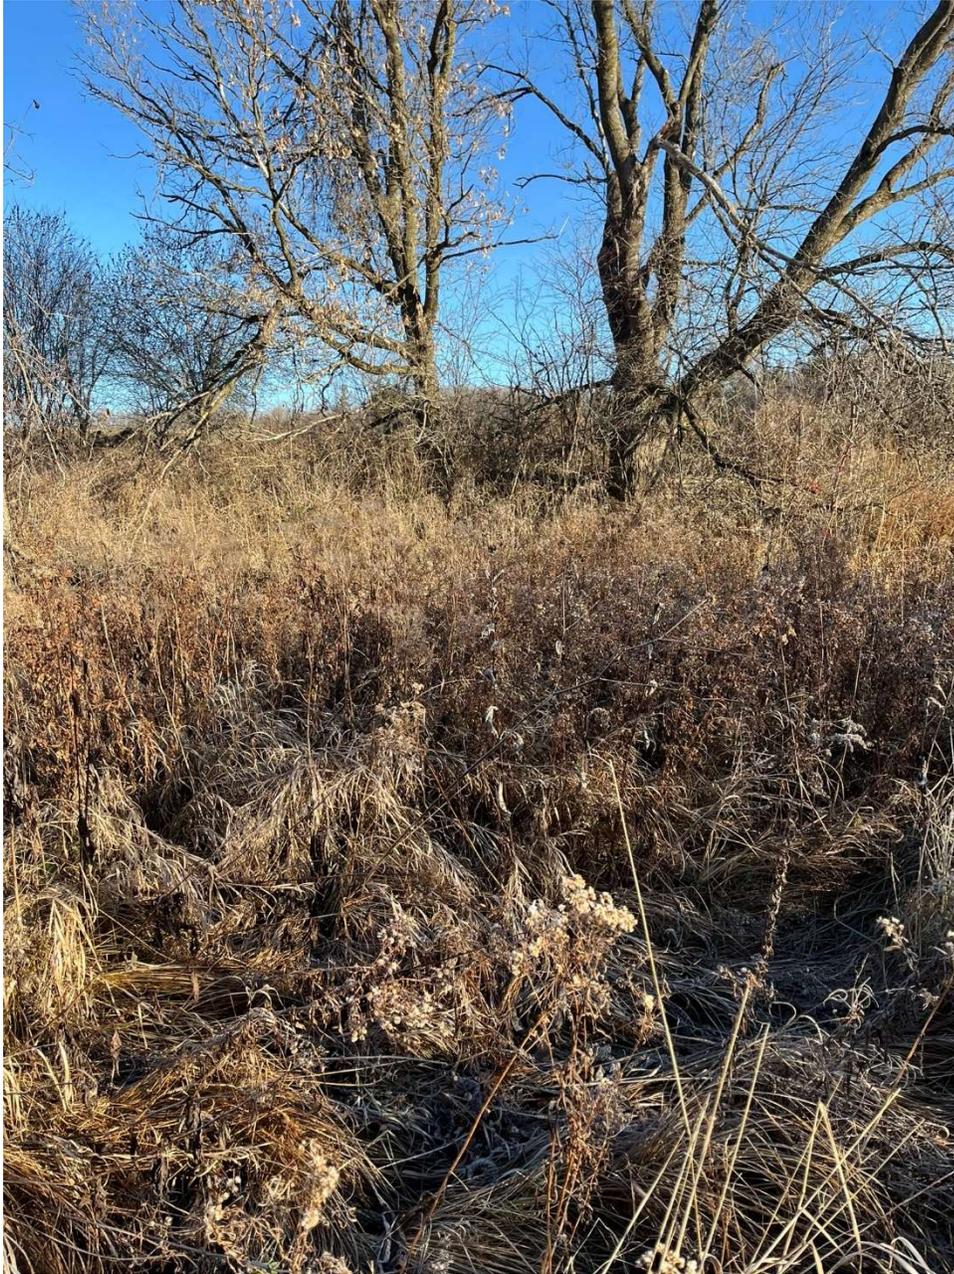
*Figure 9 Section D-D', looking up slope, facing north*

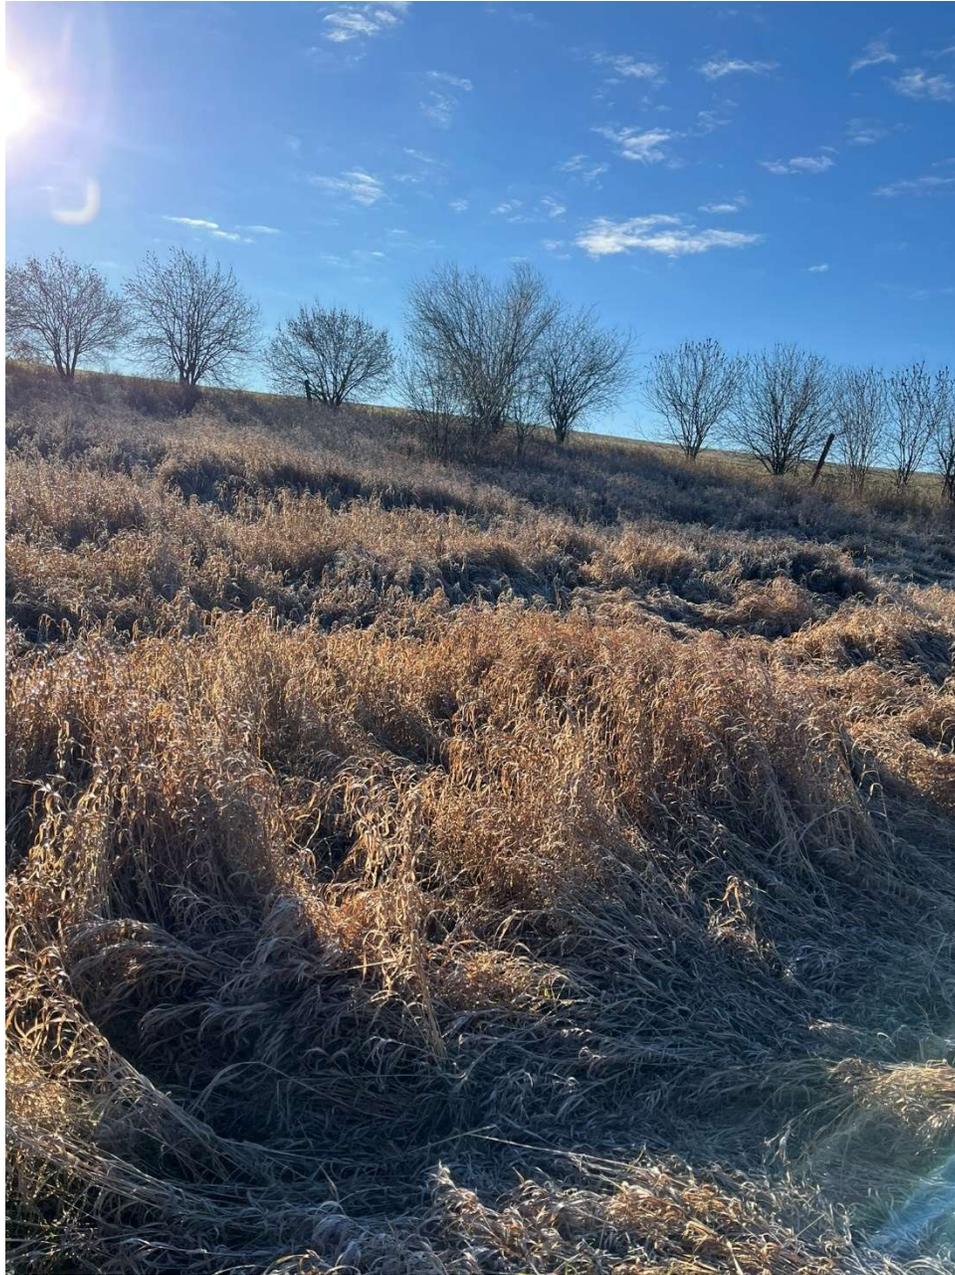
*Figure 10 Section E-E', profile of slope, facing southwest*

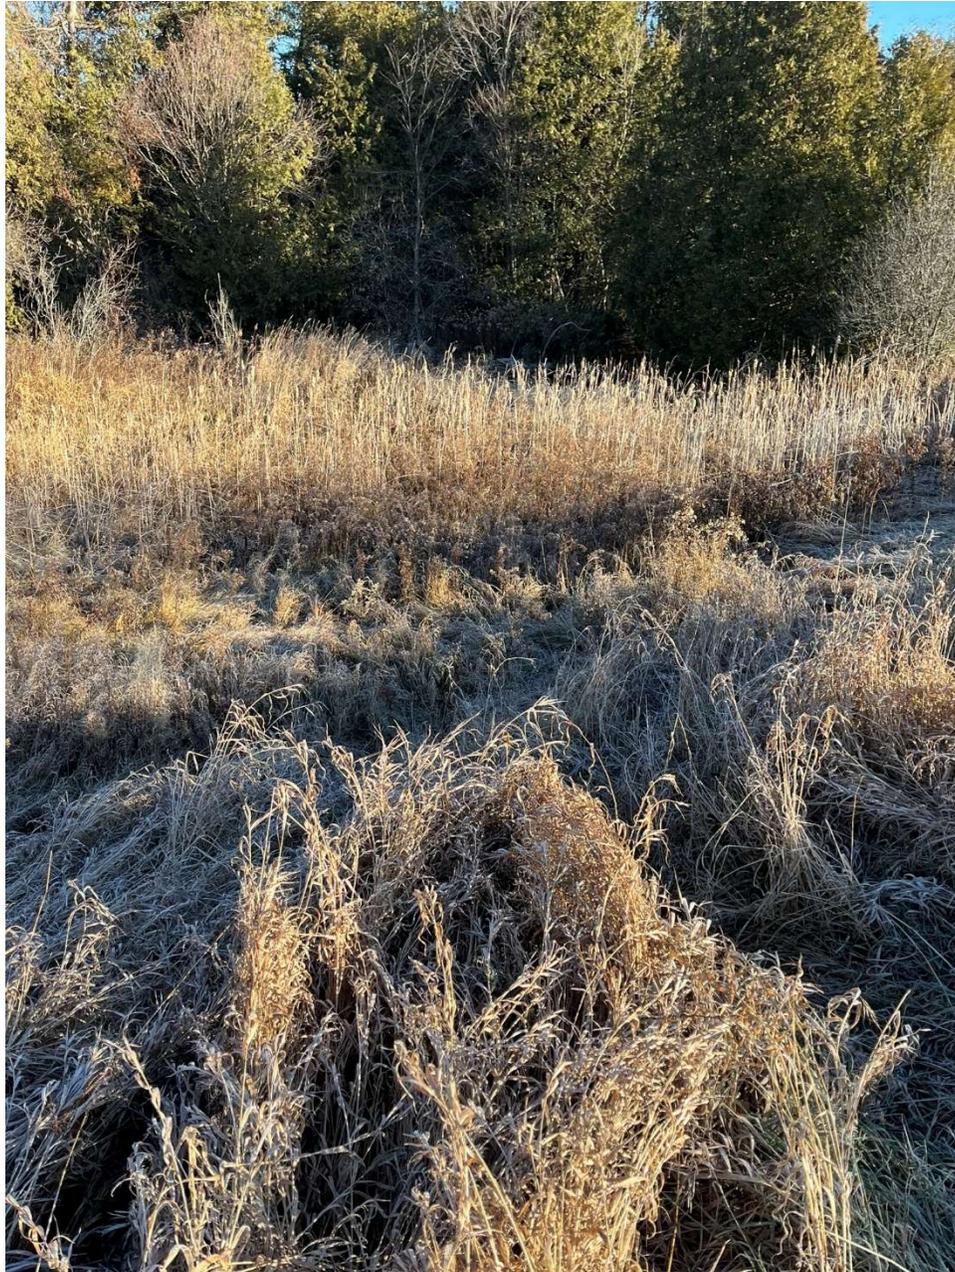
*Figure 11 Section E-E', toe of slope, facing northeast*

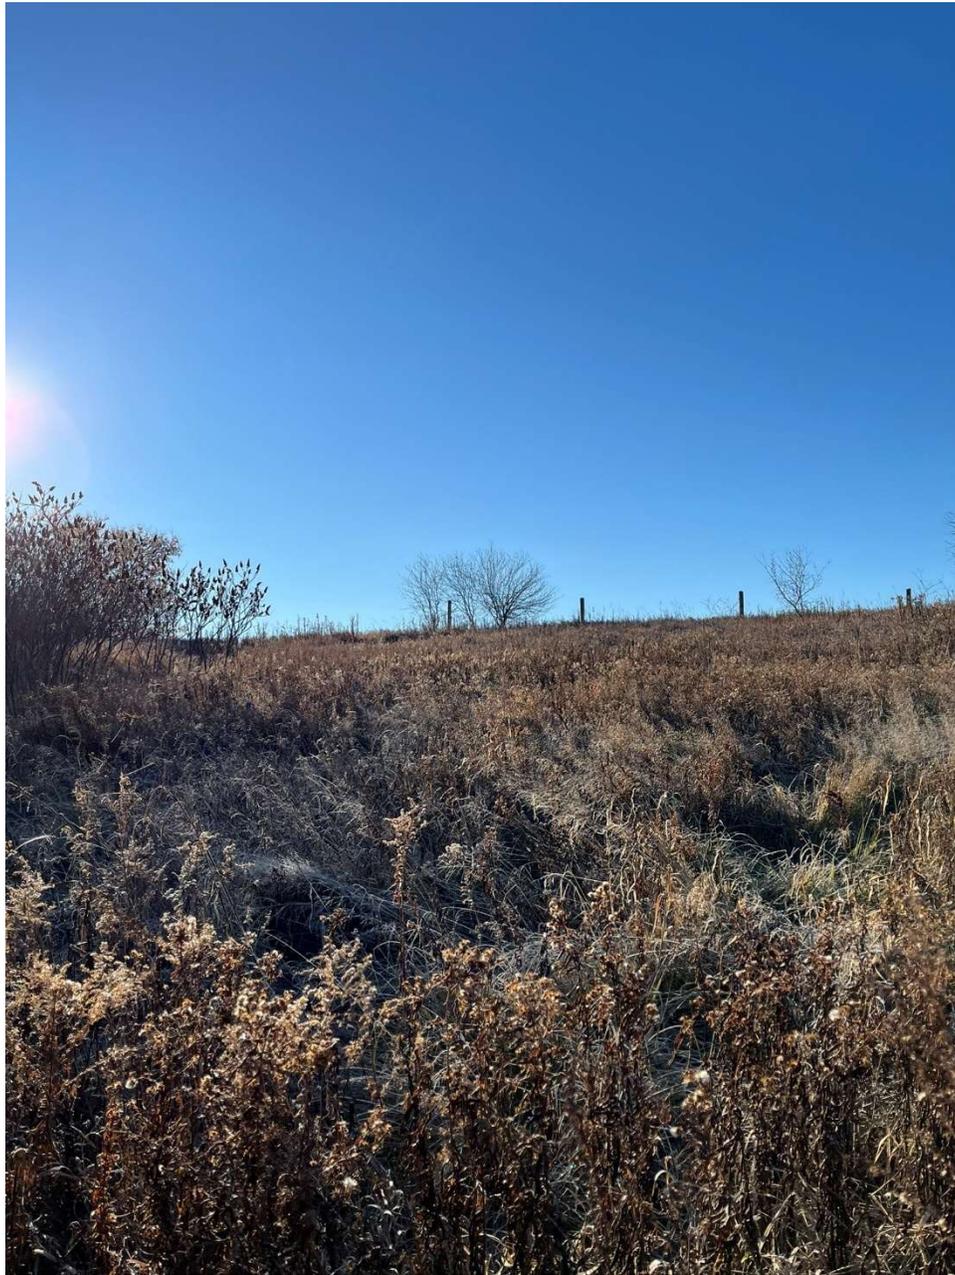
*Figure 12 Section F-F', looking up slope, facing south*

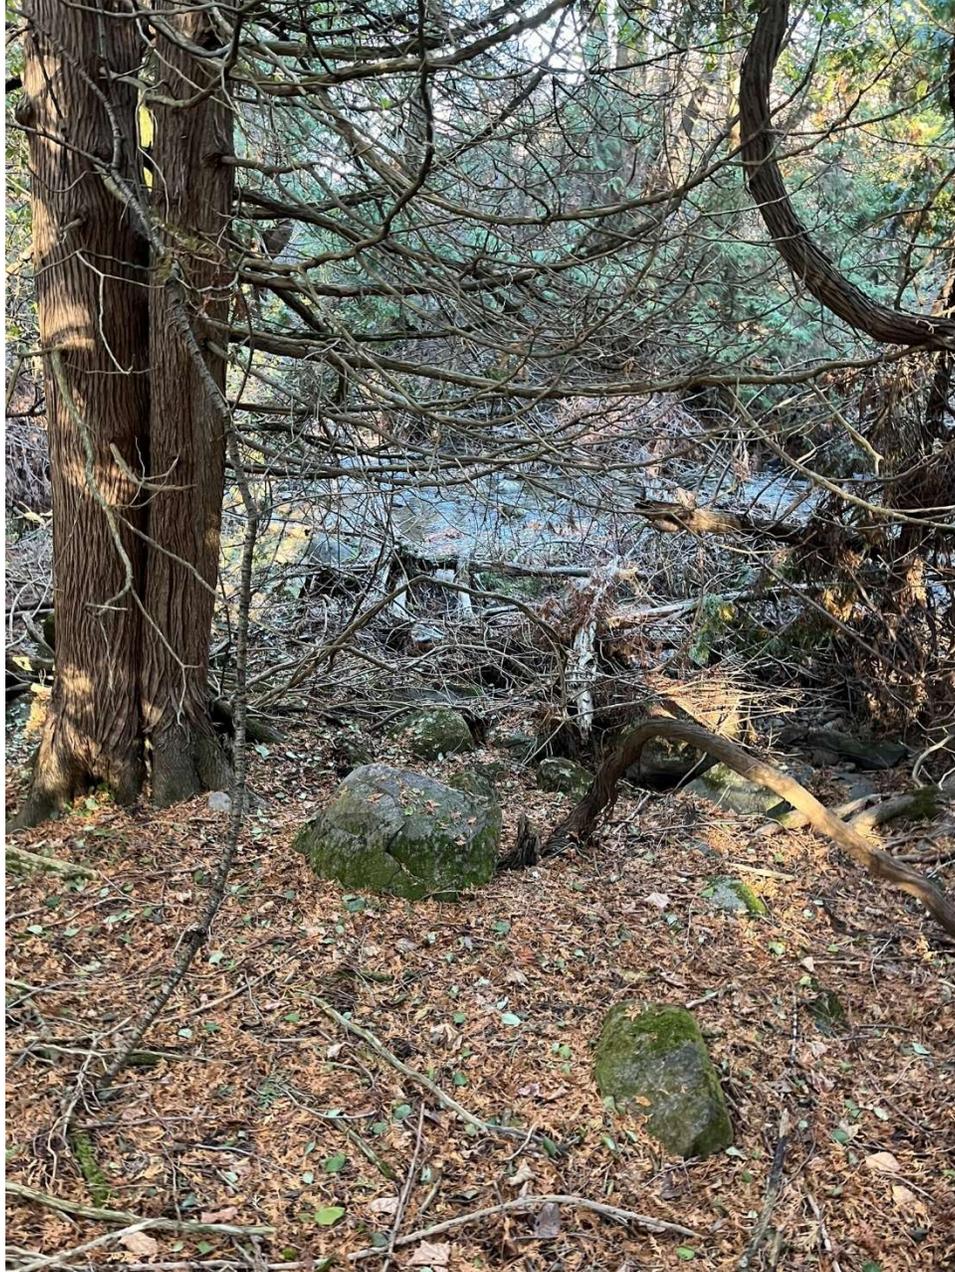
*Figure 13 Section F-F', toe of slope, facing north*

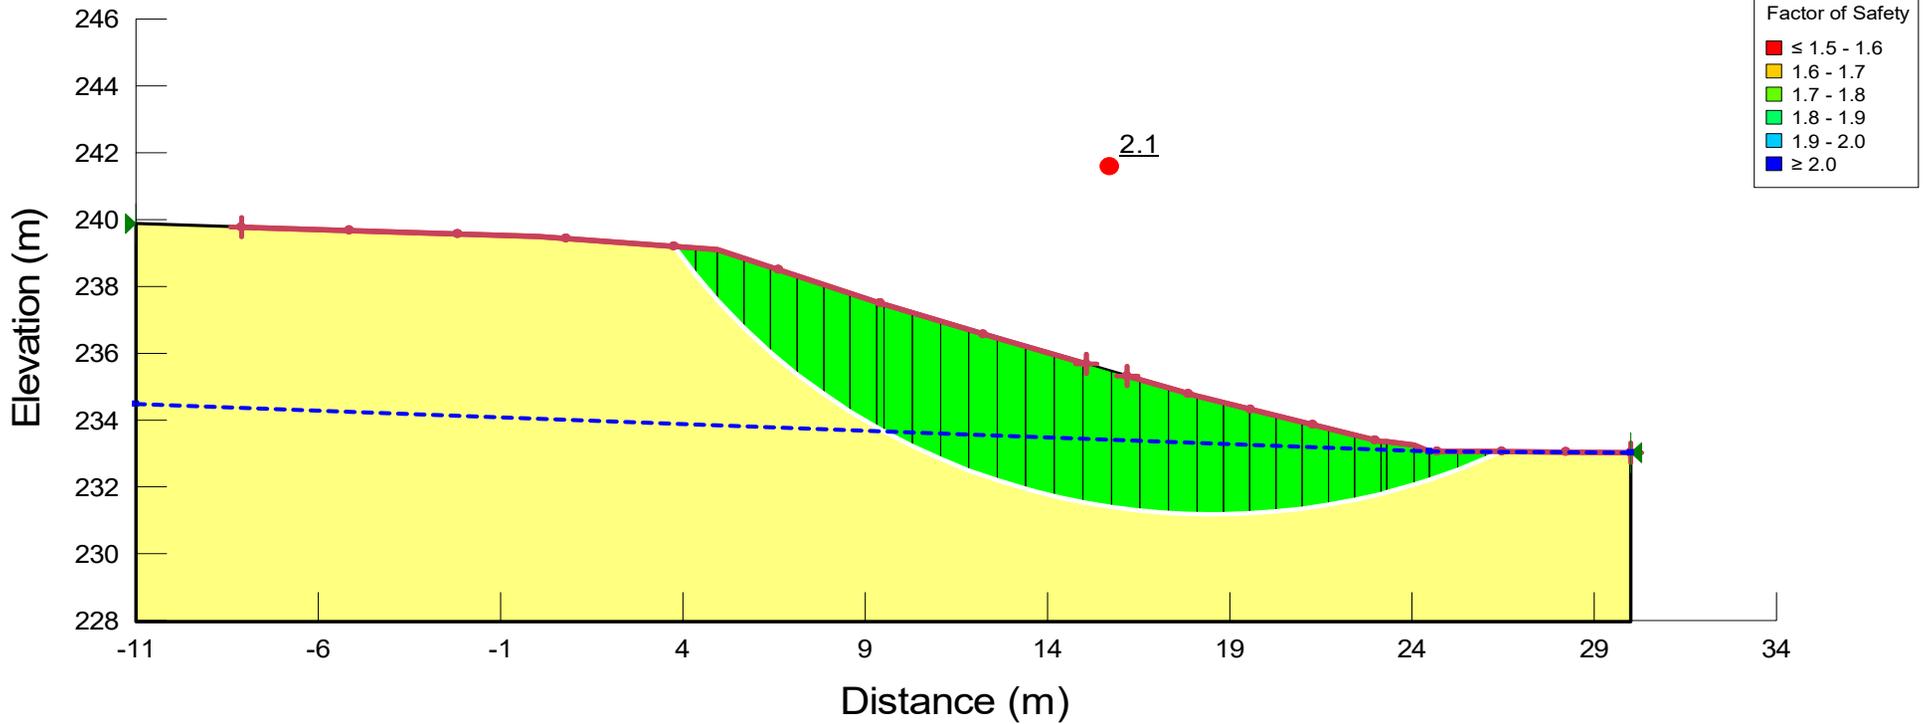
Attachment 3.1

Cross-section A-A with rating value of 21 is considered the most critical for the Site and was selected for the slope stability evaluation. The location for cross-sections A-A' and is shown on **Figure 2**. The graphical output

of the slope stability analysis is provided on **Attachment C**. The minimum factor of safety (FS) obtained for the modelled cross sections A-A' at its existing conditions is 2.1 (**Attachment 3.1**). The minimum FS yielded by this analysis indicates that the existing slope is stable, with an actual FS greater than the targeted factor of safety of 1.5. Additionally, a theoretical slope with inclination of 2 Horizontal (H) to 1 Vertical (V) was modeled (**Attachment 3.2**) and meets the targeted minimum 1.5 FS.

Based on the analytical results of these cross-sections, it is concluded that a slope with an inclination of 2H:1V or flatter can be considered stable from a global stability perspective. For planning purposes, it is recommended that a slope with an inclination of 2H:1V should be considered globally stable, and the top of such slope should be considered the stable top of a slope for planning purposes.
