27 February 2026

**Re: Erosion Hazard Limit Assessment – 963 County Road 10, Cavan-Monaghan, Ontario**

GHD Limited (GHD) was retained by Vargas P Inc. (the Client), represented by you, to conduct an Erosion Hazard Limit Assessment (EHLA) at the property located at 963 County Road 10, Cavan-Monaghan, Ontario (the Site). The Site location is illustrated on the attached **Site Location Plan, Figure 1**. GHD previously completed the following reports for proposed residential and commercial development at this Site:

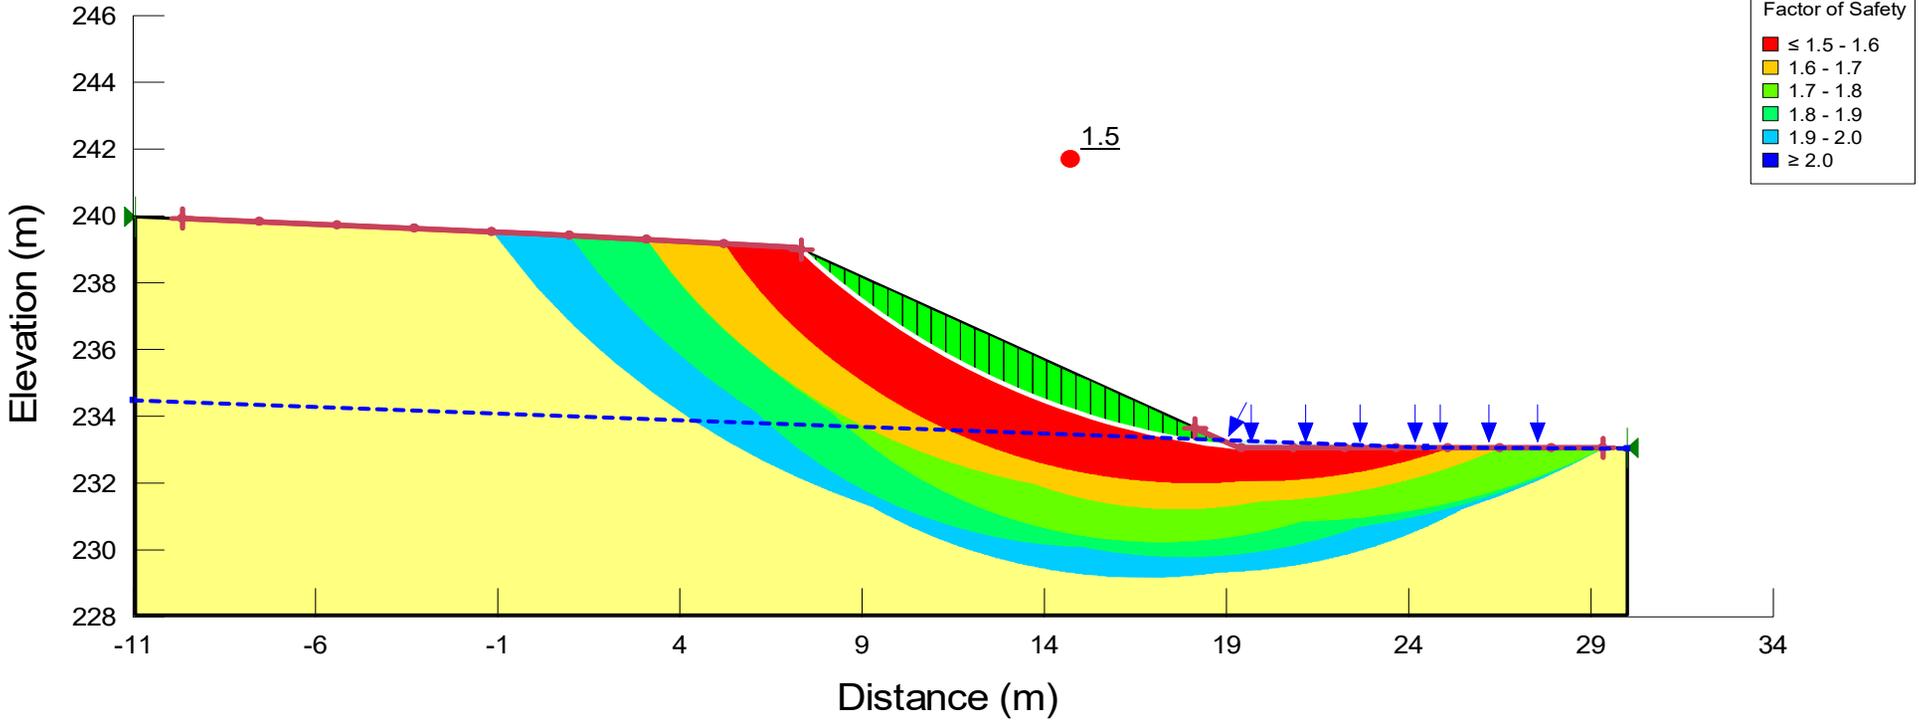
of the slope stability analysis is provided on **Attachment C**. The minimum factor of safety (FS) obtained for the modelled cross sections A-A' at its existing conditions is 2.1 (**Attachment 3.1**). The minimum FS yielded by this analysis indicates that the existing slope is stable, with an actual FS greater than the targeted factor of safety of 1.5. Additionally, a theoretical slope with inclination of 2 Horizontal (H) to 1 Vertical (V) was modeled (**Attachment 3.2**) and meets the targeted minimum 1.5 FS.

Based on the analytical results of these cross-sections, it is concluded that a slope with an inclination of 2H:1V or flatter can be considered stable from a global stability perspective. For planning purposes, it is recommended that a slope with an inclination of 2H:1V should be considered globally stable, and the top of such slope should be considered the stable top of a slope for planning purposes.
