Erosion Hazard Limit Study Report

Heritage Line Residential Development

**Lot 14, Concession 6, Otonabee-
South Monaghan, ON**

D.M. Wills Project Number 21-10985

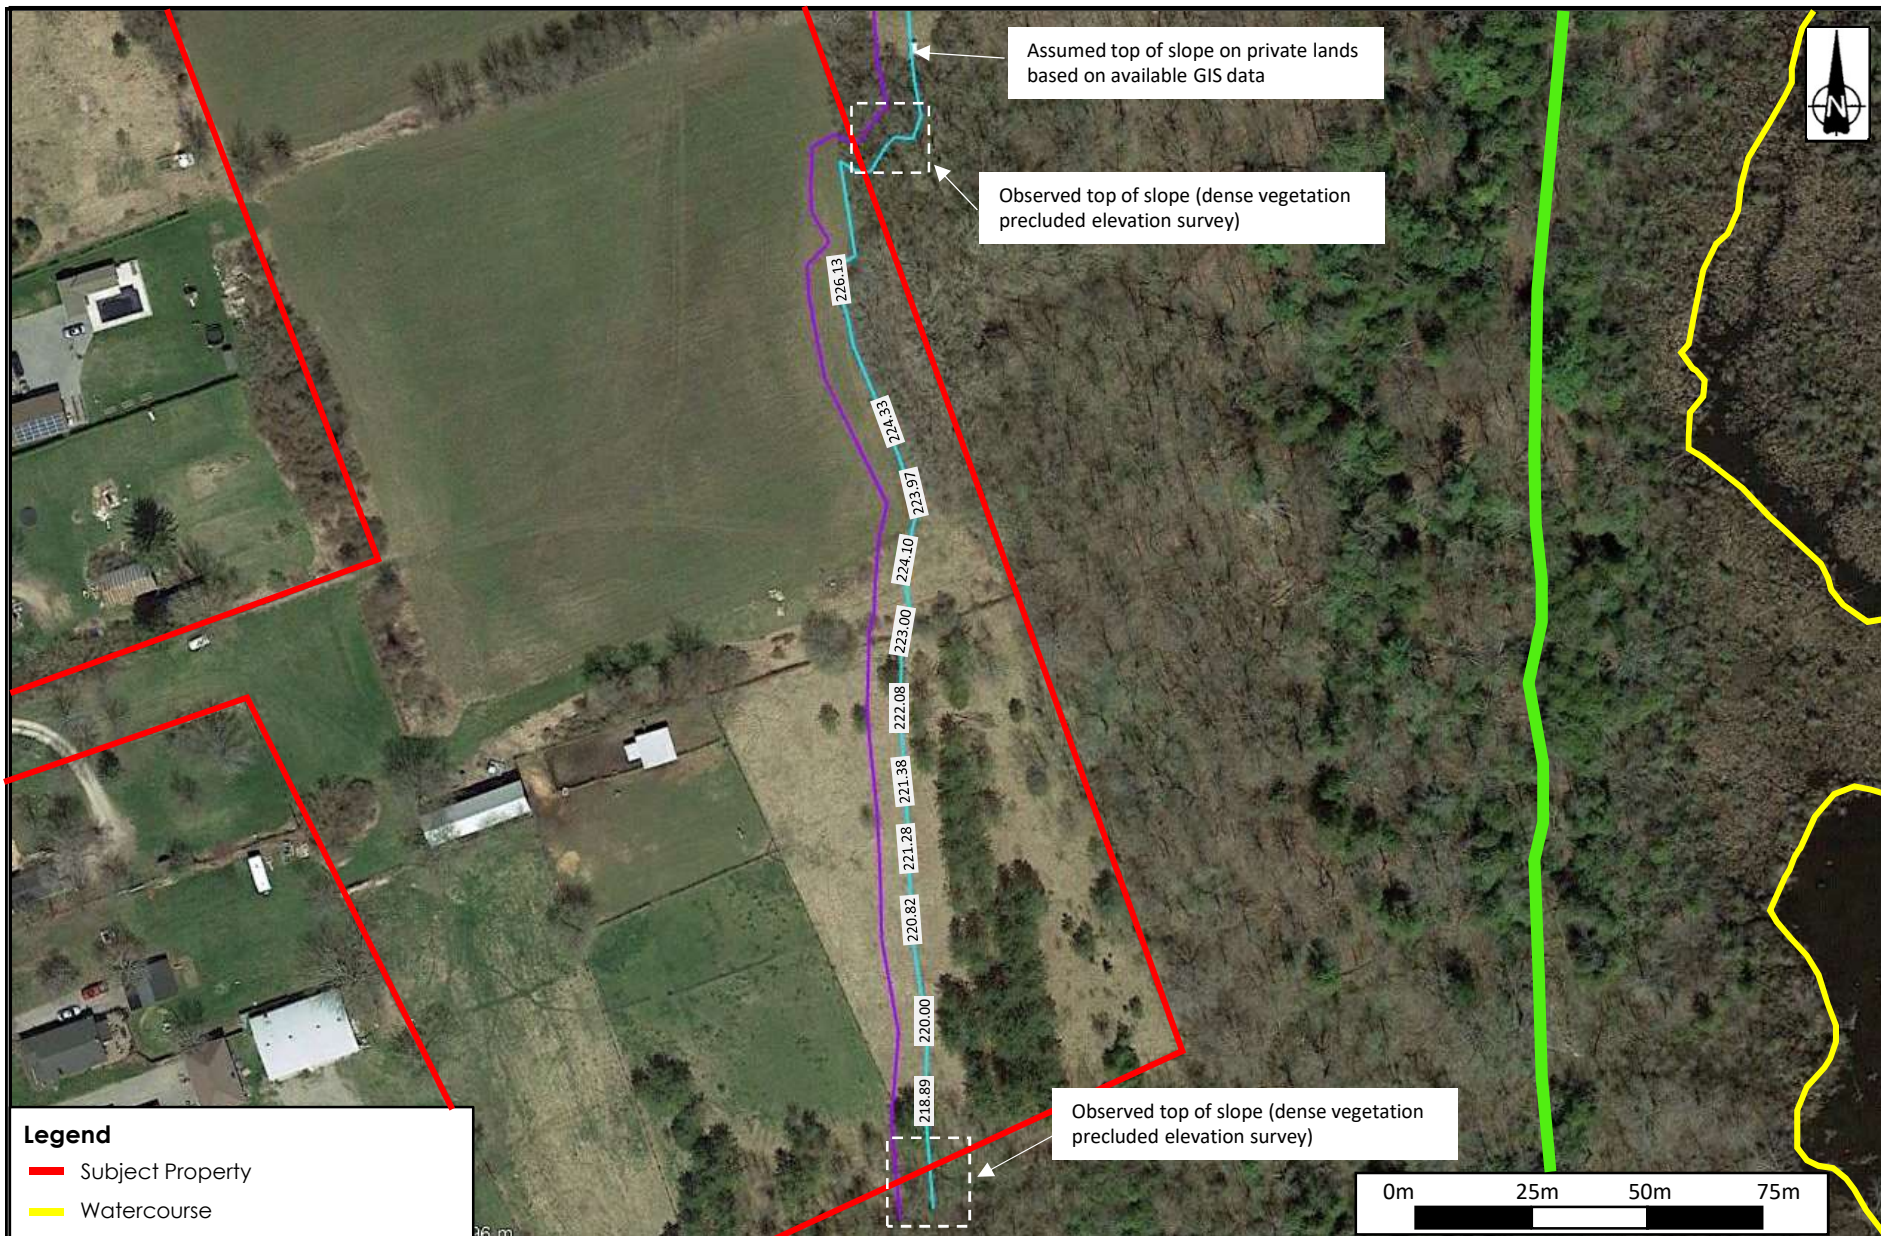
Slope Stability Setback Plan

- A toe erosion allowance was not applied in view of the Indian River (watercourse) being in excess of 15 m away from the toe of slope.
- The long term stable top of slope (LTSTOS) was determined to be the existing top of slope, as determined by Wills staff during the site reconnaissance.

- Based on the Technical Guideline, a 6 m erosion access allowance was applied beyond the LTSTOS. Although this allowance will likely not be required to permit slope stabilization activities, the 6 m allowance also coincides with the 6 m development setback limit provided in ORCA's *Watershed Planning & Regulation Policy Manual* (updated December 4, 2015) for subdivisions, condominiums, and consents in the vicinity of a confined/apparent valley system.

- Wills' second site visit (June 6, 2022) included a confirmatory visual inspection and elevation survey of the LTSTOS. Based on the field observations and accompanying survey data, it was confirmed that the LTSTOS transects multiple contour elevations, as a result of the gentle south-southeast dipping gradient of the Subject Property.

- During the second site visit, very dense vegetation prevented the survey of the LTSTOS to the east and south of the Subject Property limits. Wills visually confirmed the location of the LTSTOS, and observed that it was generally perpendicular to the Subject Property boundary at both locations. The projection of the LTSTOS off of the Subject Property is shown on **Figure 3**.

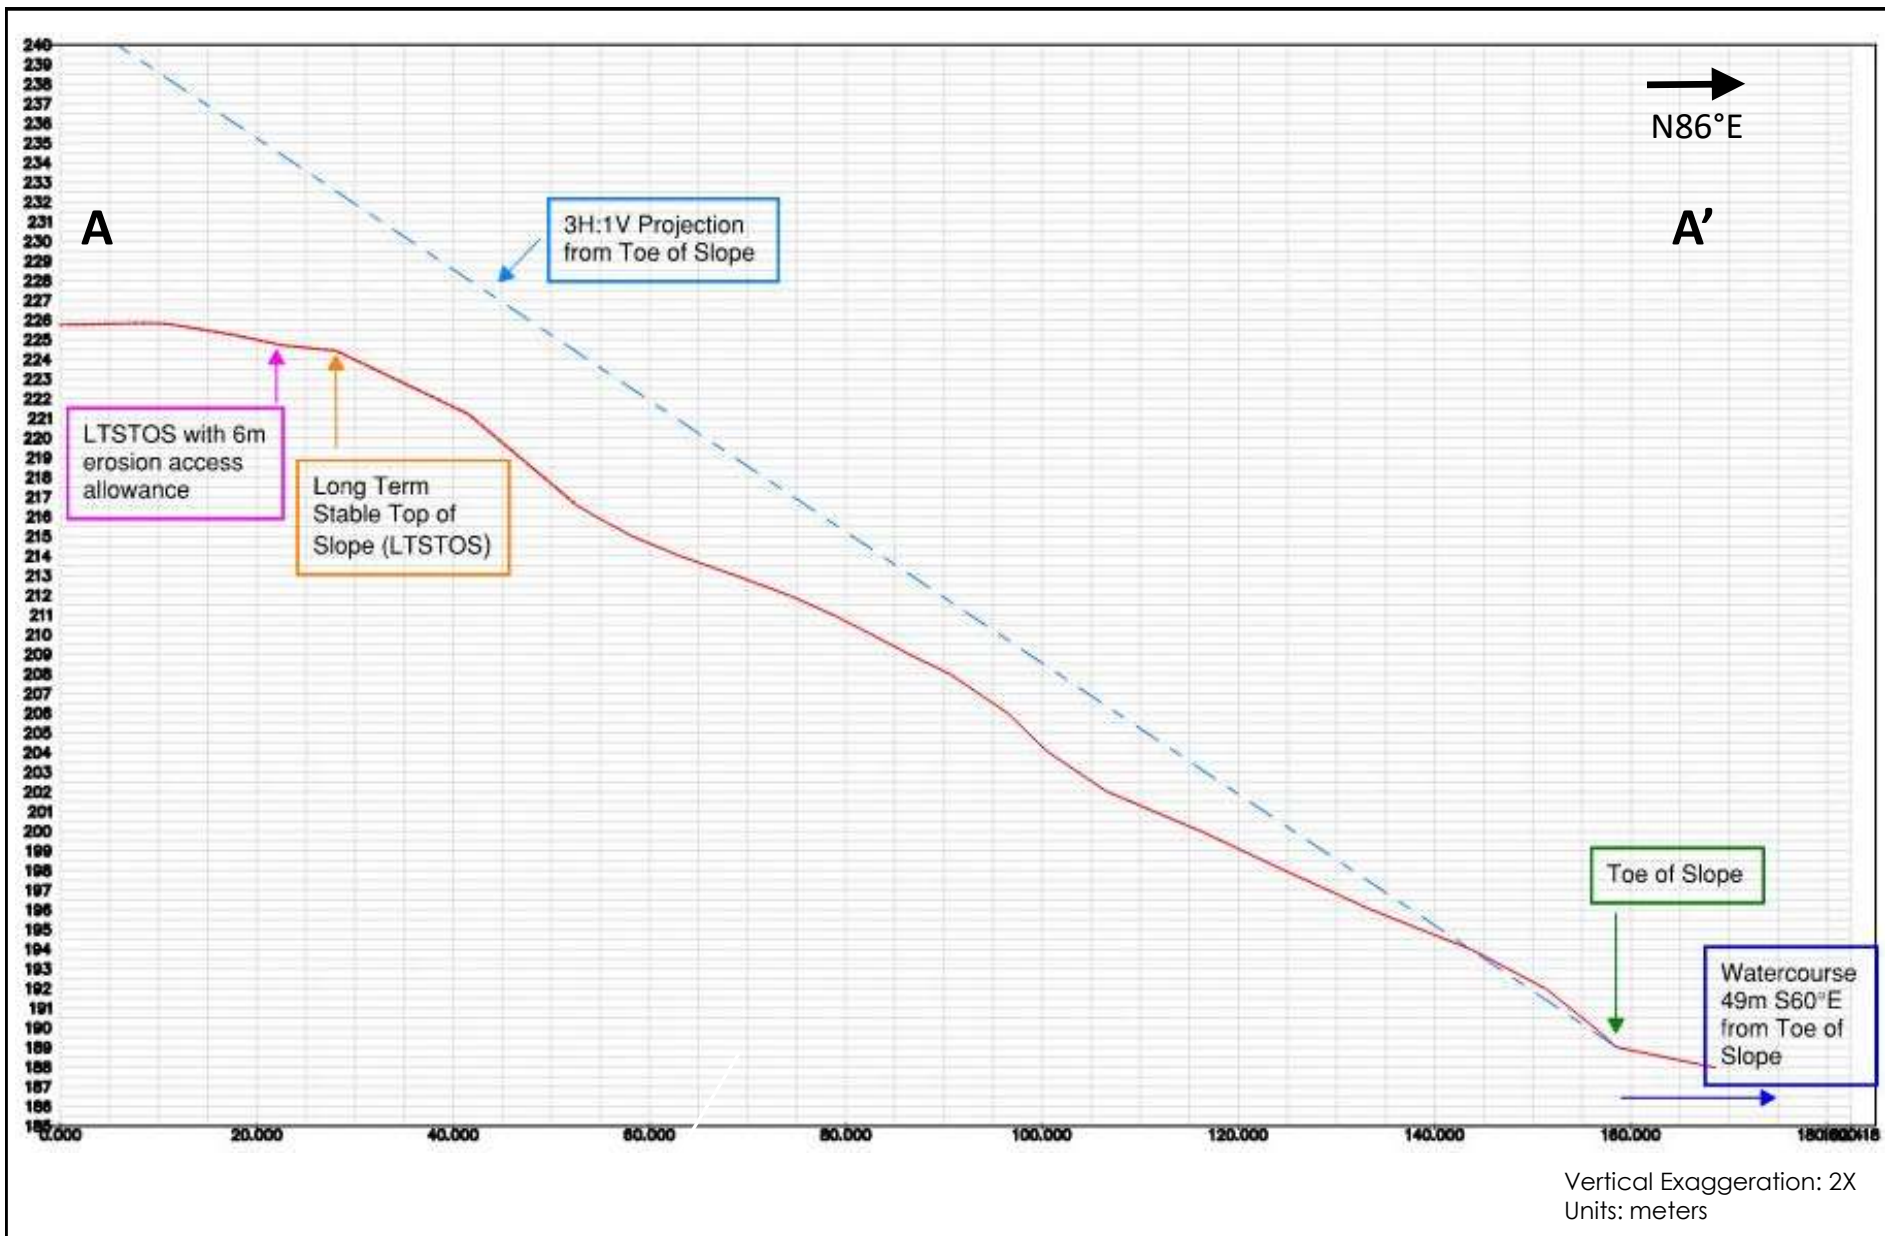
Slope Section AA'

- Existing topographic survey for the Subject Slope, and Wills' confirmatory slope measurements indicate the Subject Slope has an overall gradient that is shallower than 3H:1V (as projected from the toe of slope), and is considered stable on the basis of the Technical Guideline.

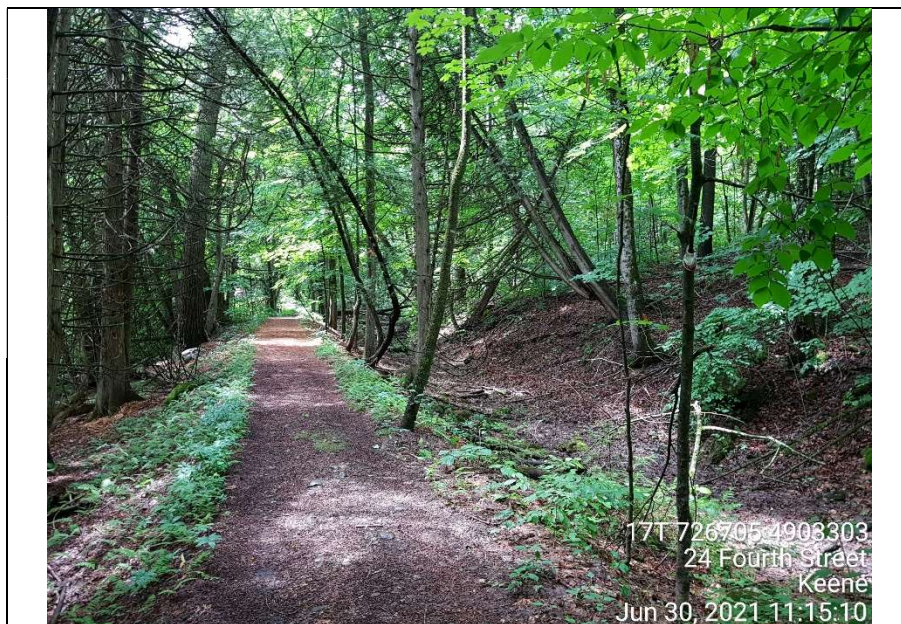
Photograph No.: 1
Date: June 30, 2021
Direction: South
Description: Trail adjacent to toe of slope.

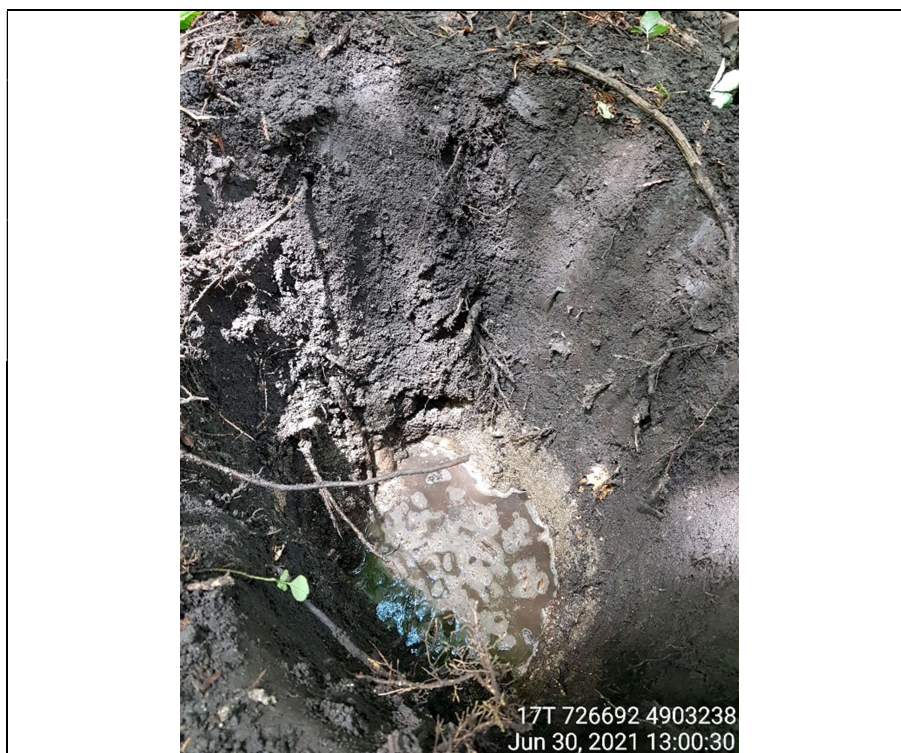
Photograph No.: 2
Date: June 30, 2021
Direction: West
Description: TP21-01 at toe of slope. Dark brown sandy silt topsoil overlying light brown sand material. Groundwater pooling in test pit.

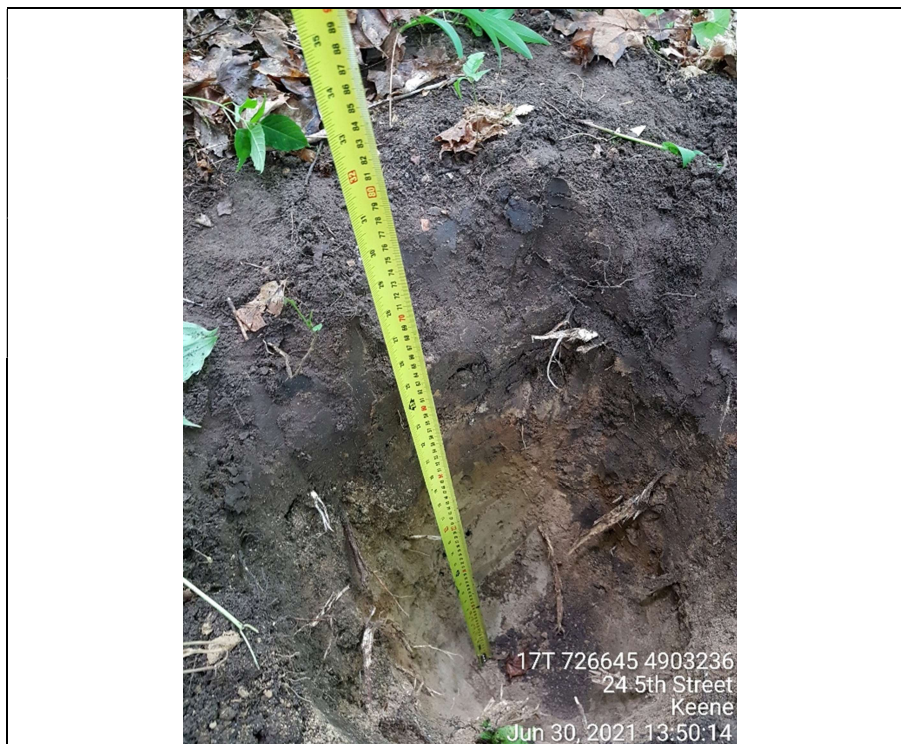
Photograph No.: 3
Date: June 30, 2021
Direction: West
Description: TP21-02 on slope face. Dark brown sandy silt topsoil overlying medium to light brown silty sand till. No groundwater encountered.

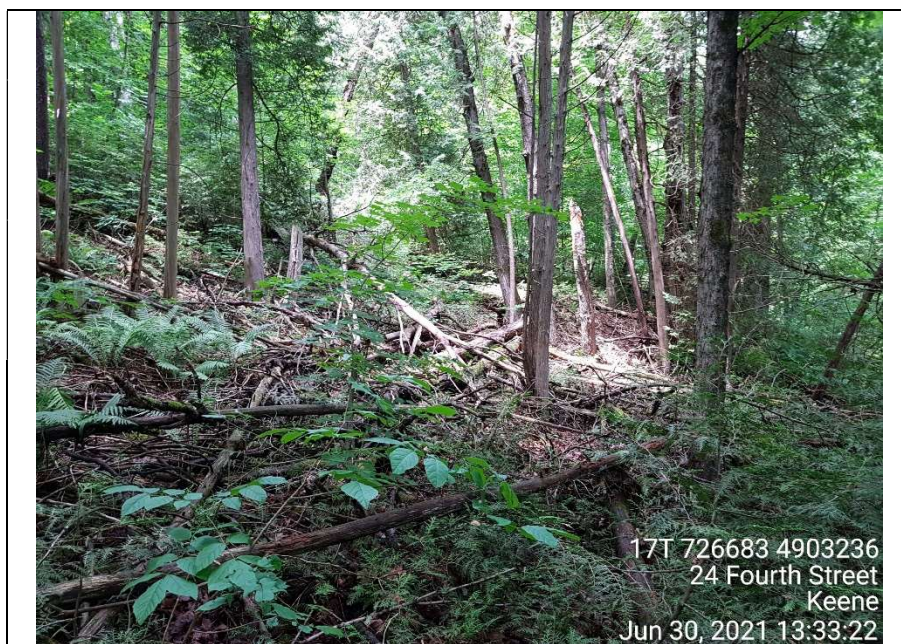
Photograph No.: 4
Date: June 30, 2021
Direction: North
Description: View of mid-section of slope. Ground cover, mixed forest and deadfall.

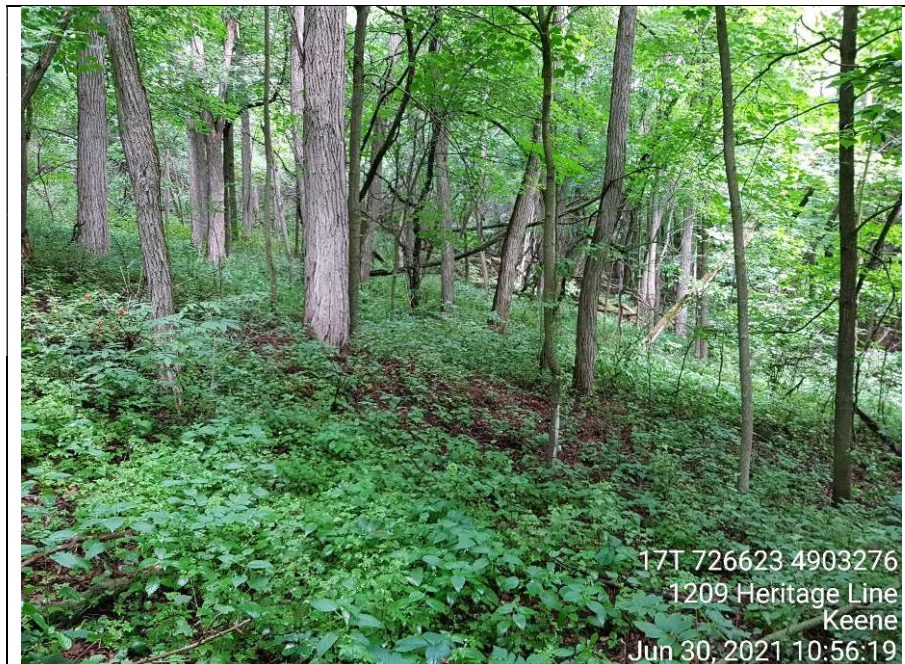
Photograph No.: 5
Date: June 30, 2021
Direction: North
Description: Mid-section of slope. Ground cover and hardwood growthq.

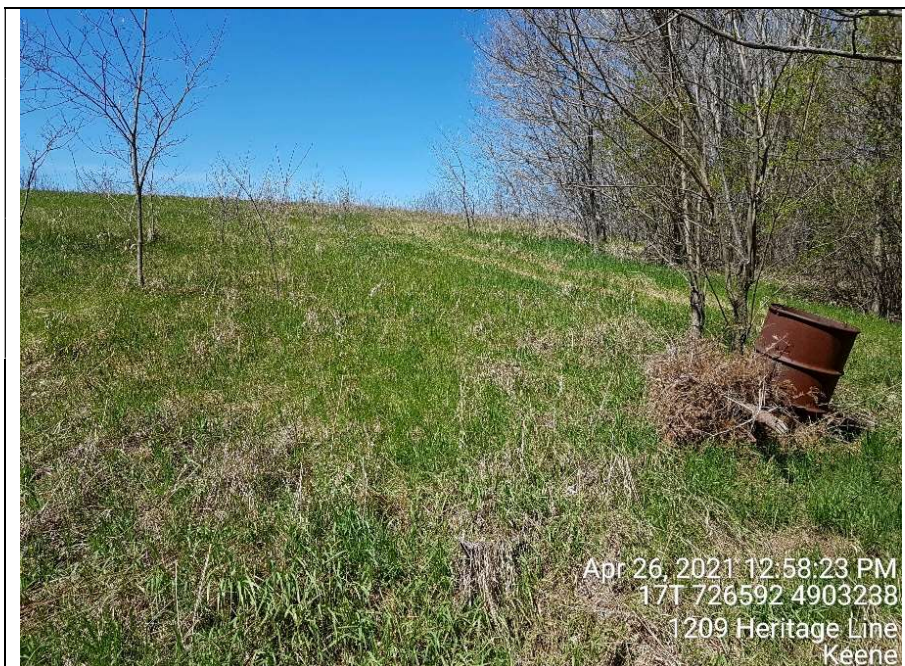
Photograph No.: 6
Date: June 30, 2021
Direction: Northwest
Description: Photo taken west of tree line, slope crest visible in background.

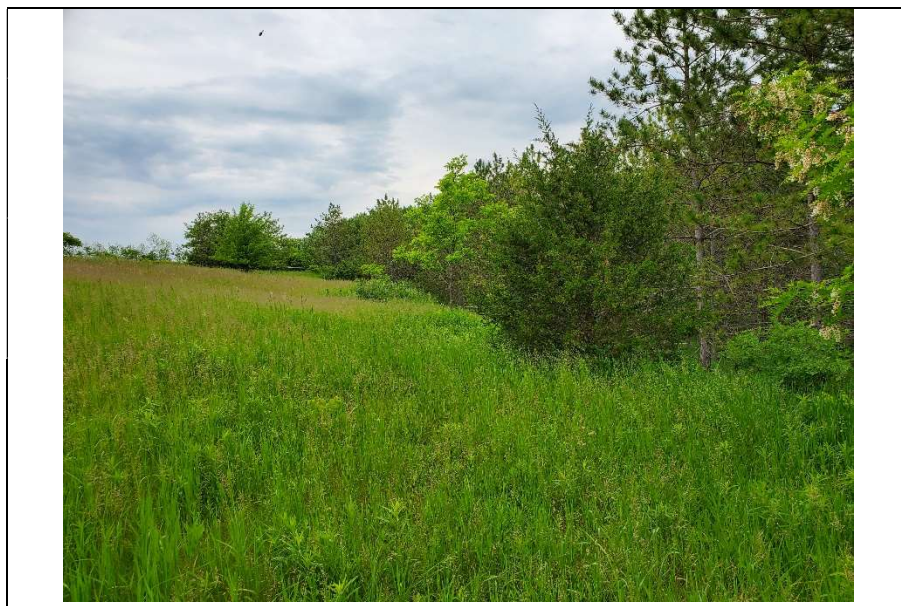
Photograph No.: 7
Date: June 06, 2022
Direction: North
Description: Southern end of Subject Property. Slope crest visible on the right.
