**963 County Road 10, Millbrook
Cavan-Monaghan, ON**

Fluvial Geomorphic Assessment

February 26, 2026

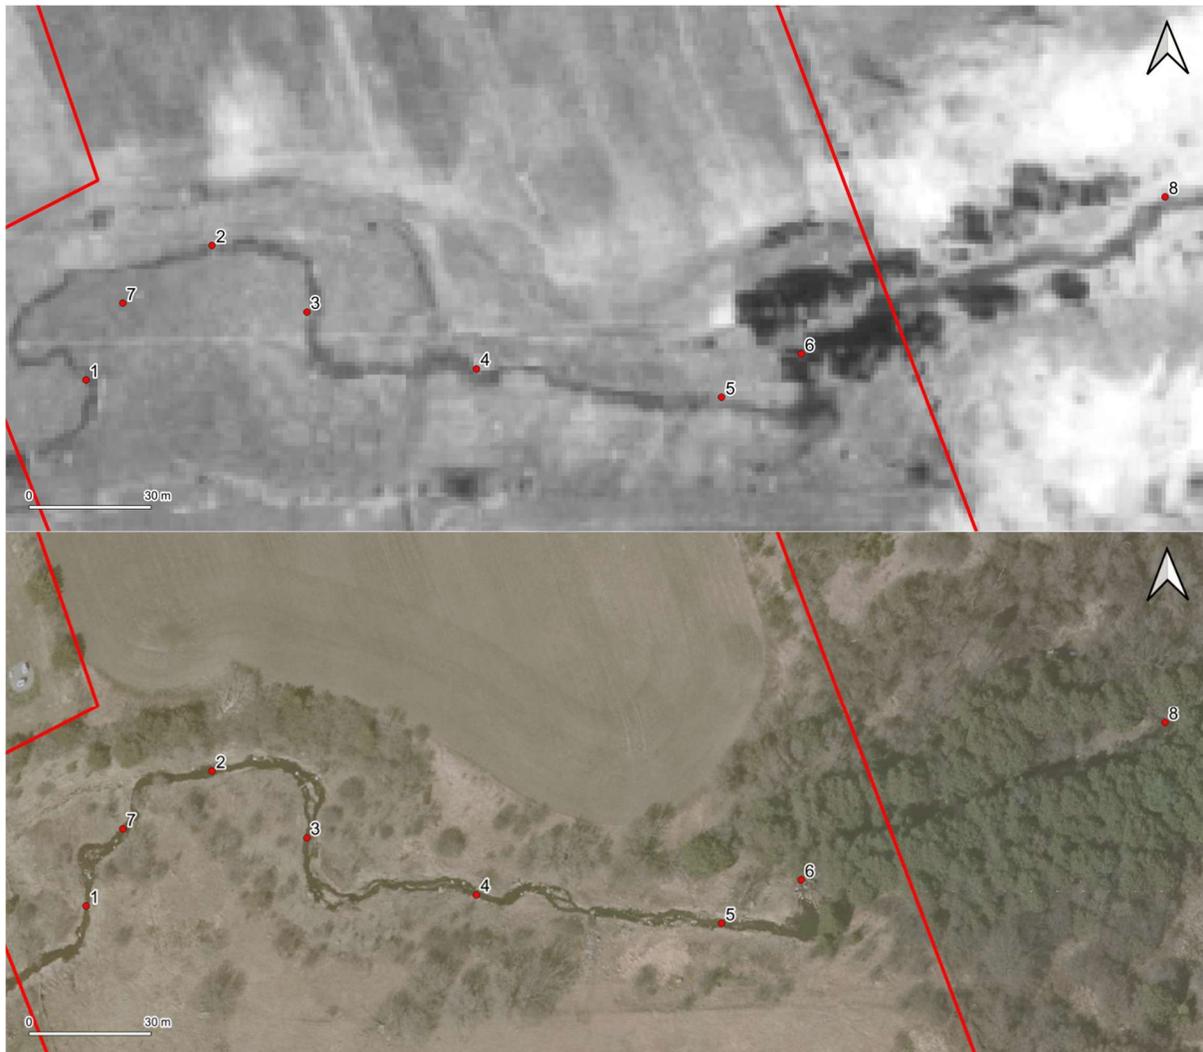
Figure 3: Aerial photo comparison from 1975 to 2024

Although the historical imagery was not suitable for detailed bank delineation, it was sufficient for examination of long-term trends in general watercourse alignment. When comparing a 1975 aerial to a 2024 aerial, it seems that one meander bend on the upstream portion of the property was cutoff at some point between 1975 and 1999, but that the remainder of the watercourse (specifically near the proposed crossing) has remained generally unchanged. It appears that the watercourse centreline has moved between 0 and 3 metres over the past 50 years as indicated by the georeferenced points on **Figure 3**, although there may be some subjectivity in the photo georeferencing. This suggests that a toe erosion allowance at the lower end of the MNRF recommendation would be suitable as a 100-year erosion rate proxy. In this case however, even an 8-metre buffer on either side of the watercourse would still result in an excessively wide crossing. Therefore, a crossing span coinciding with the Credit Valley Conservation (CVC) recommendation of spanning at least 3 times the bankfull width for watercourses less than 4 metres wide (CVC, 2019) would be more appropriate.

It should be noted that **Table 1** provides average values observed through the full reach. In the vicinity of the proposed crossing (near georeferencing control point #5 in **Figure 3**), the bankfull width is approximately 2.5 metres. When combined with the increasing confinement of the watercourse in this area due to the north and south slopes, a buffer of 2 metres on either side of the watercourse is deemed appropriate. This would result in an overall crossing span of approximately 6.5 metres.

As a general recommendation, the length of the structure should be limited as much as possible while still maintaining roadbed stability. It should be aligned with the current, relatively straight flow path.

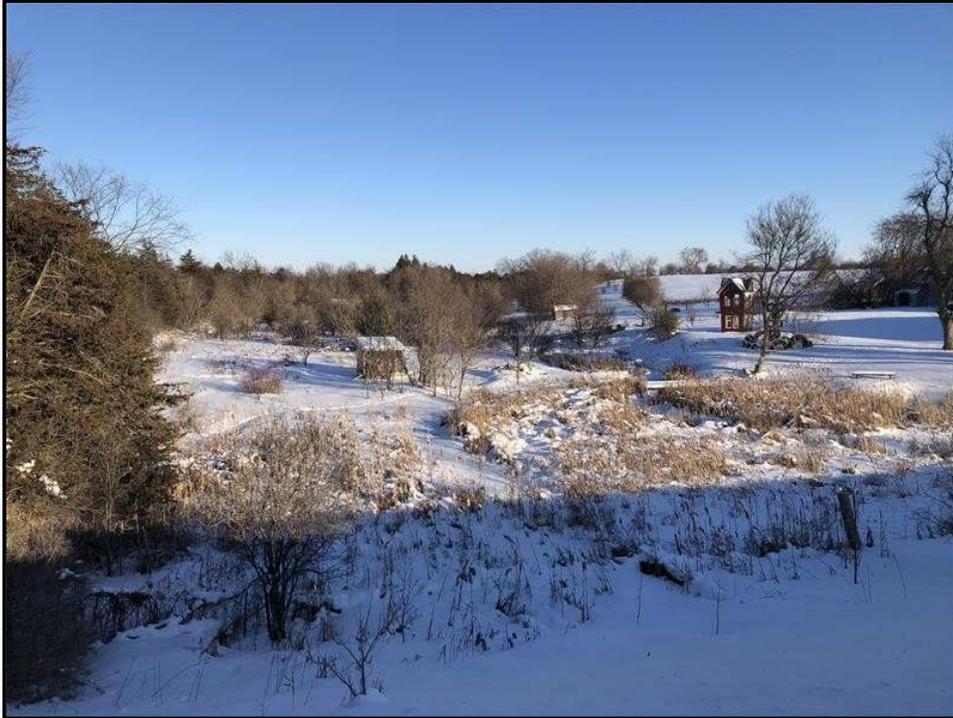
FROM: County Road 10
LOOKING: Downstream (east)
COMMENT: Vegetated channel corridor confined by steep slope to north (left side)

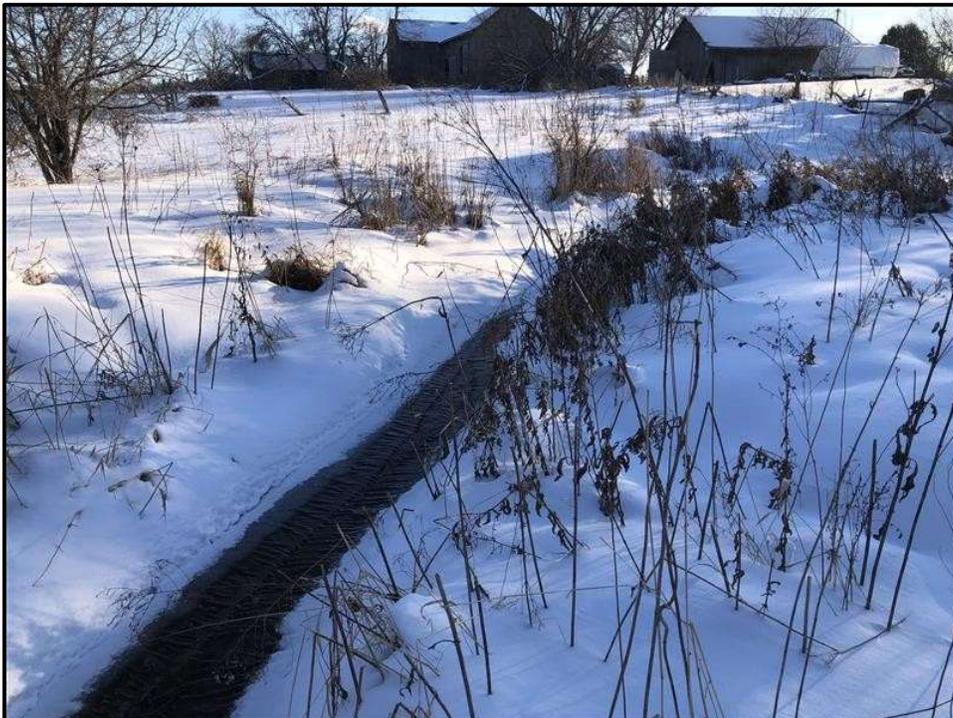
FROM: Left bank
LOOKING: Upstream (south)
COMMENT: Well-connected floodplain, shallow flow through riffle

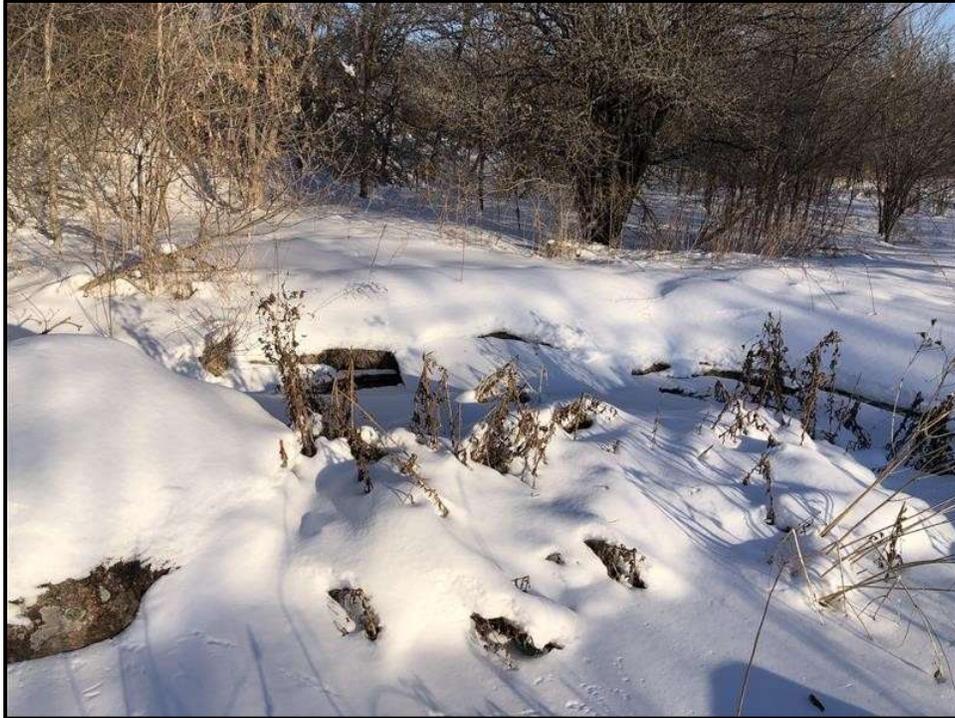
FROM: Right bank
LOOKING: Toward left bank (northeast)
COMMENT: Steep, scoured bank on outer meander bend

Bank scour, steep banks in meander bends

- A low-flow channel should be maintained through the structure involving placement of appropriately sized rounded riverstone,
- Bank protection within the downstream meander bend should be considered during detailed design; and,

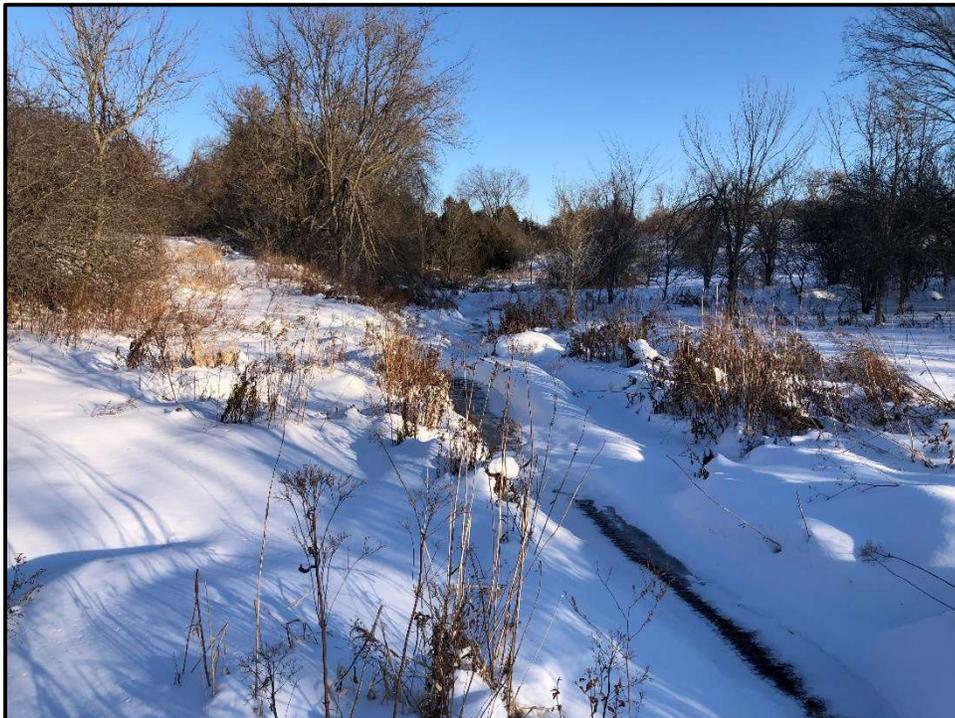
FROM: Left bank, midway through reach
LOOKING: Downstream (east)
COMMENT: Valley increasingly confined, forested area/property limit in background

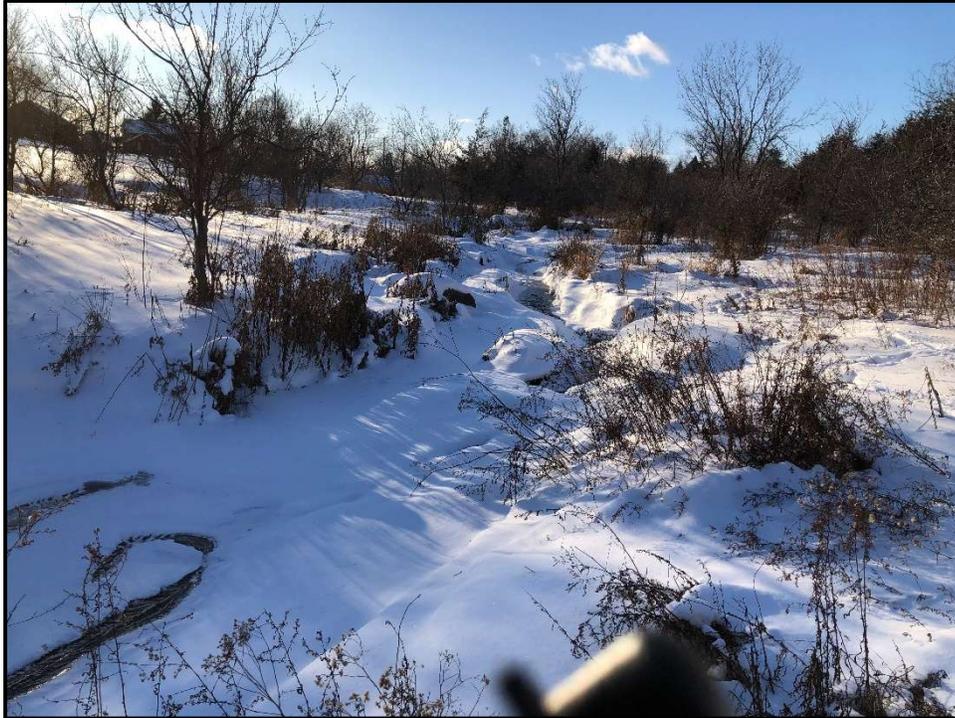
FROM: Left bank, near property boundary
LOOKING: Upstream (west)
COMMENT: Gentle meandering with pool-riffle sequence, several large boulders visible

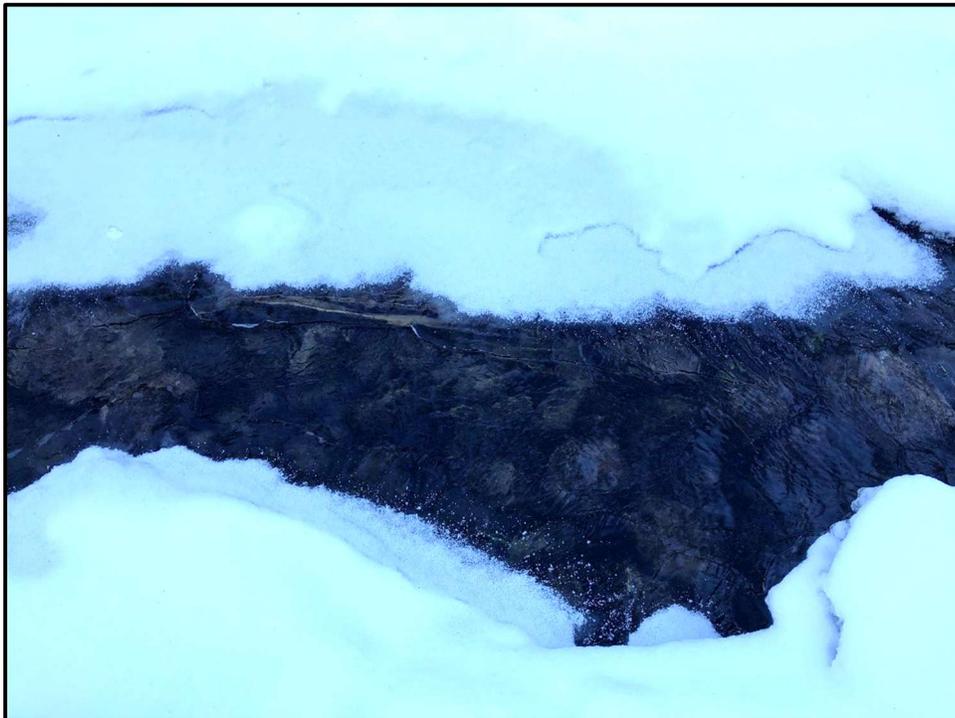
FROM: Right bank
LOOKING: Down, at channel bed
COMMENT: Riffle substrate comprised of small-large cobbles (image filtered for visibility)
