**Phase I Environmental Site Assessment (ESA)
1355 County Road 4 (804 Iron Woods Drive), Warsaw
Part of Lots 10 & 11, Concession 1 (Dummer)
Township of Douro-Dummer, County of Peterborough**

Project#: 19-2620

September 2019

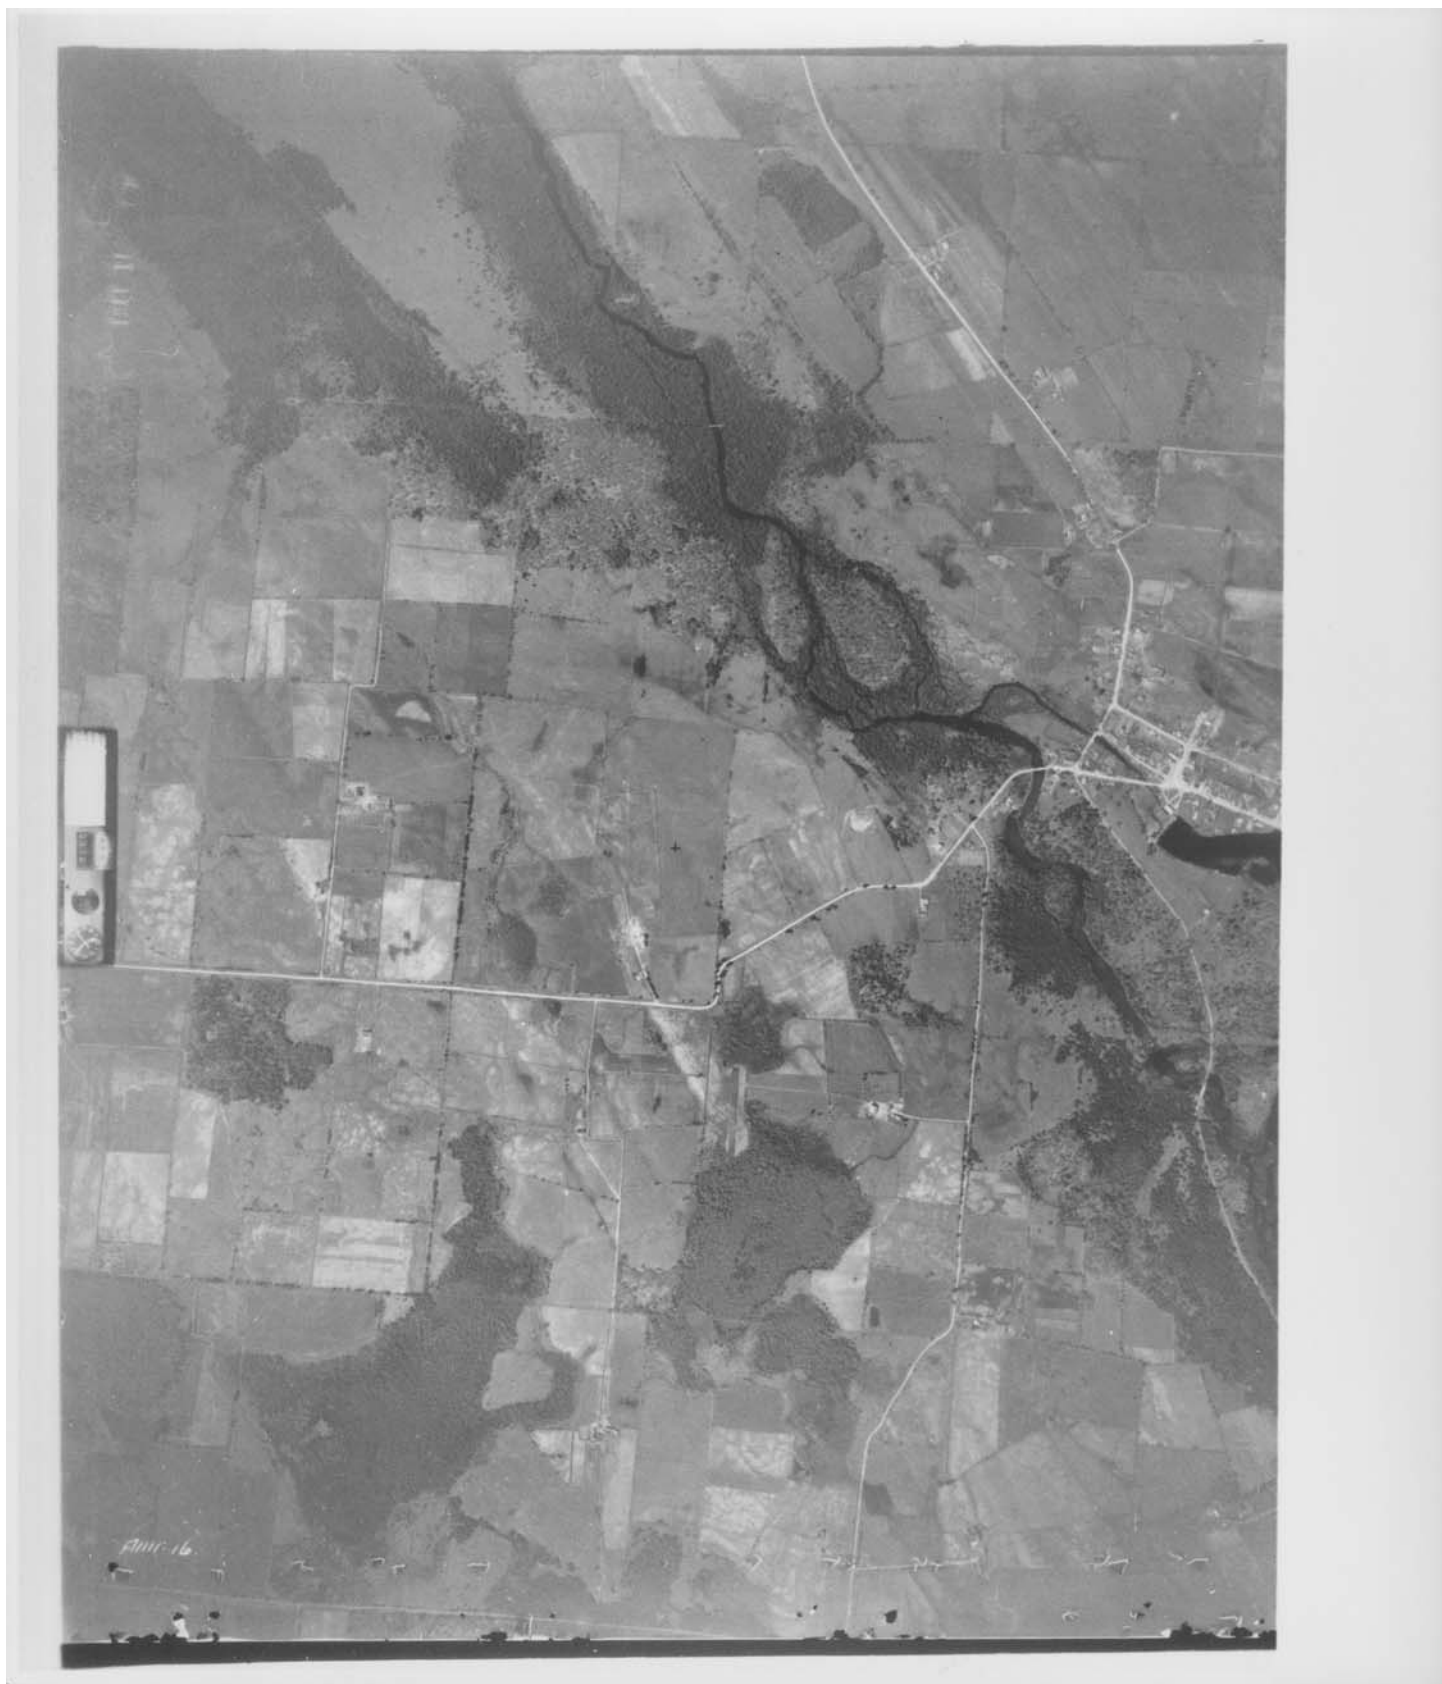
National Air Photo Library
1929

In 1929, the Phase I Property appears to be undeveloped. Wetlands are noted to the south and southeast, while the remaining portions of the property are mainly vegetated field, resembling present day conditions. Development is noted within the Phase I Study Area, mainly to the north. Other surrounding land uses appear to be vacant or agricultural.

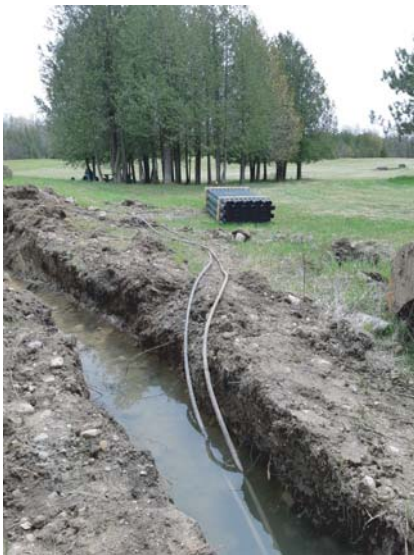
Photo C: Excavation on Phase I Property

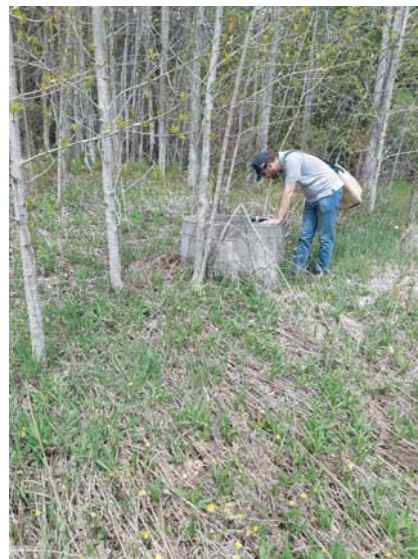
The site contains a large diameter dug well at the western corner of the property. Although it is not currently servicing any dwellings, it is anticipated that it may eventually service the proposed residence. Underground piping leading to the well was partially excavated by the current owner. The excavation was noted to contain water, presumably from intersecting the shallow groundwater table. A pond is located just south of the well.

Photo D: Dug well located on Phase I Property

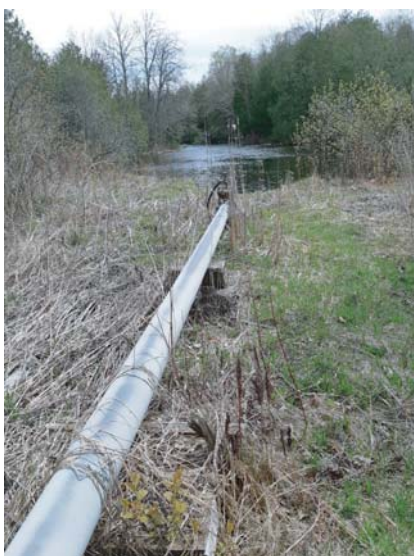
A gas powered water pump and distribution lines are located in the central portion of the site. The pump was formerly utilized to obtain water from the Indian River for the purpose of irrigating the golf course. No odours of gas or visual staining were noted in this area.

Photo E: Irrigation intake line on Phase I Property

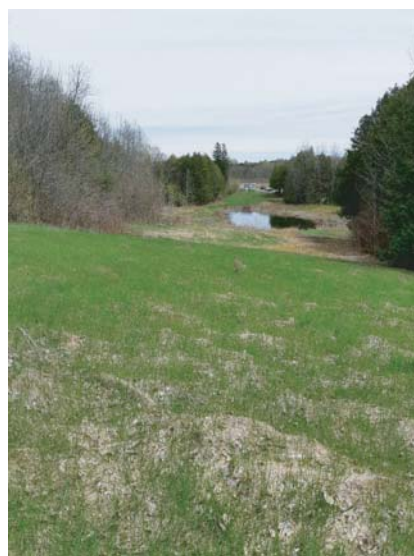
Photo F: Looking east at pond on Phase I Property

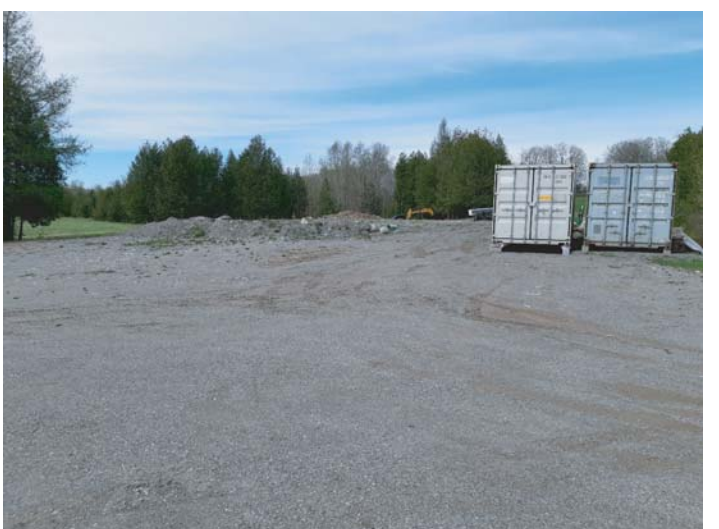
No structures were observed on the Phase I Property. However, materials and equipment presumably related to the preparation of the future development of a residence on the site were noted along the northern boundary near the entrance, including two large storage containers, stone, tractor, piping, wood, etc. Two (2) empty liquid storage containers were also noted in this area. The containers were labelled as “soybean lecithin”, a common food additive. It is presumed that the containers were not used for operations at the Phase I Property, and are intended to be reused for water storage. Piles of brush from cut trees were also noted near this area.

Photo F: Construction materials located on Phase I Property
