Hydrogeological Assessment, Woodview Golf Subdivision

June 8, 2023

Prepared for:
Eric Challenger

Cambium Reference: 15101-001

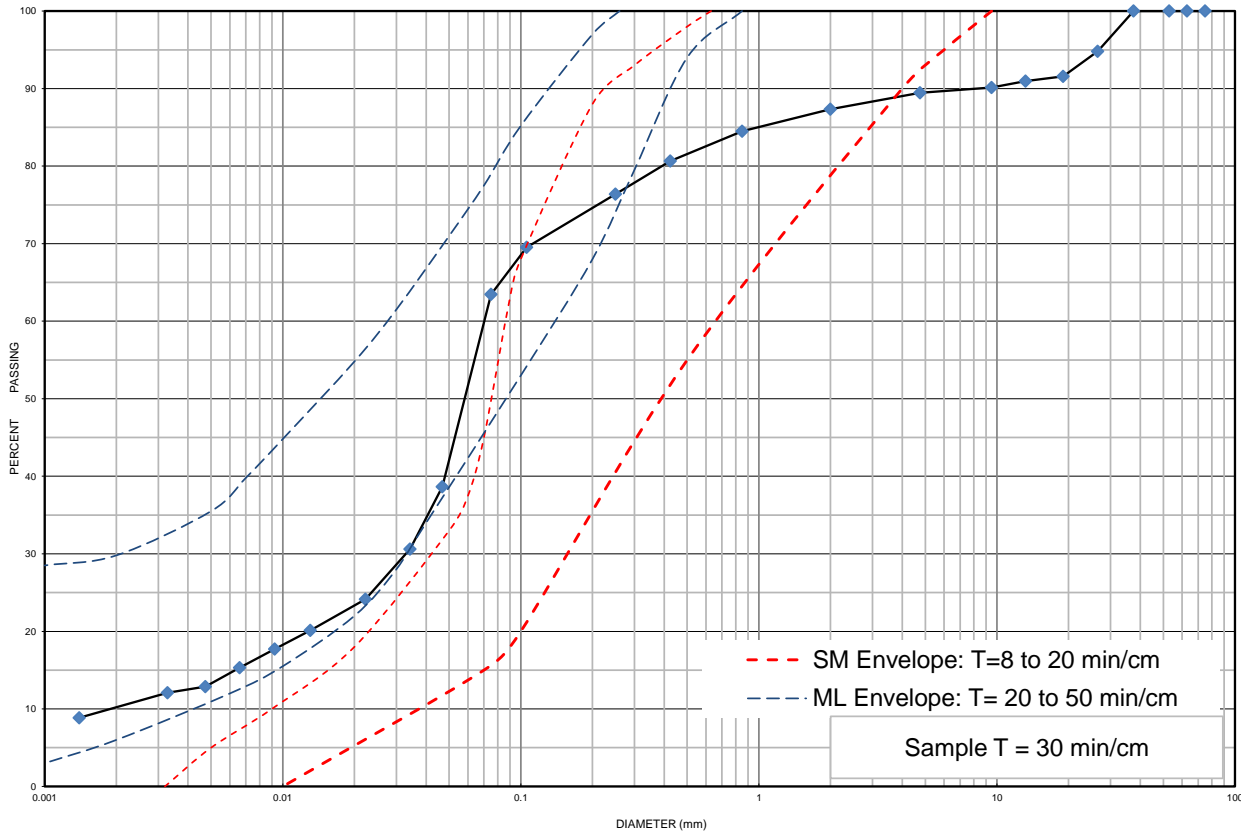
Borehole No.	Sample No.	Depth	Gravel	Sand	Silt	Clay	Moisture
TP 103-22	GS 2	0.3 m to 0.5 m	11	26	52	11	8.8
Description		Classification	D ₆₀	D ₃₀	D ₁₀	C _u	C _c
Sandy Silt some Gravel some Clay		ML	0.0700	0.0330	0.0018	38.89	8.64
