Hydrogeological Assessment Report – Part of Lot 19, Concession 19 – Township of Galway- Cavendish and Harvey, County of Peterborough

July 23, 2025

Prepared for:
Jeffery Homes

Cambium Reference: 17986-003

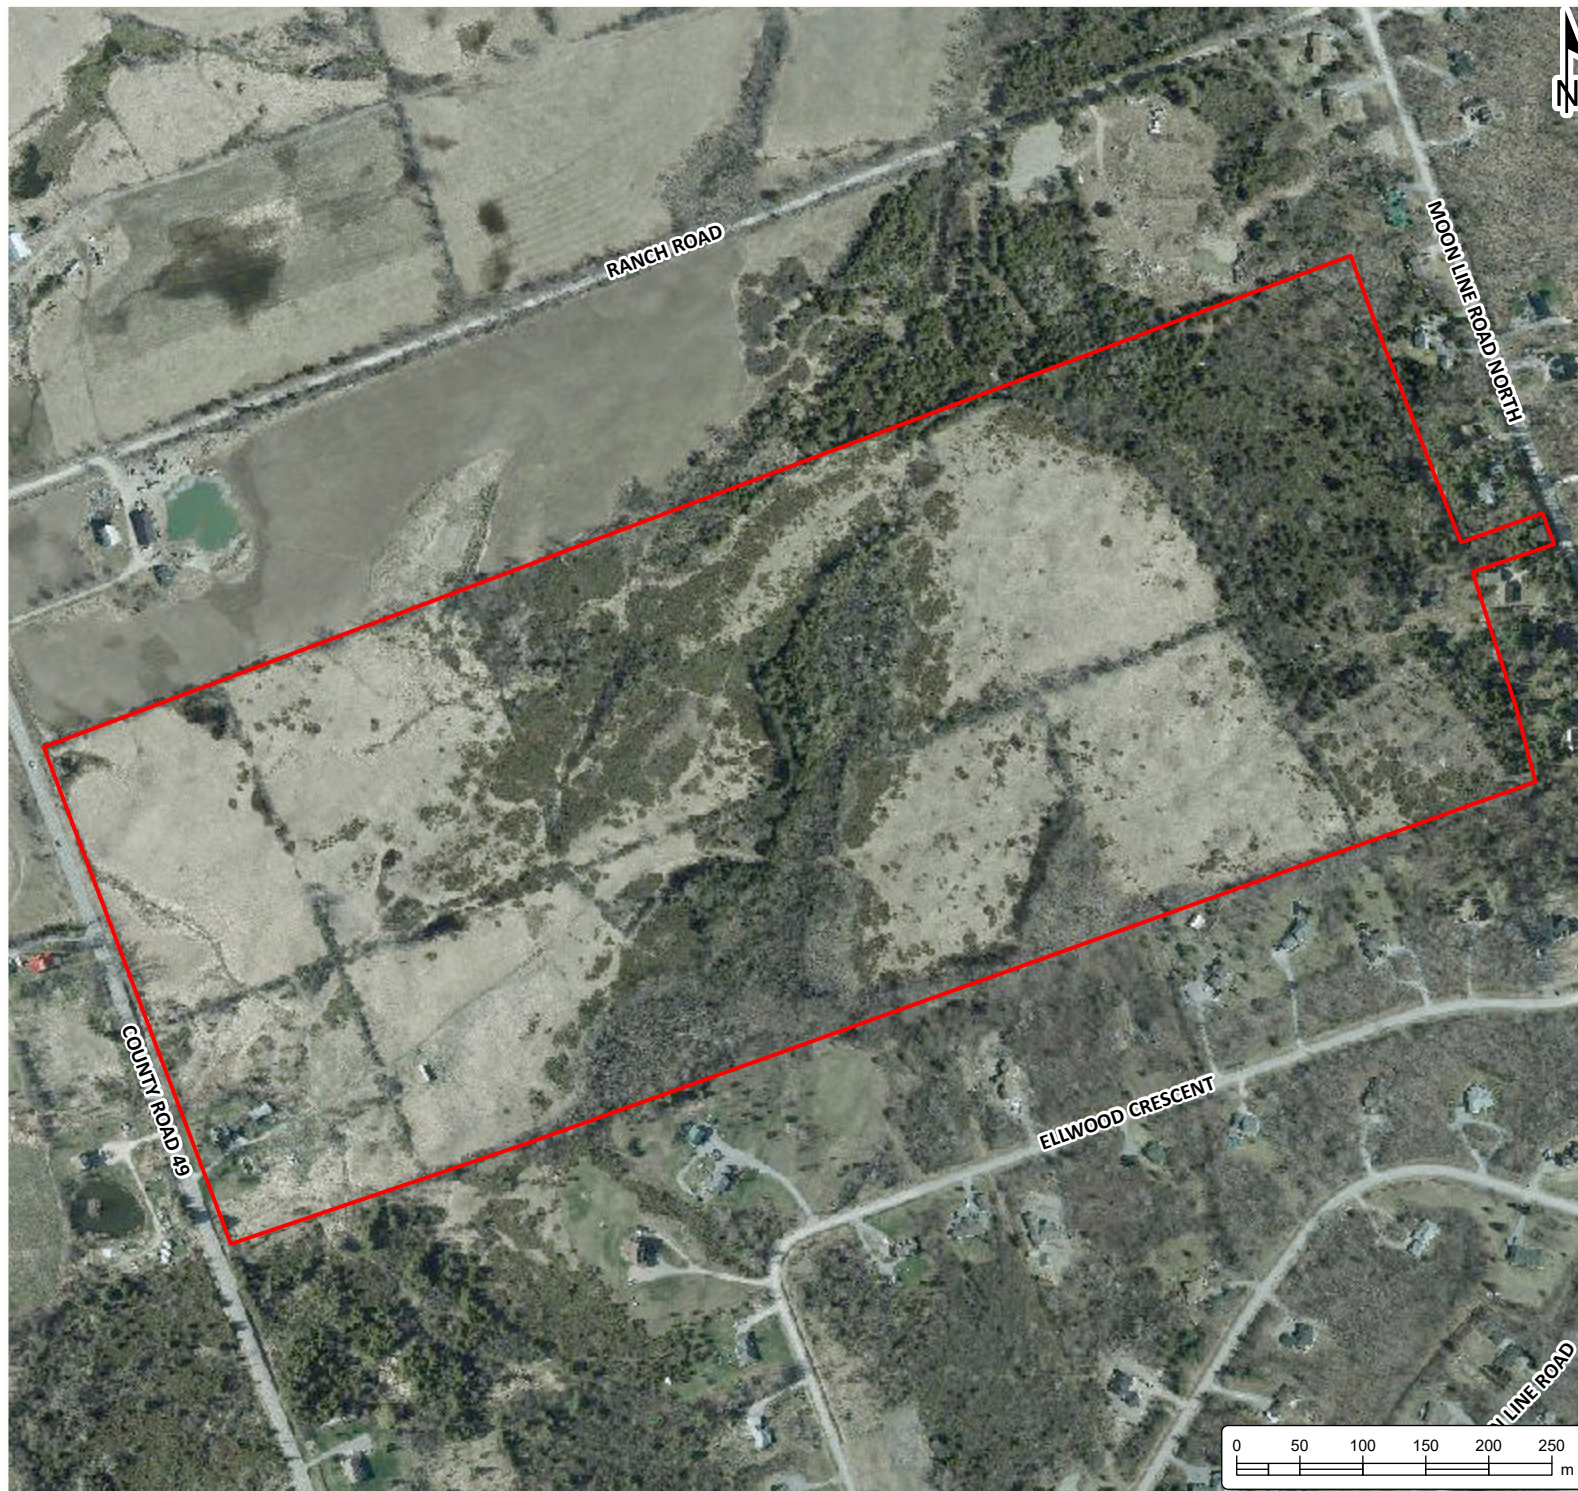
| Checked by: | KW | Figure: | 2 |

Cambium completed a borehole investigation and test pit investigation on October 25 to October 27, 2023, to assess subsurface conditions at the Site. A total of 14 boreholes, designated as BH101-23 to BH114-23, were advanced to a termination depth ranging from 2.44 to 4.98 mbgs for geotechnical and hydrogeological purposes. Four boreholes, BH101-23, BH108-23, BH109-23, and BH113-23 were equipped as monitoring wells to allow for the assessment of groundwater levels and elevations over time. Borehole and monitoring well locations are included in Figure 2, and borehole logs are included in Appendix B.
