Towerhill Developments Inc.

Environmental Impact Study

Millbrook, Ontario

September 2020

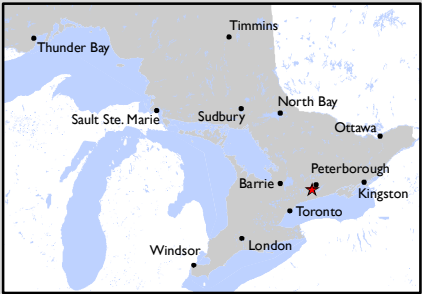
**FIGURE 2
PROVINCIAL AND AGENCY
LAND USE DESIGNATIONS**

- Study Area
- Natural Core Area
- Natural Linkage Area
- Locally Significant Wetland
- Unevaluated Wetland
- Significant Woodland
- Water Body (MNR)
- Woodlands (MNR)

In addition, distinctive landscape features were identified within the unevaluated wetland area through both background review and consultation with ORCA, as visible in aerial imagery on Figure 2. These distinctive wetland formations have been noted in the Cavan Township Environmentally Sensitive Areas Study as “ice-block ridges” and associated wetland depressions; which, according to ORCA, form a unique type of habitat in Peterborough County. These areas are presumed to be in various stages of succession and may provide valuable habitat for waterfowl, wading birds and furbearers (ORCA, 2017). Based on this, ORCA requested that a wetland evaluation be completed on wetlands within the Study Area and considered as part of the larger unevaluated wetland area.

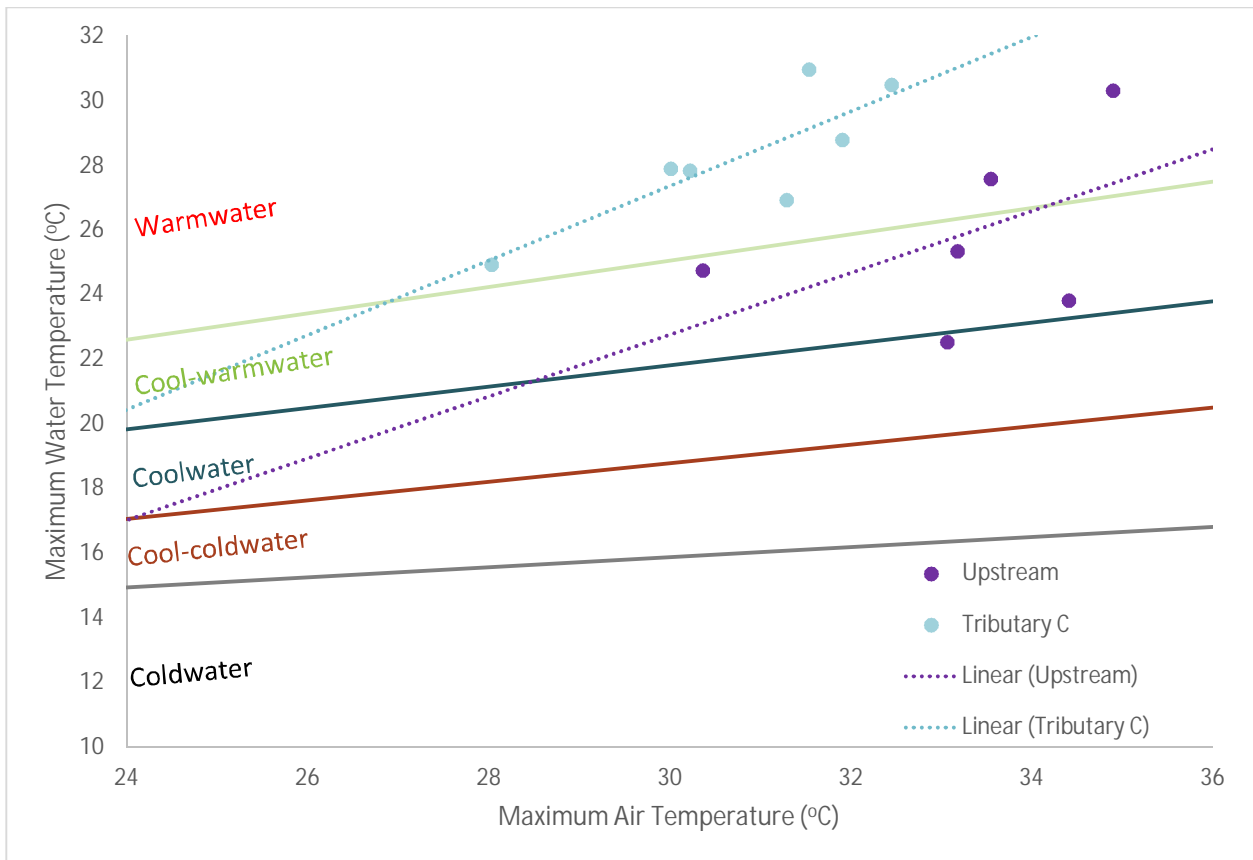
Inset 1: Thermal Regime of Tributary B and C

The OSAP Manual defines thermal regime of watercourses using an algorithm based on air temperature. Using the data extracted to Table 5, a scatter plot was created to show the distribution of data and then compared to the thermal regime nomogram first created by Stoneman and Jones (1996) and adapted by Chu et al. (2009) and used in the OSAP manual.

Based on the trend in data shown above, the thermal regime in Tributary B falls within the “Cool-Warmwater” zone (warmwater in accordance with Stoneman and Jones [1996]); while Tributary C falls within the “Warmwater Zone”. The results for Tributary B were expected based on the results of the previous data collected on site between 2016 and 2018. The results for Tributary C, however, were somewhat surprising as Baxter Creek is described as a cold water system; but reflects observations we have recorded within Tributary C, that has been dry during certain periods of the year.

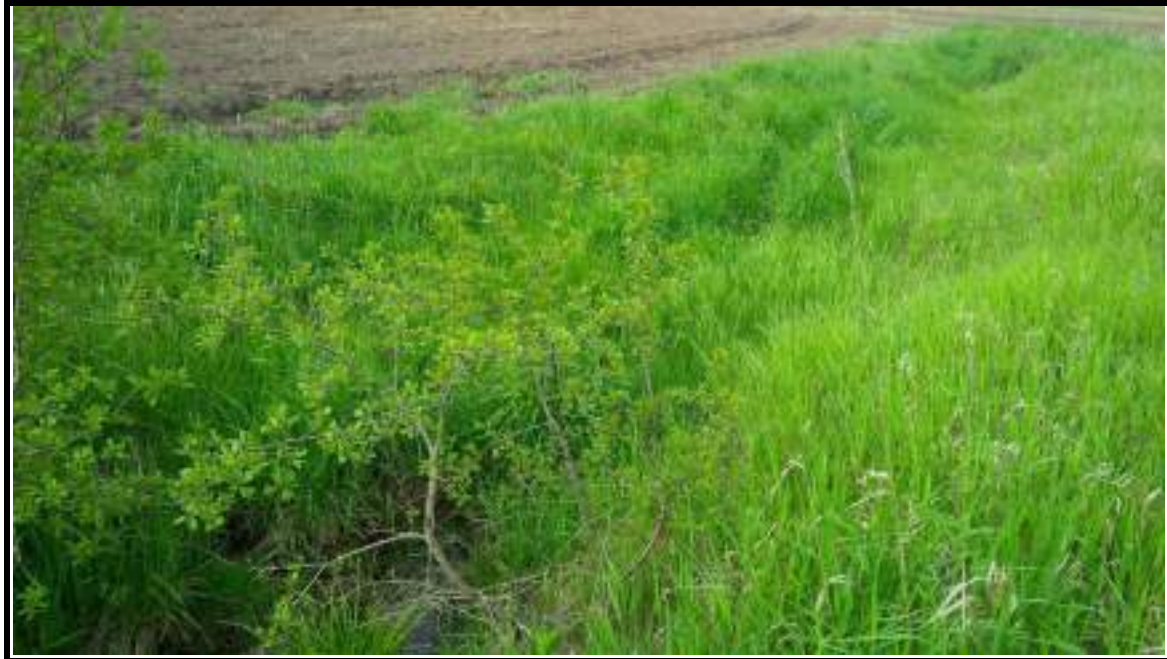
PHOTOGRAPH NO.: 1

LOOKING: Upstream at the headwaters of the tributary

COMMENT: Grassy, forbes-like channel, small cross-sectional geometry

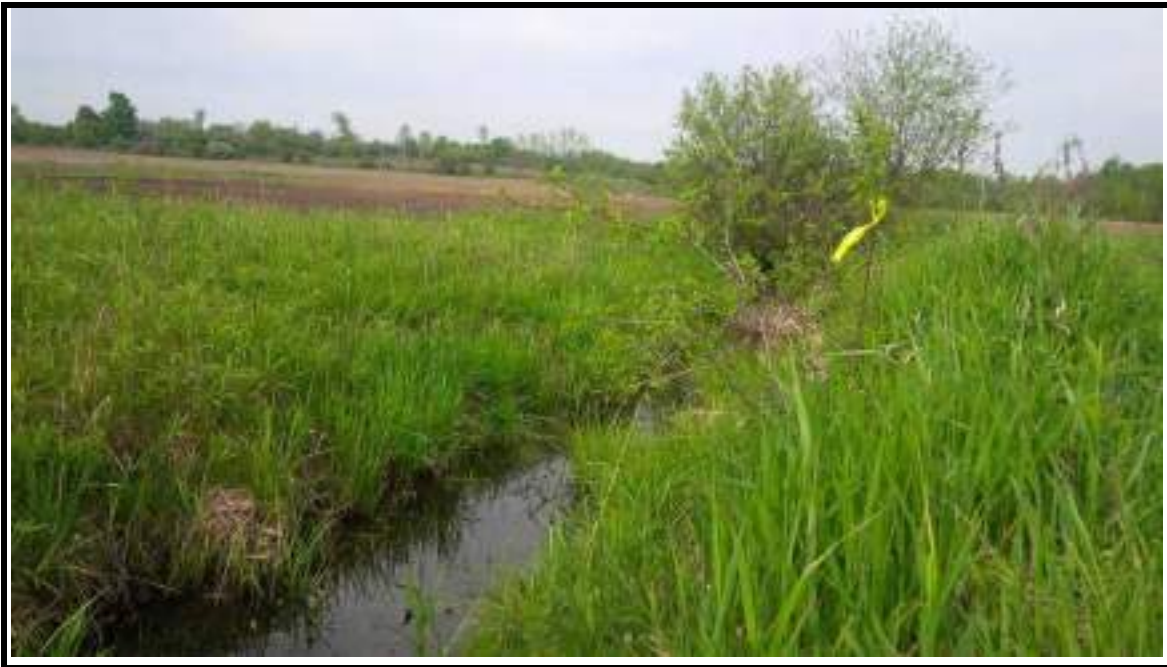
PHOTOGRAPH NO.: 2

LOOKING: Upstream at Cross-Section 1

COMMENT: Channel width has appeared to have naturally increased from upstream; banks are stable

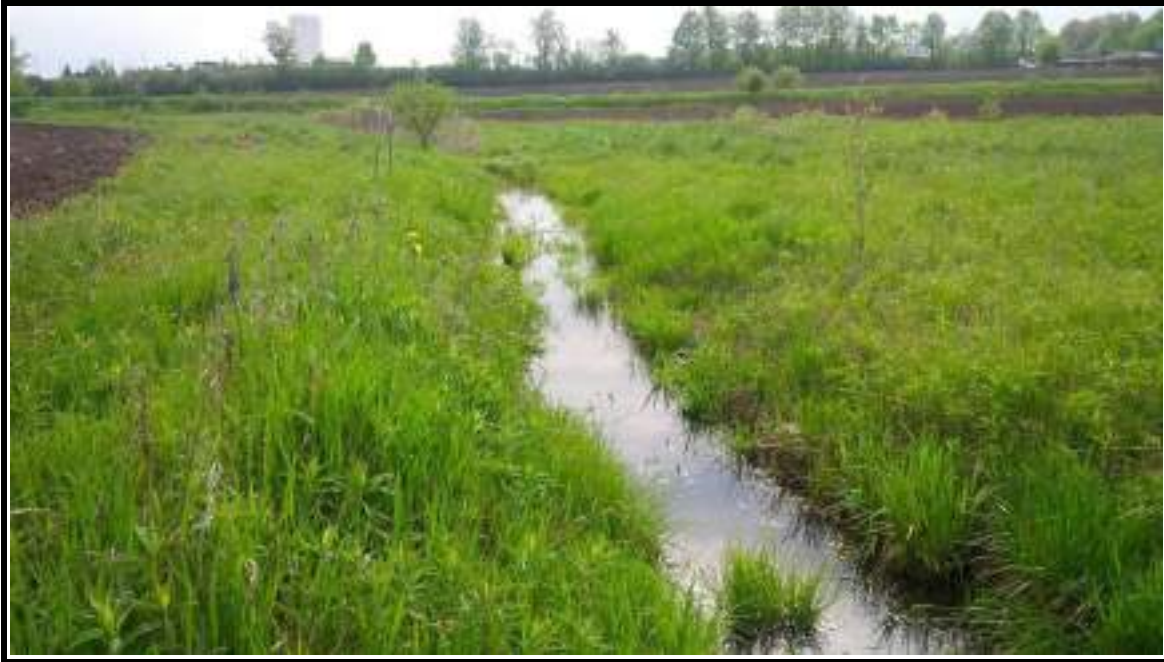
PHOTOGRAPH NO.: 3

LOOKING: Downstream at Cross-Section 1

COMMENT: Banks and floodplains are stabilized by a variety of long grasses; appear to be stable

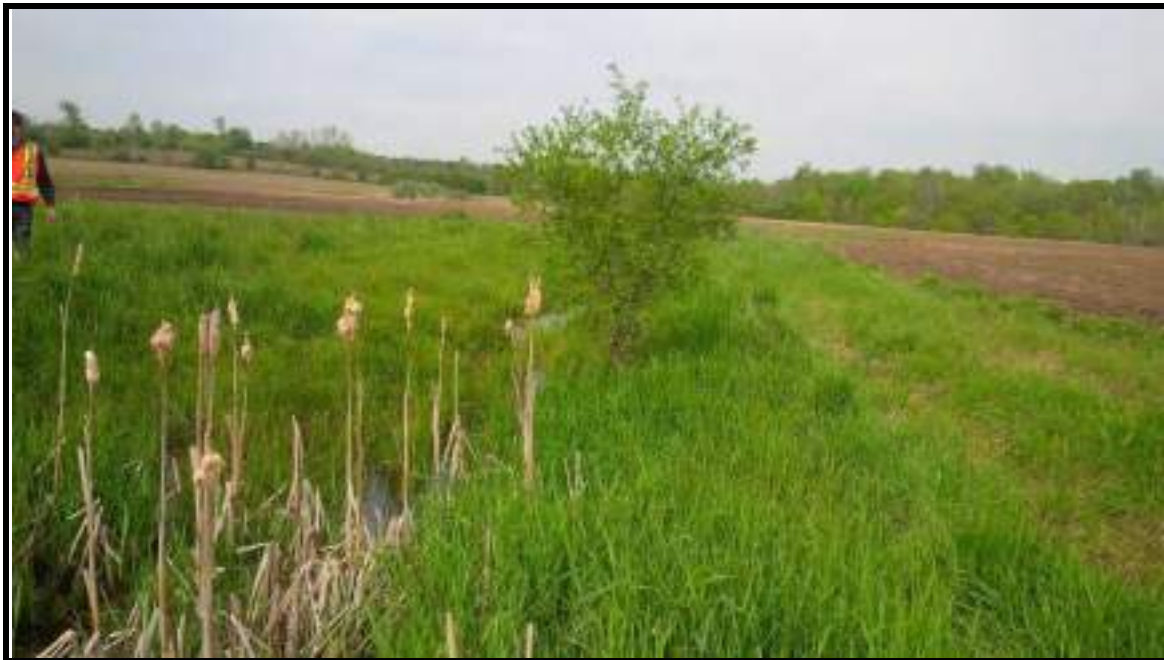
PHOTOGRAPH NO.: 4

LOOKING: Upstream at Cross-Section 2

COMMENT: Small tree on left bank; tall vegetation within the channel

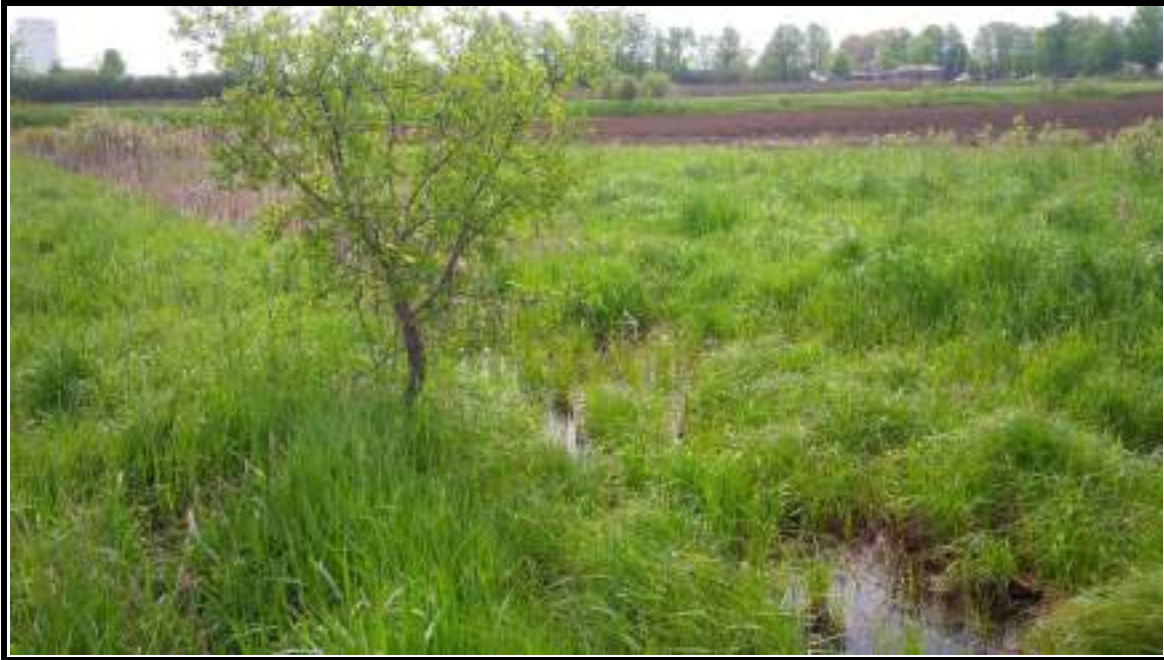
PHOTOGRAPH NO.: 5

LOOKING: Downstream at Cross-Section 2

COMMENT: Channel bed has significantly more dense grasses and vegetation

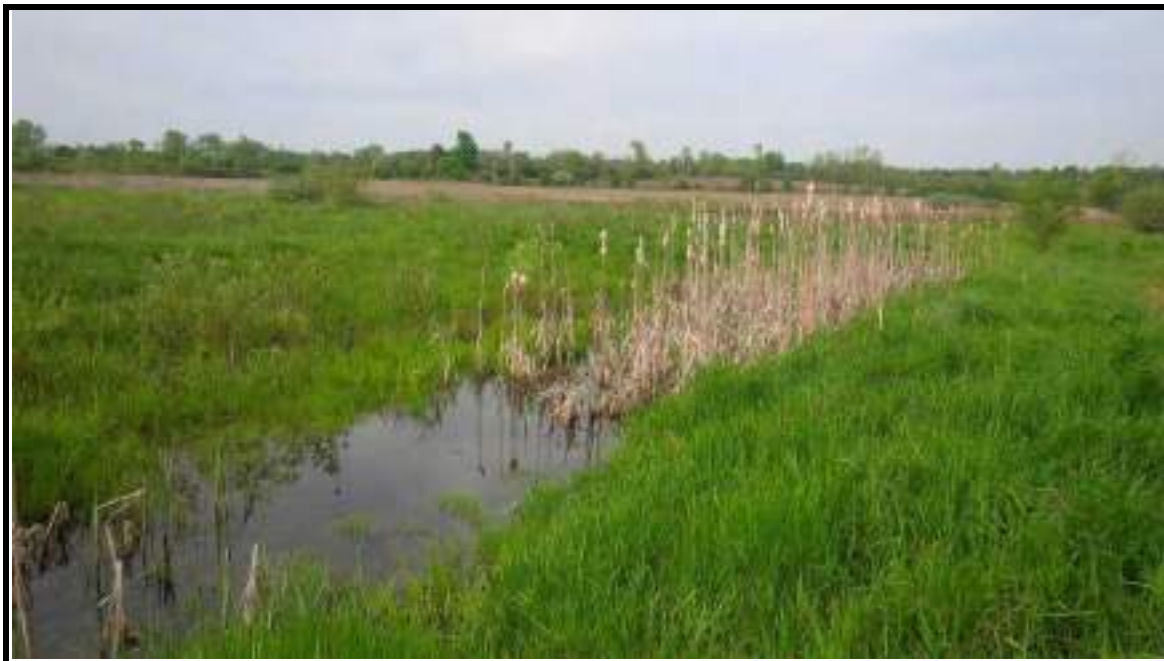
PHOTOGRAPH NO.: 6

LOOKING: Upstream at Cross-Section 3

COMMENT: Tall vegetation in channel (increase in roughness of the bed) is slightly narrower than the downstream pool; naturally, there is a greater water depth in the pool

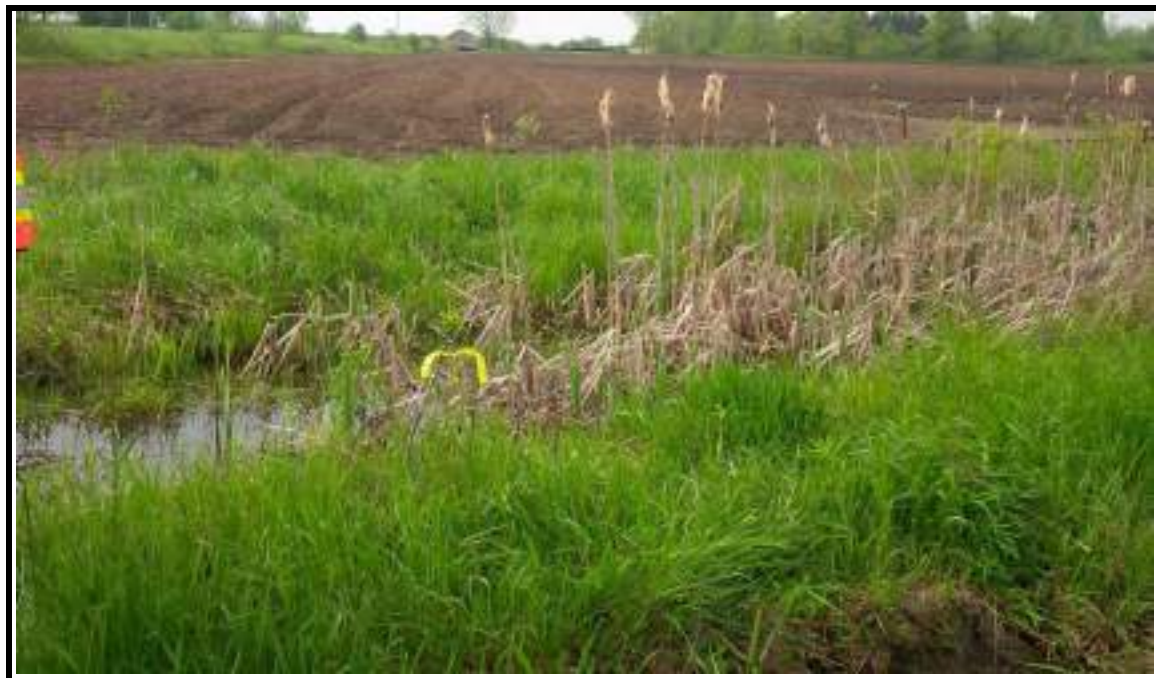
PHOTOGRAPH NO.: 8

COMMENT: Tall vegetation within the channel bed is seen again; downstream there is a small shrub on the right bank diverting flow to the left

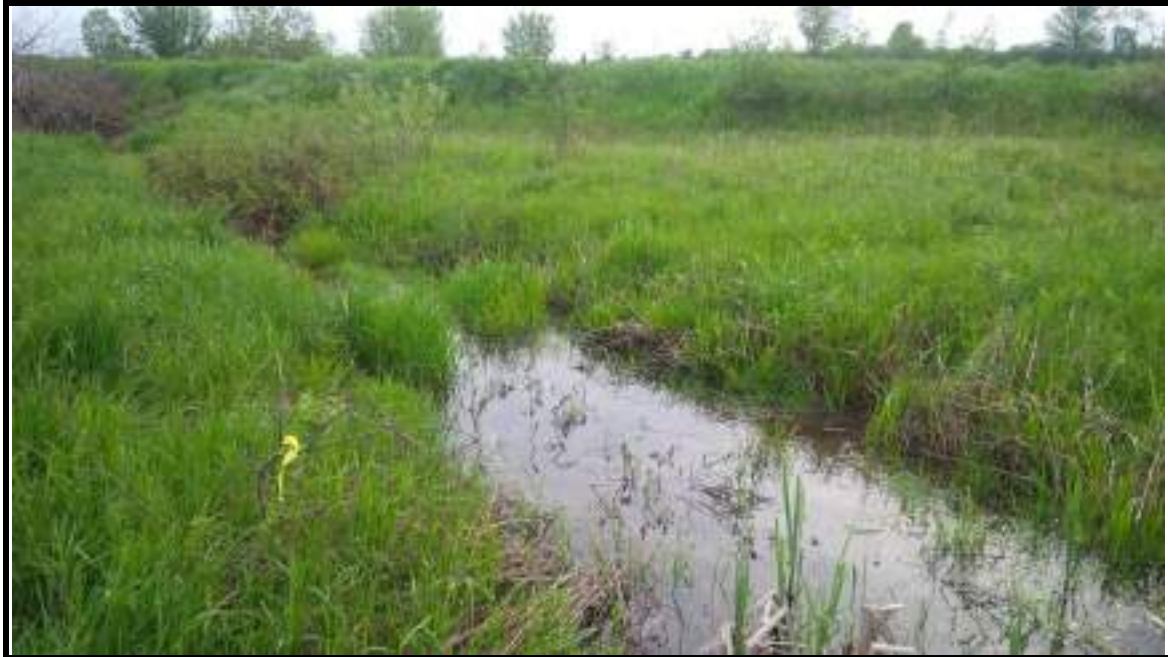
PHOTOGRAPH NO.: 9

LOOKING: Downstream at Cross-Section 4

COMMENT: Deeper pool is seen with less dense vegetation on the channel bed; width has increased

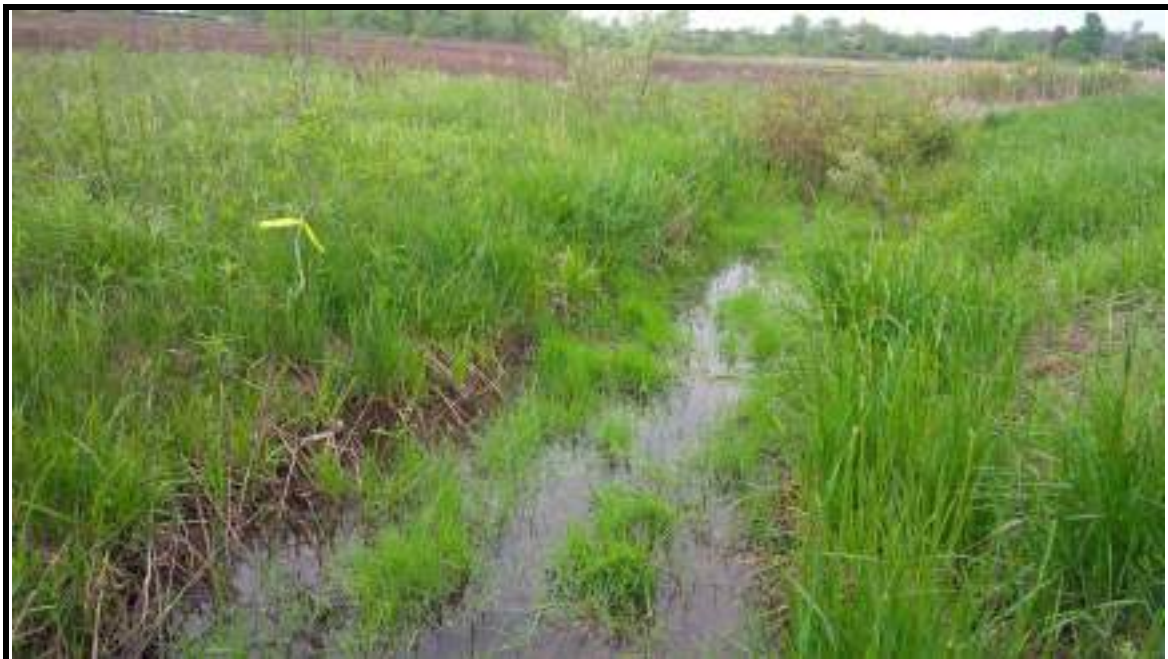
PHOTOGRAPH NO.: 10

LOOKING: Upstream at Cross-Section 5

COMMENT: Small exposed, bar-like, depositional features within the channel have grown new grasses

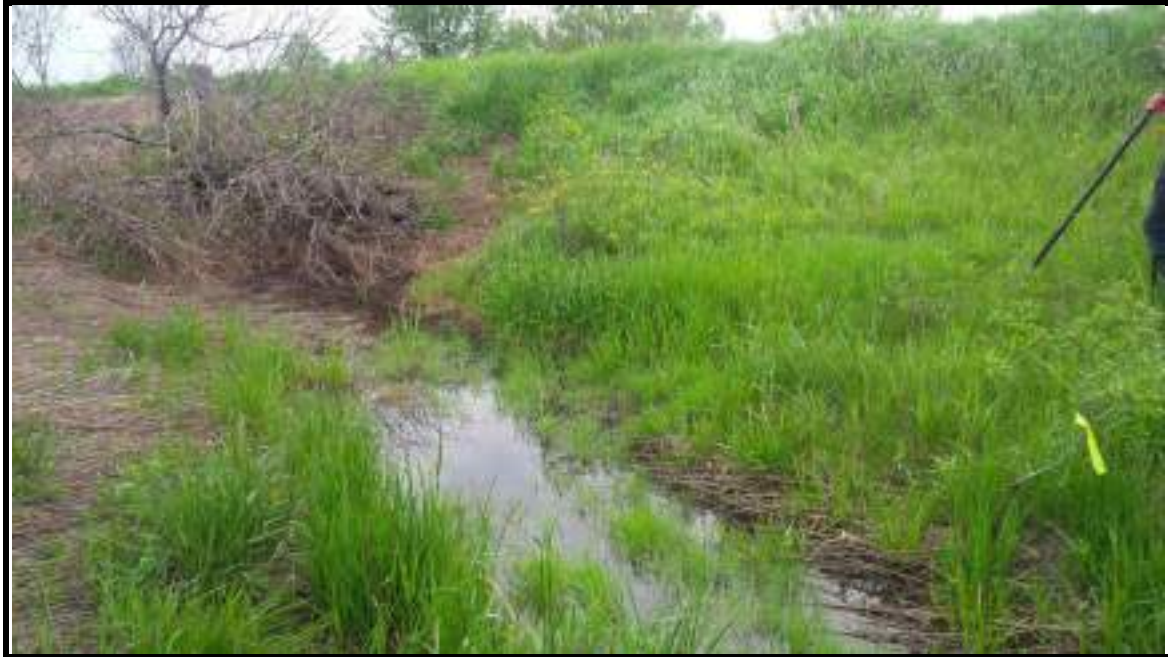
PHOTOGRAPH NO.: 11

LOOKING: Downstream at Cross-Section 5

COMMENT: Significant flattening of vegetation is seen on both the left and right banks due to runoff

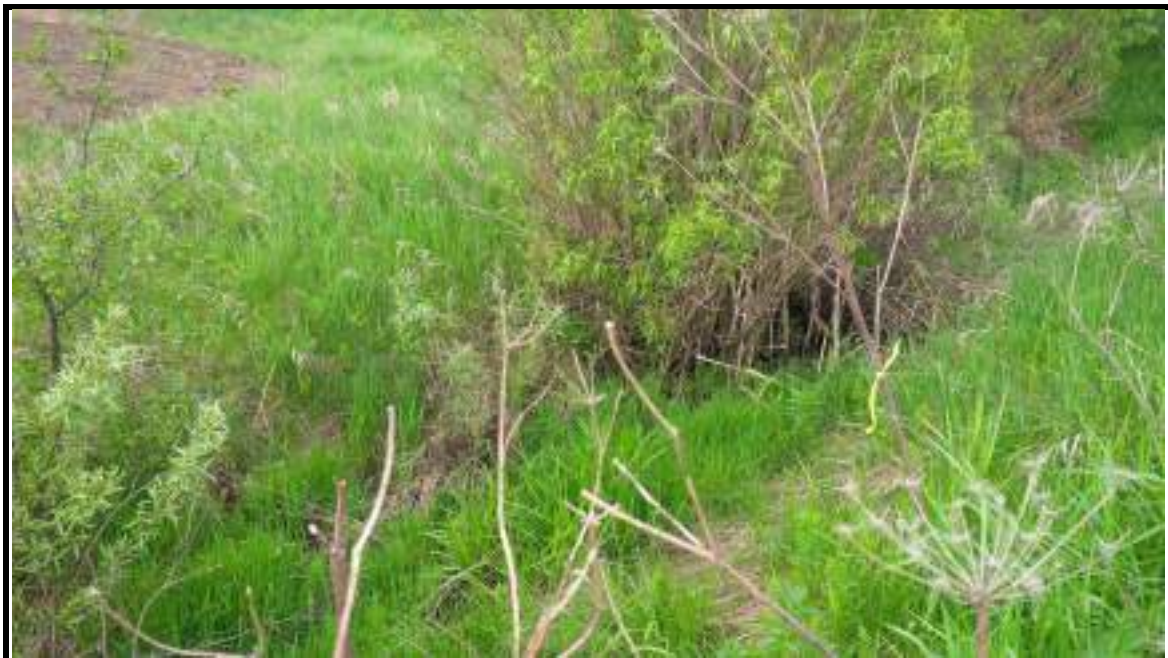
PHOTOGRAPH NO.: 12

LOOKING: Upstream at Cross-Section 6

COMMENT: Section of small, dense shrubs, flow path of channel is less defined and there is diversion of flow around the vegetation

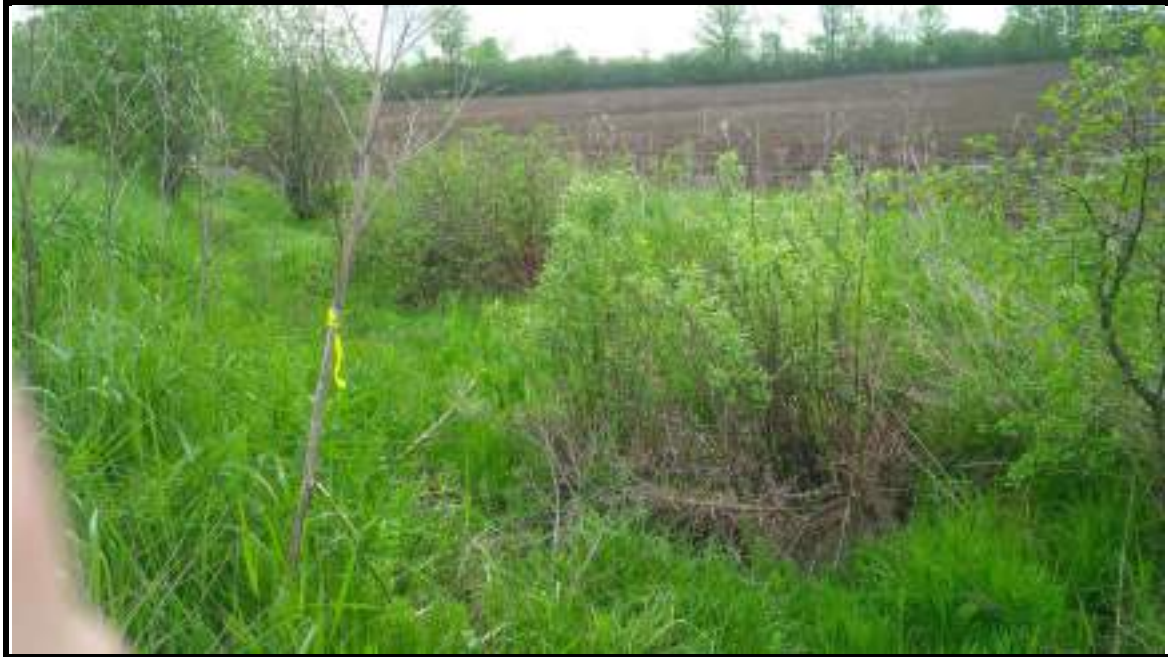
PHOTOGRAPH NO.: 13

LOOKING: Downstream at Cross-Section 6

COMMENT: Small shrubs on right bank have grown over top of the channel and diverted flow path

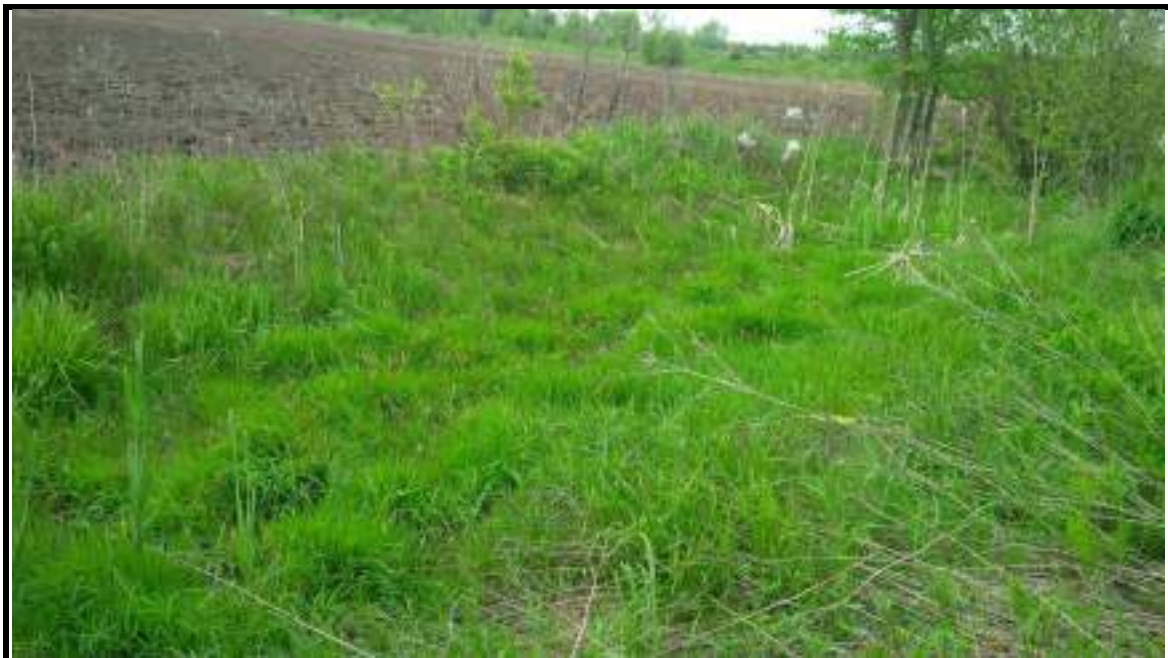
PHOTOGRAPH NO.: 14

LOOKING: Upstream at Cross-Section 7

COMMENT: Very little flow is present; bed, banks and terraces are stabilized by short grasses

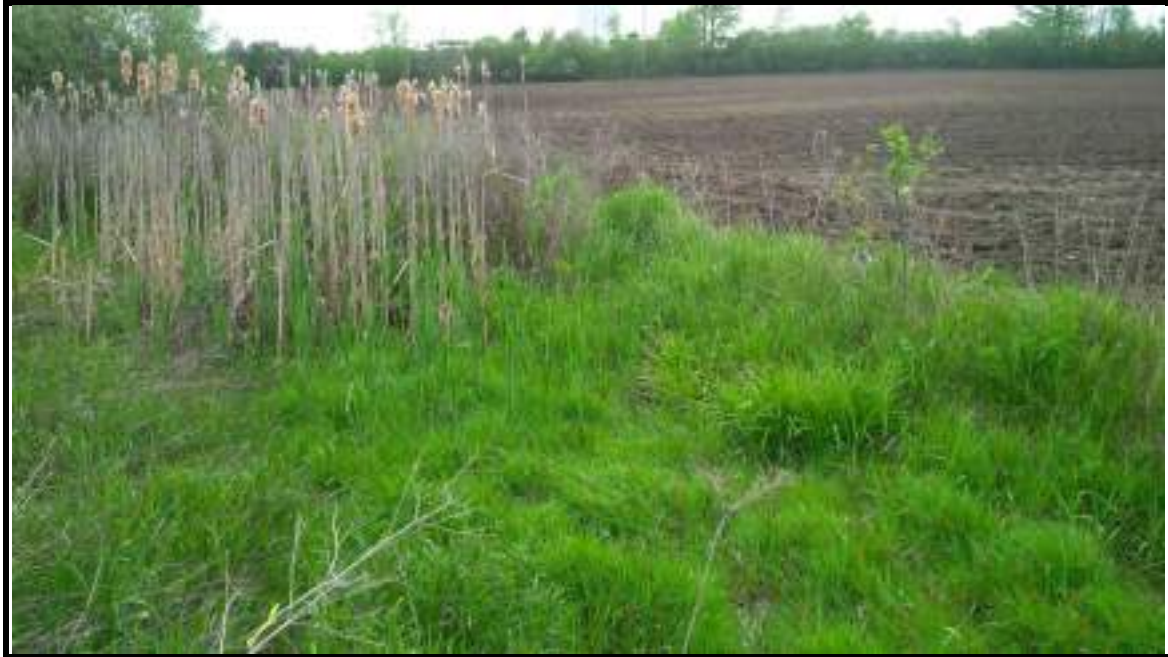
PHOTOGRAPH NO.: 15

LOOKING: Downstream at Cross-Section 7

COMMENT: Tall vegetation is seen downstream and channel narrows slightly

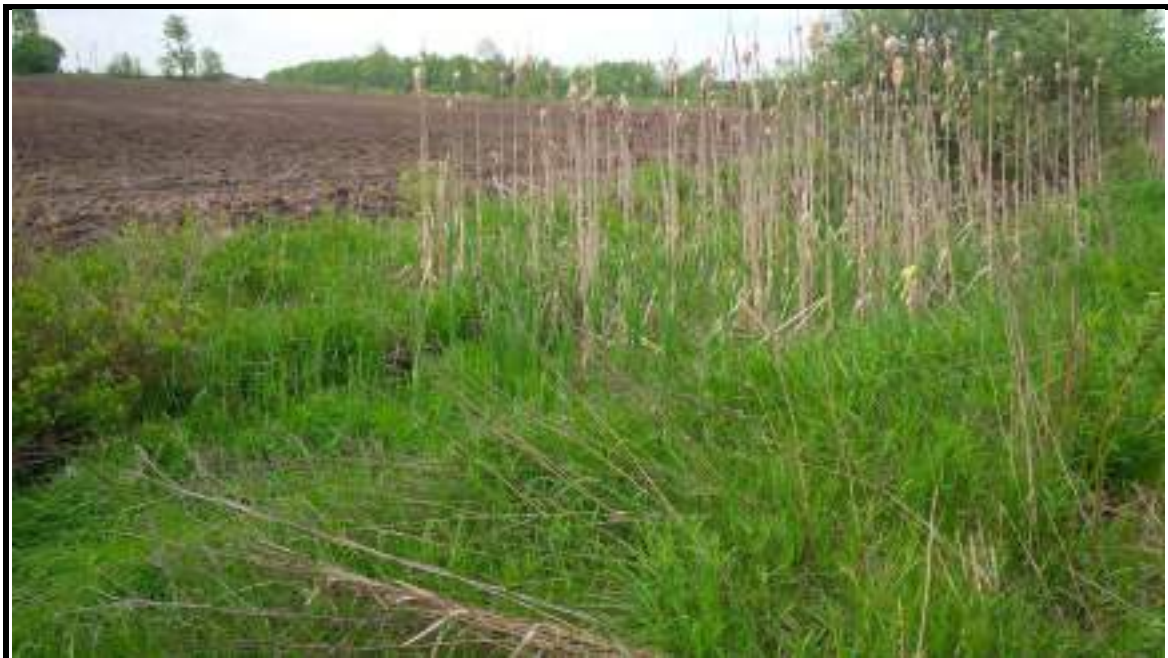
PHOTOGRAPH NO.: 16

LOOKING: Upstream at Cross-Section 8

COMMENT: Some tall grasses on the left bank have been flattened due to runoff; channel width is smaller but cut deeper

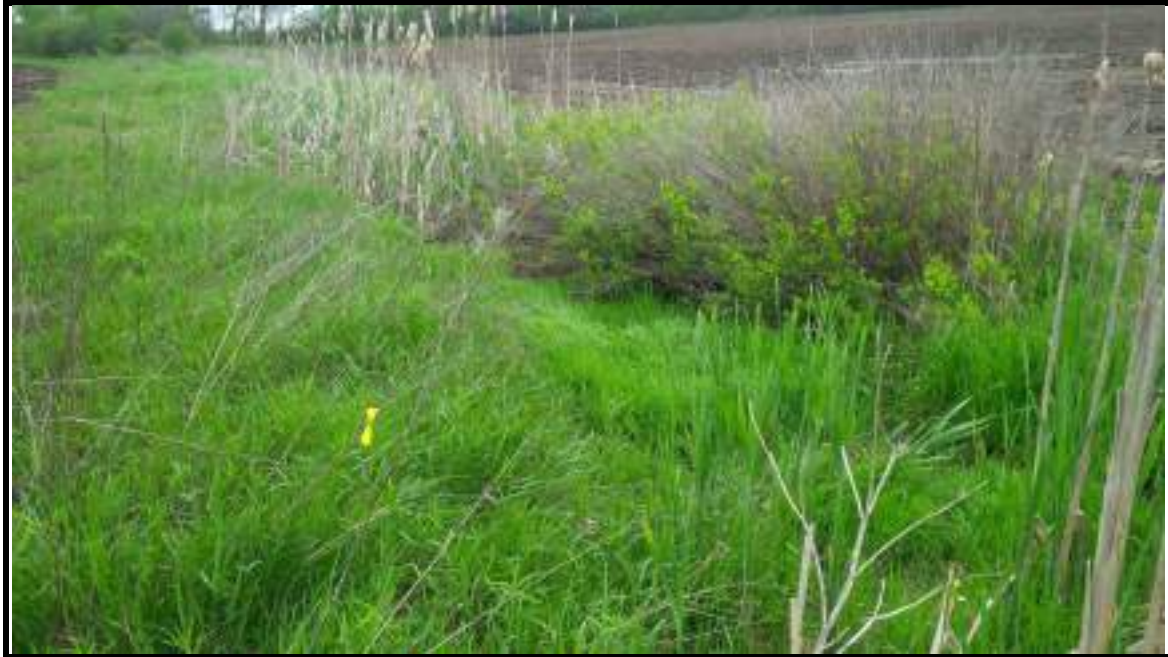
PHOTOGRAPH NO.: 17

LOOKING: Downstream at Cross-Section 8

COMMENT: Shrub on the right bank is diverting flow into a patch of taller willows

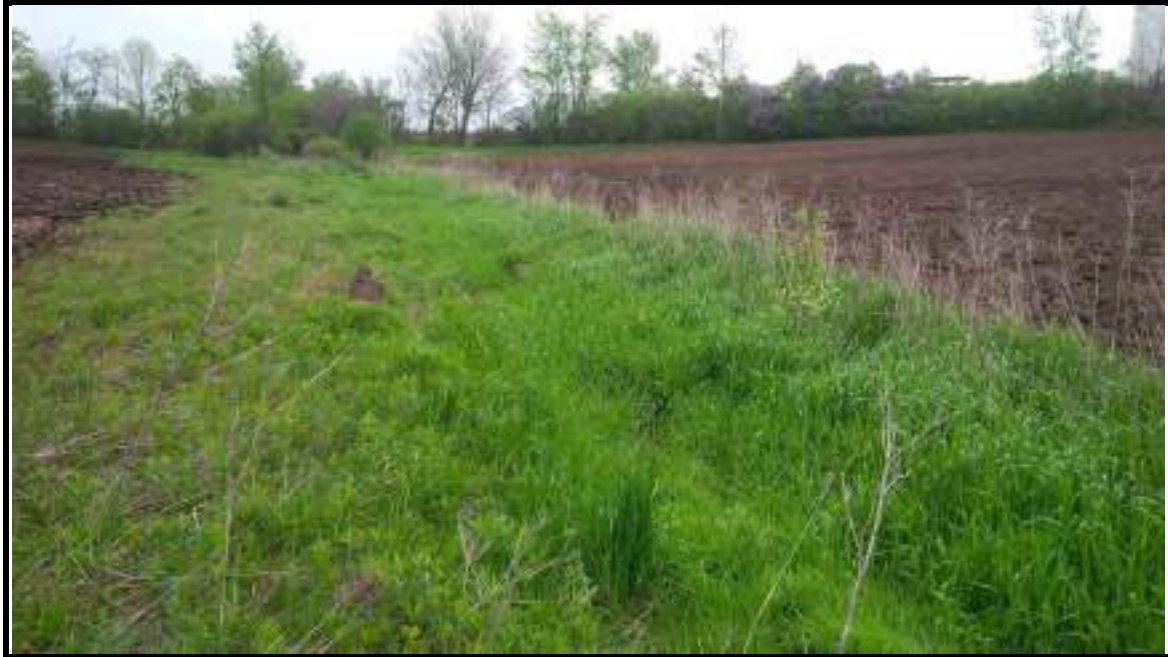
PHOTOGRAPH NO.: 19

LOOKING: Downstream at Cross-Section 9

COMMENT: Some flattening of vegetation due to runoff is seen on left bank

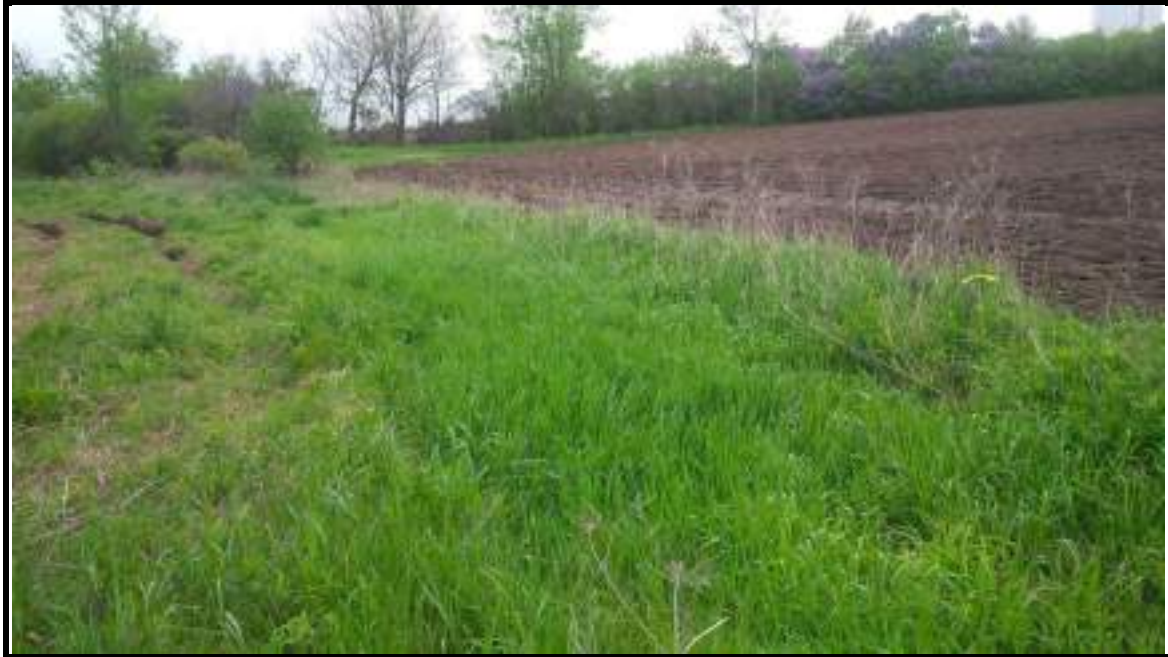
PHOTOGRAPH NO.: 21

LOOKING: Downstream at Cross-Section 10

COMMENT: Grasses have overgrown and are creating shade over the channel; some anthropogenic erosion seen on left bank

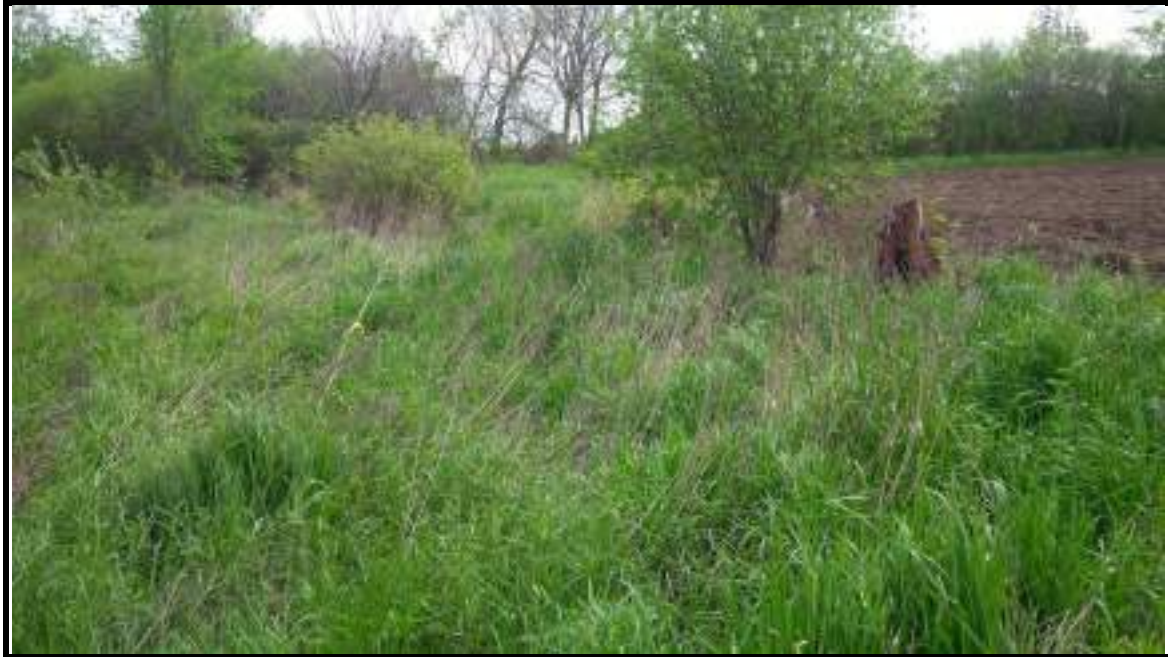
PHOTOGRAPH NO.: 23

COMMENT: Channel has narrowed and become slightly deeper; two small trees and shrubs are noted on the right banks

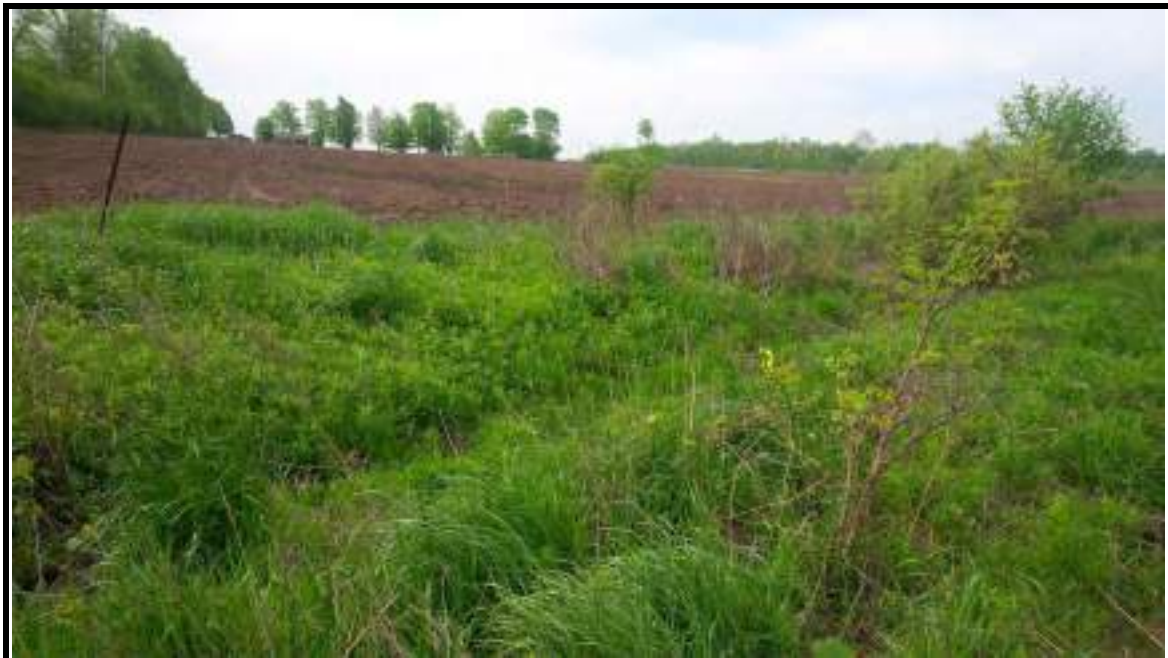
PHOTOGRAPH NO.: 24

LOOKING: Upstream at Cross-Section 12

COMMENT: Width of riparian buffer has increased; channel has widened and there is less vegetation overhanging the channel

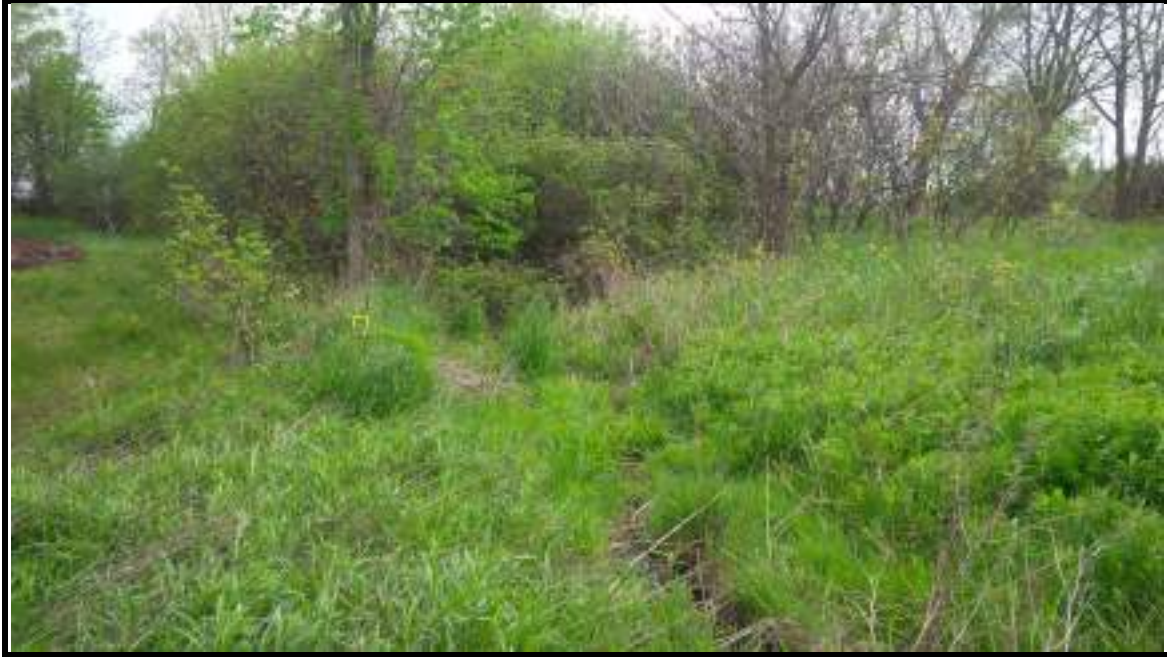
PHOTOGRAPH NO.: 25

LOOKING: Downstream at Cross-Section 12

COMMENT: Channel meanders slightly to the right before entering a reach with a dense thicket of older growth vegetation

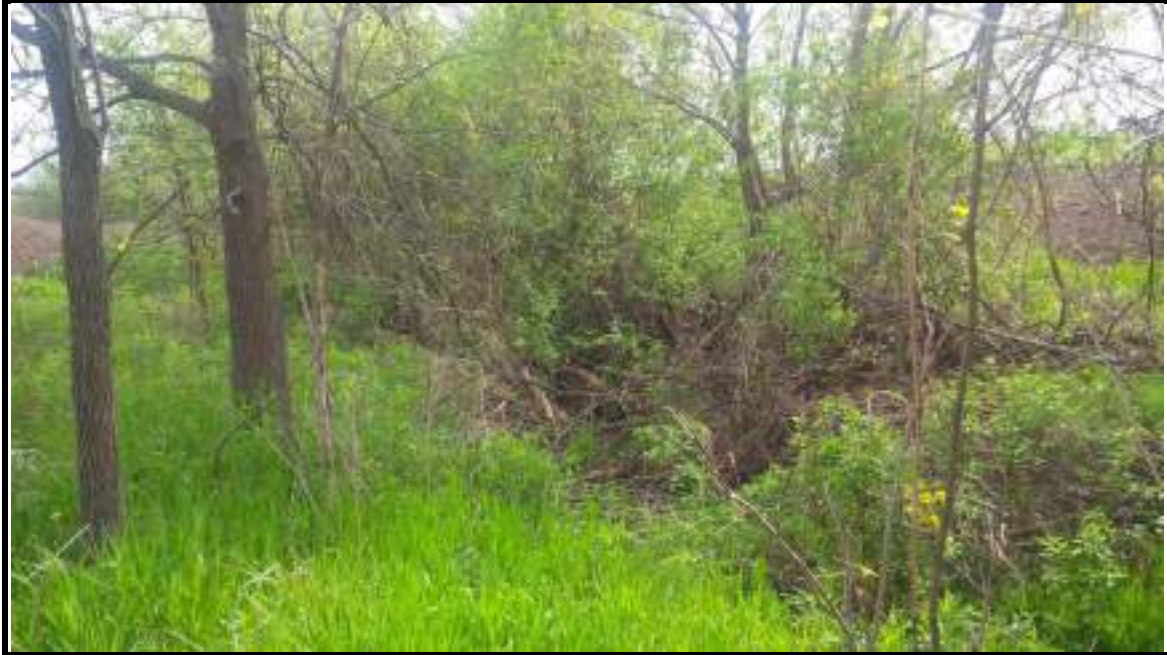
PHOTOGRAPH NO.: 27

LOOKING: Downstream at Cross-Section 13

COMMENT: Woody debris is covering the channel

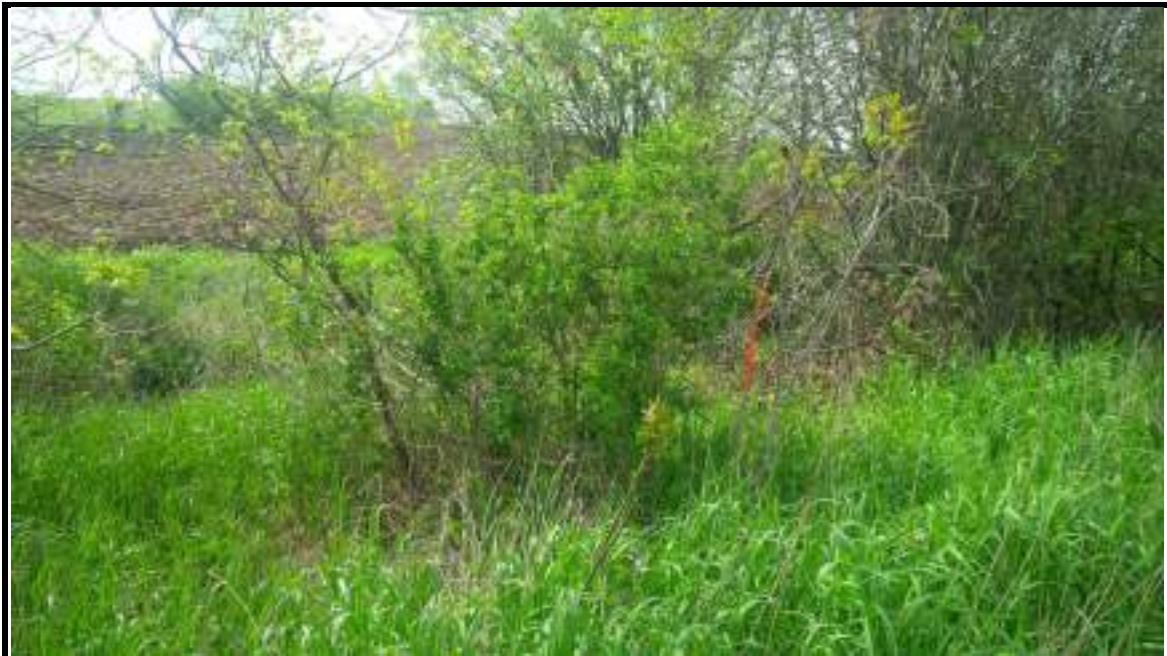
PHOTOGRAPH NO.: 28

LOOKING: Upstream at Cross-Section 14

COMMENT: Few younger, small shrubs have grown on the left bank, grassy berm (appears to be man-made) is on the right bank

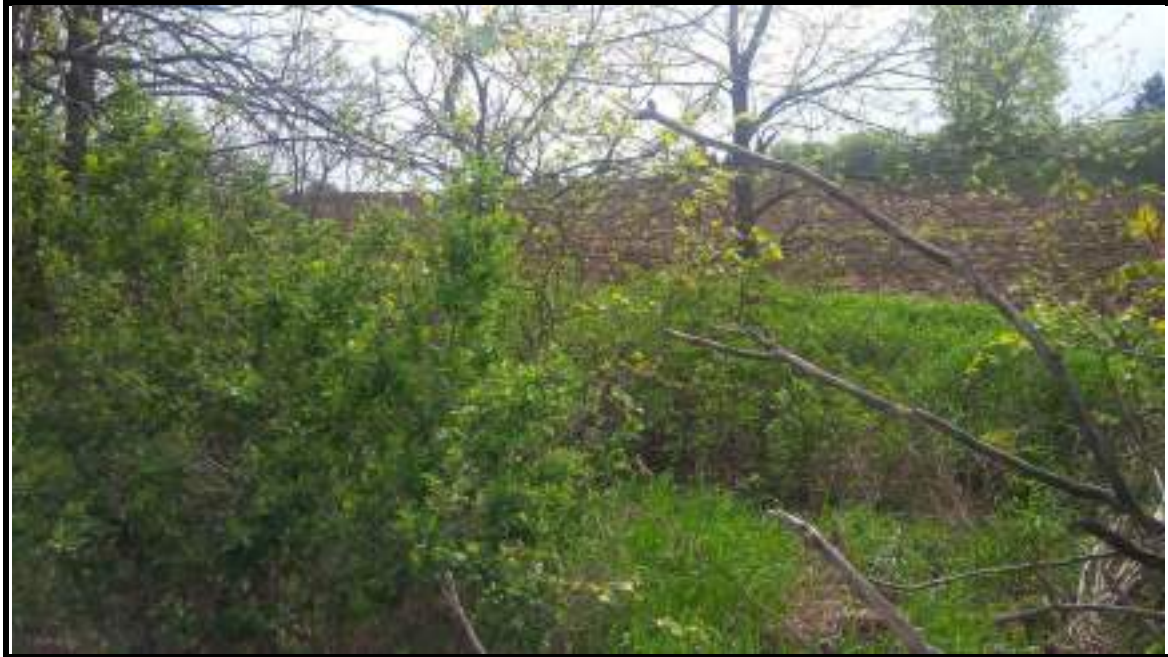
PHOTOGRAPH NO.: 29

LOOKING: Downstream at Cross-Section 15

COMMENT: Flow in channel is significantly greater; Larger shrubs on the left bank; Berm on the right bank

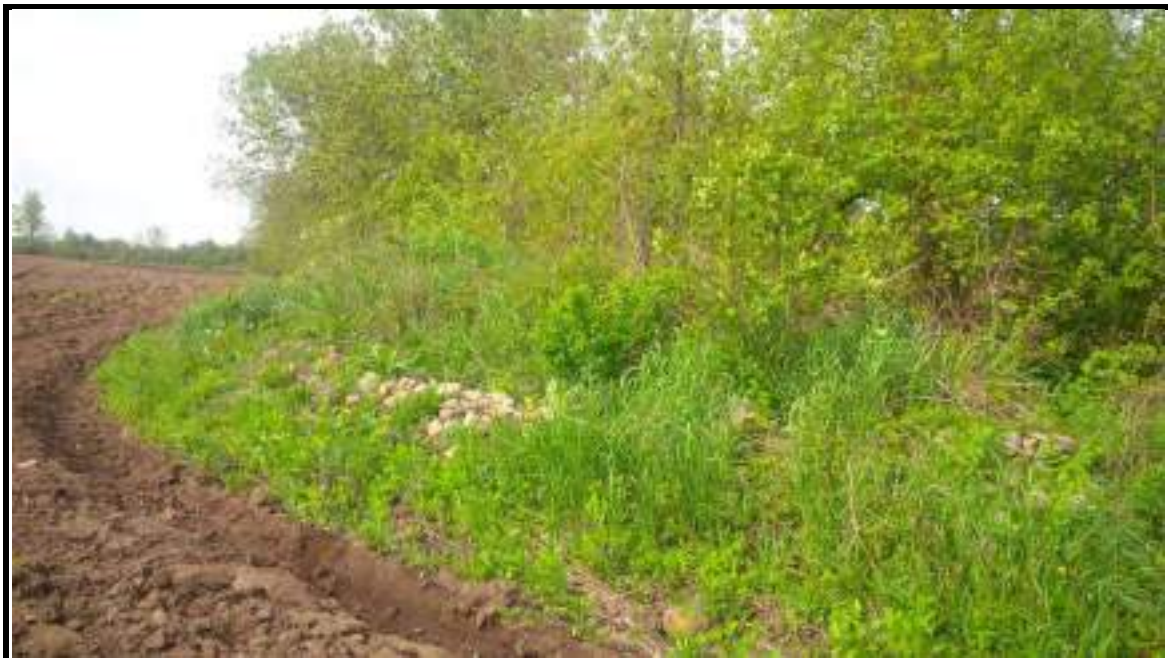
PHOTOGRAPH NO.: 30

LOOKING: Berm built of earthen river stone, located between Cross-Section 15 and 16

COMMENT: Berm has eliminated connectivity of main channel to the floodplain; dense tree cover

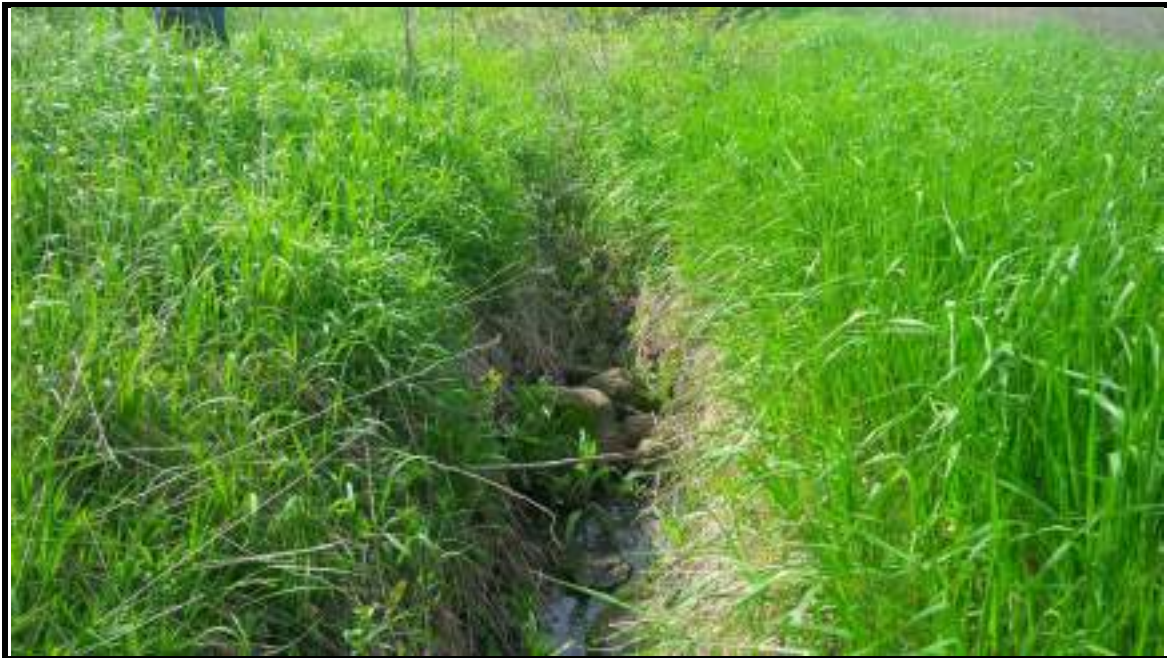
PHOTOGRAPH NO.: 32

COMMENT: Old gate on the left bank is falling in; some bank instability; runoff has resulted in riling on the left bank; bed of channel appears to be degrading; some sinuosity of channel
