Towerhill Developments Inc.

Environmental Impact Study

Millbrook, Ontario

September 2020

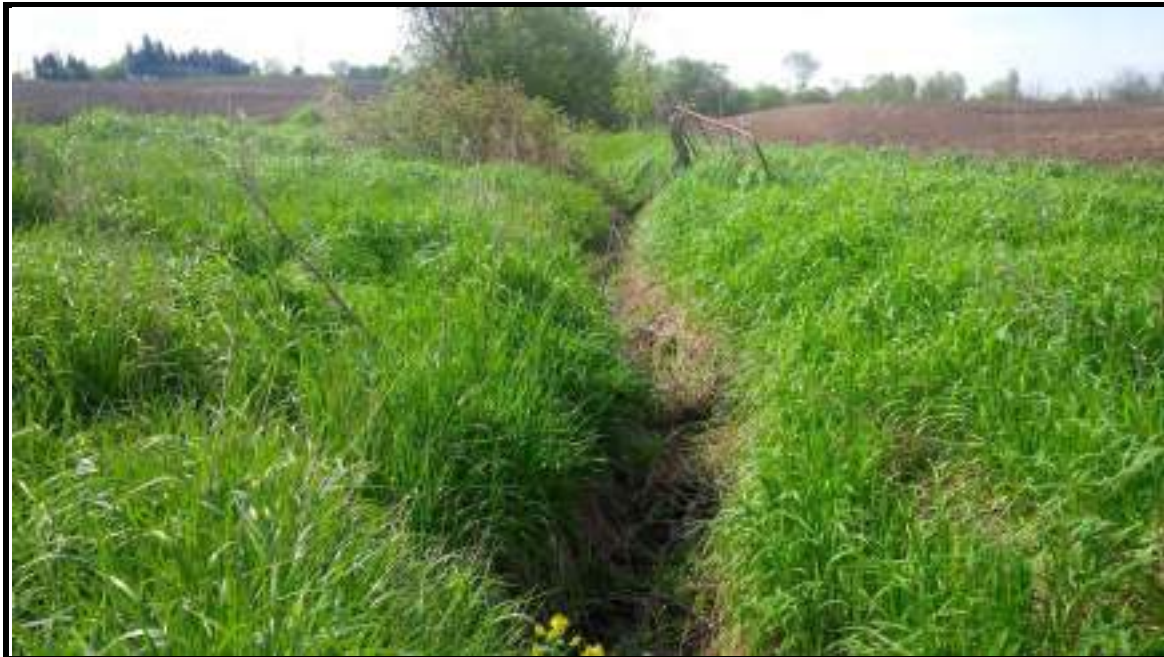
PHOTOGRAPH NO.: 33

FROM: In the stream

LOOKING: Upstream at Cross-Section 17

COMMENT: Old gate on the left bank is falling in; some bank instability; runoff has resulted in riling on the left bank; bed of channel appears to be degrading; some sinuosity of channel

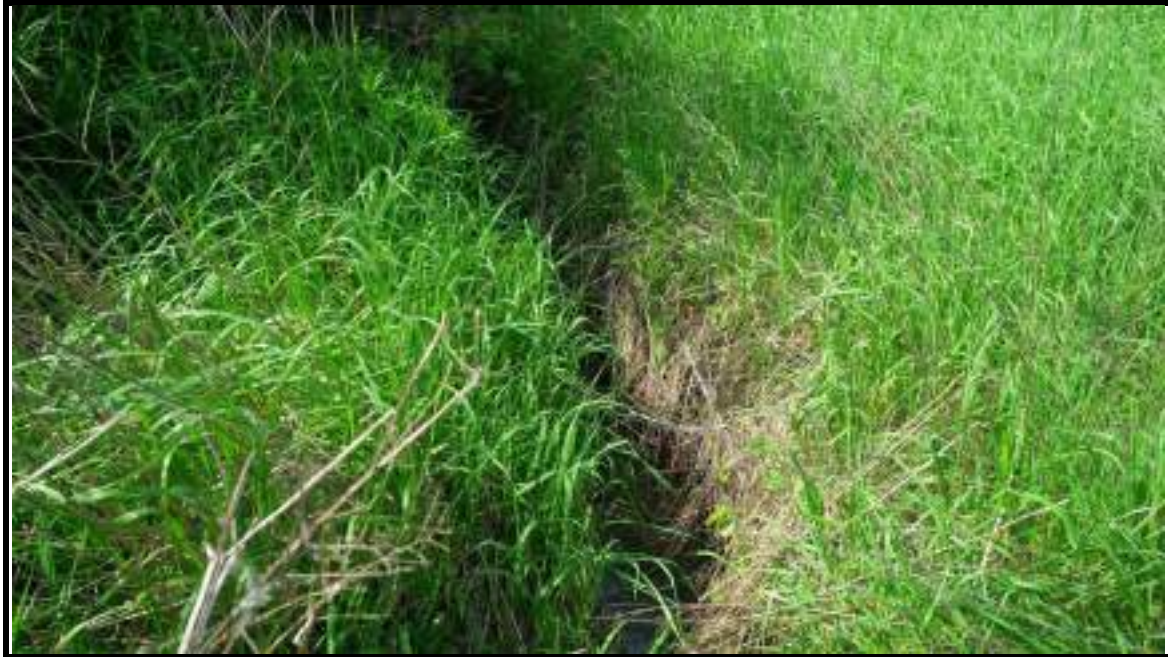
PHOTOGRAPH NO.: 35
FROM: Center of channel
LOOKING: Upstream at Cross-Section 18
COMMENT: Some toeing of banks; bed has degraded; lack of connection between banks and floodplains

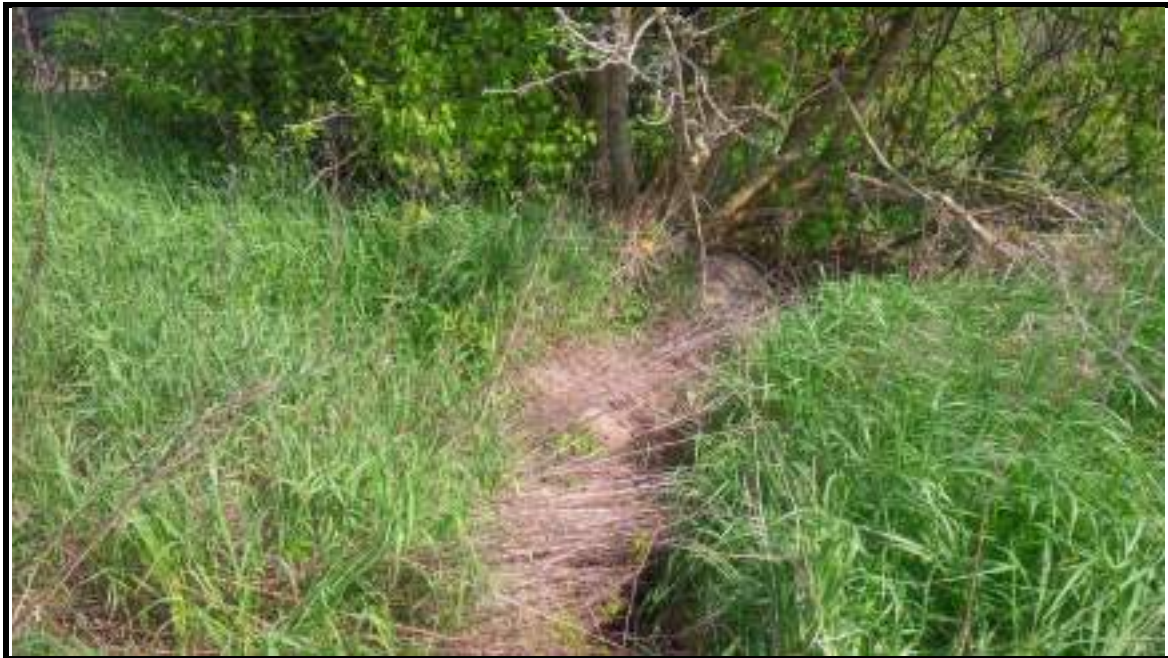
PHOTOGRAPH NO.: 36
FROM: Center of channel
LOOKING: Downstream at Cross-Section 18
COMMENT: Runoff and bank instability appear on the left bank; river flowing into dense thicket of vegetation

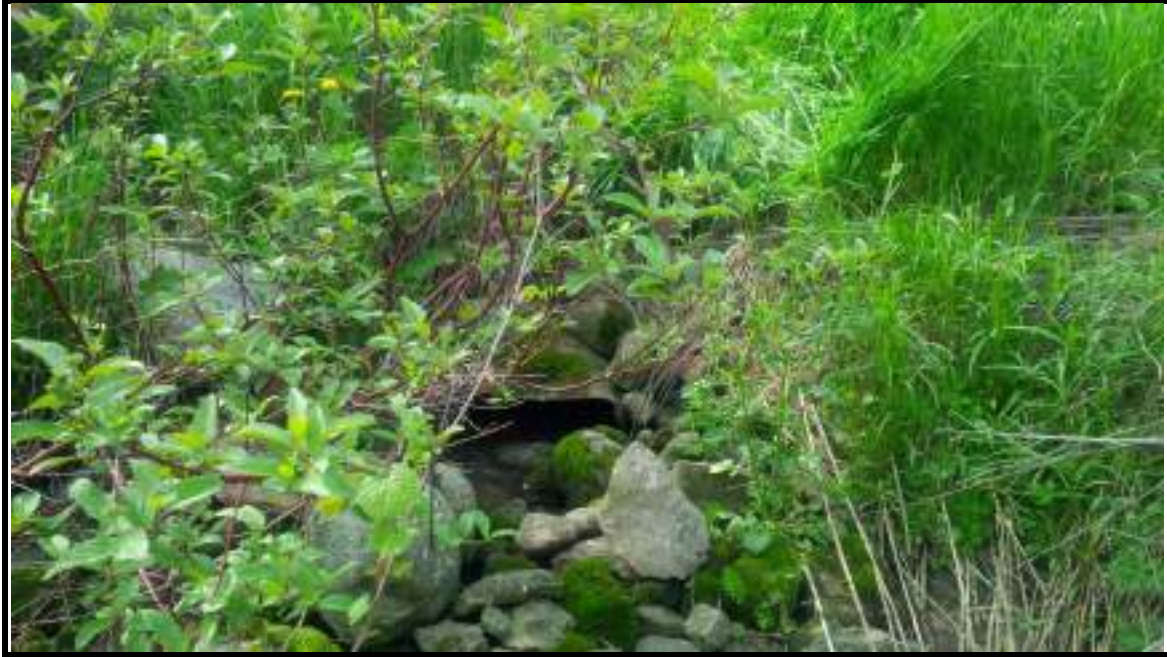
PHOTOGRAPH NO.: 37

FROM: Center of channel

LOOKING: Upstream (between Cross-Section 18 and 19) at culvert

COMMENT: Culvert has been compressed; river stone (range in size from 15cm to 30cm) at the outlet; water flowing beneath the culvert from other side

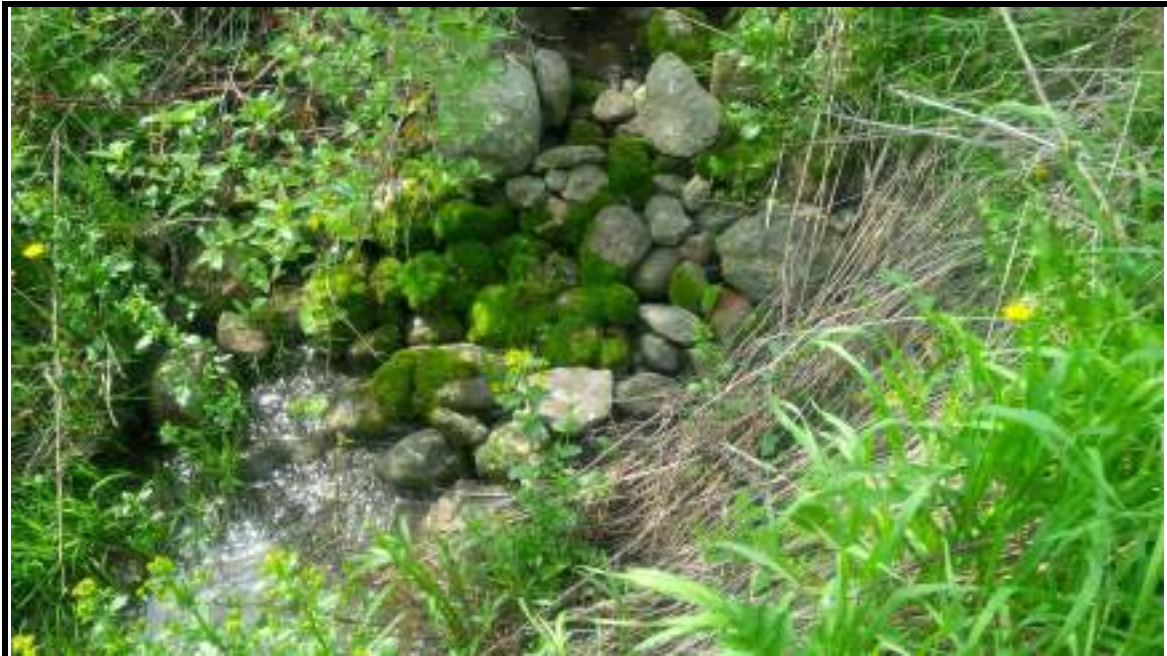
PHOTOGRAPH NO.: 38

FROM: Center of channel, slightly downstream of Cross-Section 22

LOOKING: Upstream (between Cross-Section 18 and 19) at culvert

COMMENT: River-stone riprap has significant moss cover and little water flowing overtop; downstream is sandy-silt

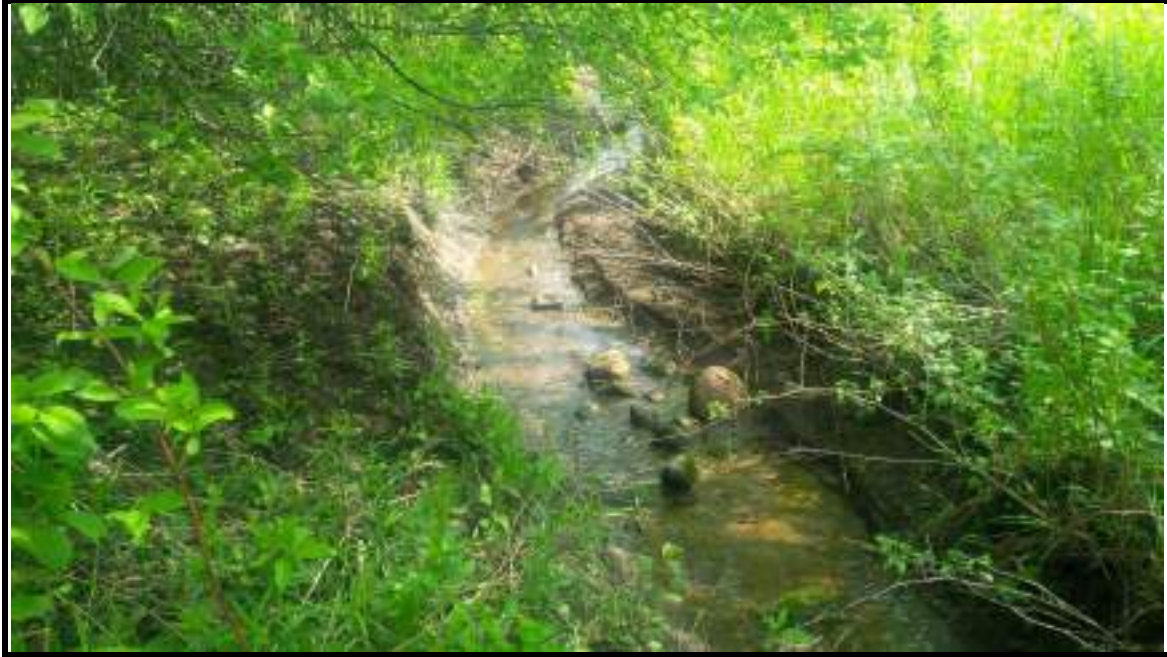
PHOTOGRAPH NO.: 39

FROM: Left bank

LOOKING: Downstream (between Cross-Section 18 and 19 and downstream of culvert)

COMMENT: Bed composed of sandy-silt with some larger stones; significant meander in the channel and development of a point bar terrace on the right bank; banks appear to be fairly stable; some overhanging vegetation on the right bank

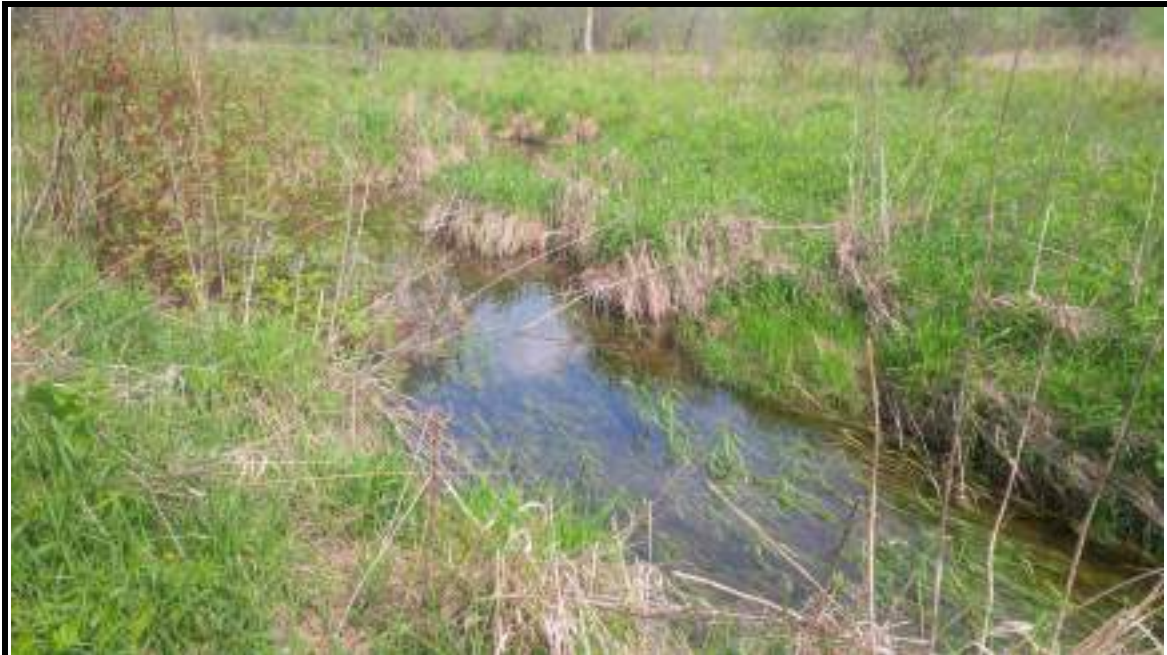
PHOTOGRAPH NO.: 40

FROM: Right bank

LOOKING: Upstream at Cross-Section 19 (at confluence of study reach with Baxter Creek)

COMMENT: Channel is significantly wider with substantially greater flow depth;

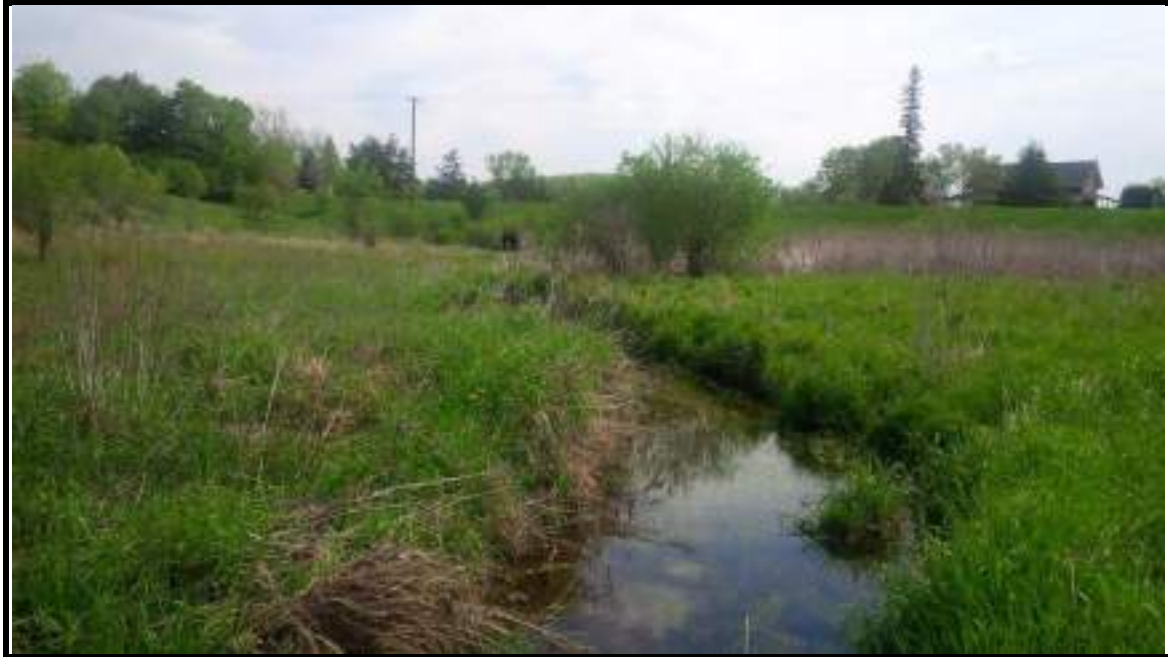
PHOTOGRAPH NO.: 41

FROM: Right bank

LOOKING: Downstream at Cross-Section 19 (at confluence of study reach with Baxter Creek)

COMMENT: Bed is composed of a mix of grasses and larger river stone; right bank is saturated

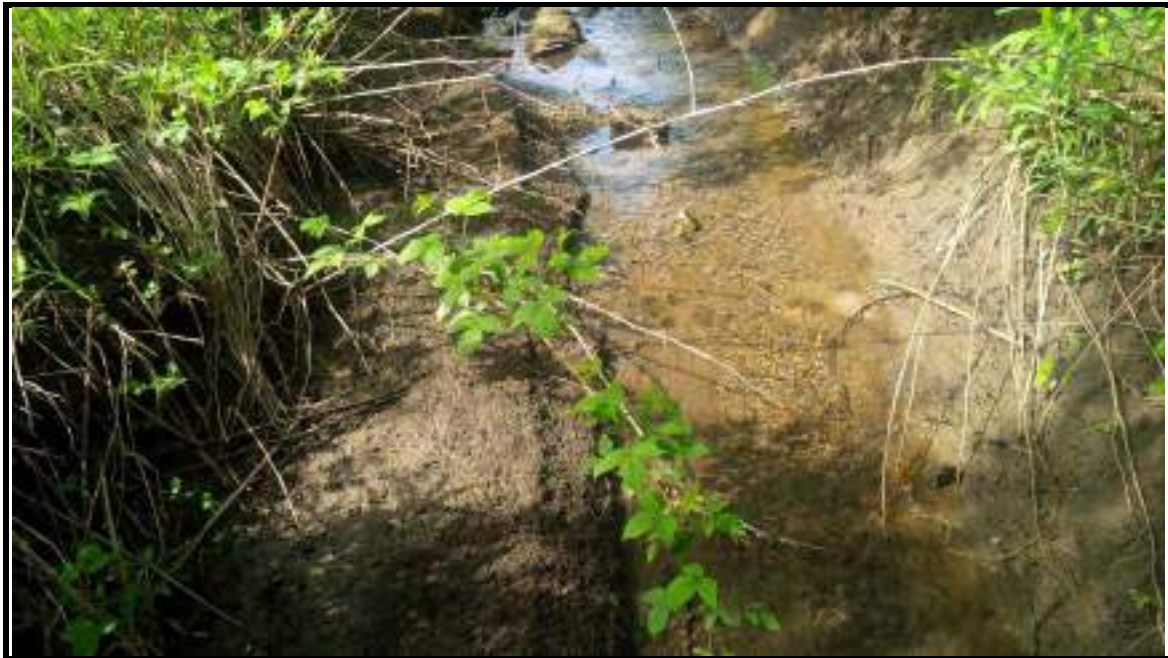
PHOTOGRAPH NO.: 42

FROM: Center of channel

LOOKING: Upstream at Cross-Section 20

COMMENT: Exposed, depositional bar has formed on the right bank

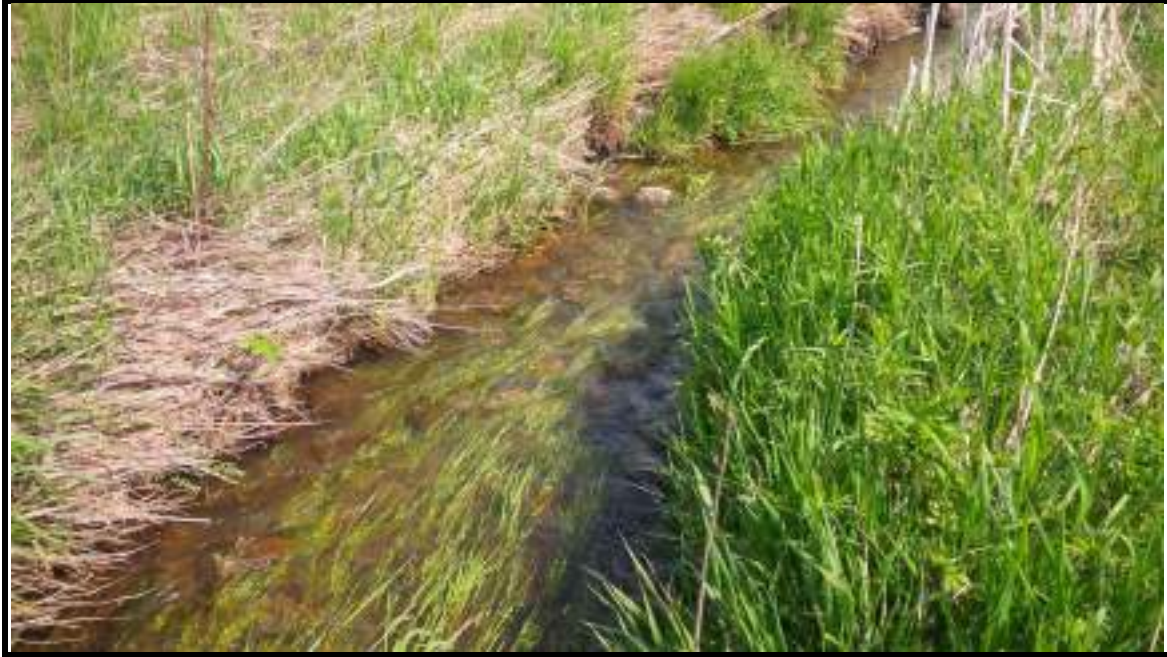
PHOTOGRAPH NO.: 43

FROM: Right bank

LOOKING: Downstream at Cross-Section 20

COMMENT: Discharge has increased; right bank is saturated and slightly unstable

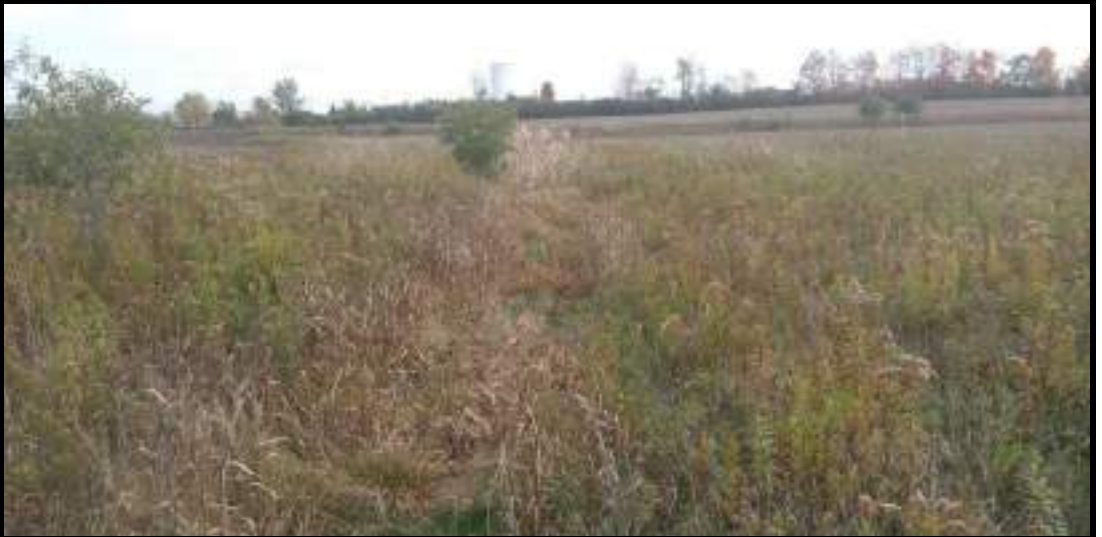
Photo 1

Looking downstream toward County Road 10 from the far upstream end of Tributary B. Channel difficult to detect. Dry and overgrown with grasses.

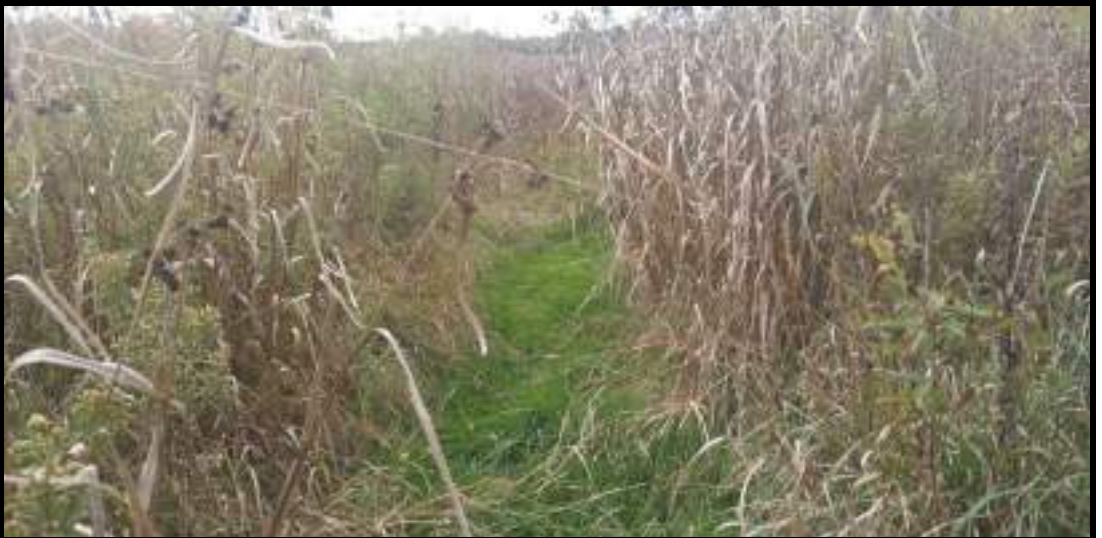
Photo 2

Channel bed more evident walking downstream. No bare soil, only dense grass.

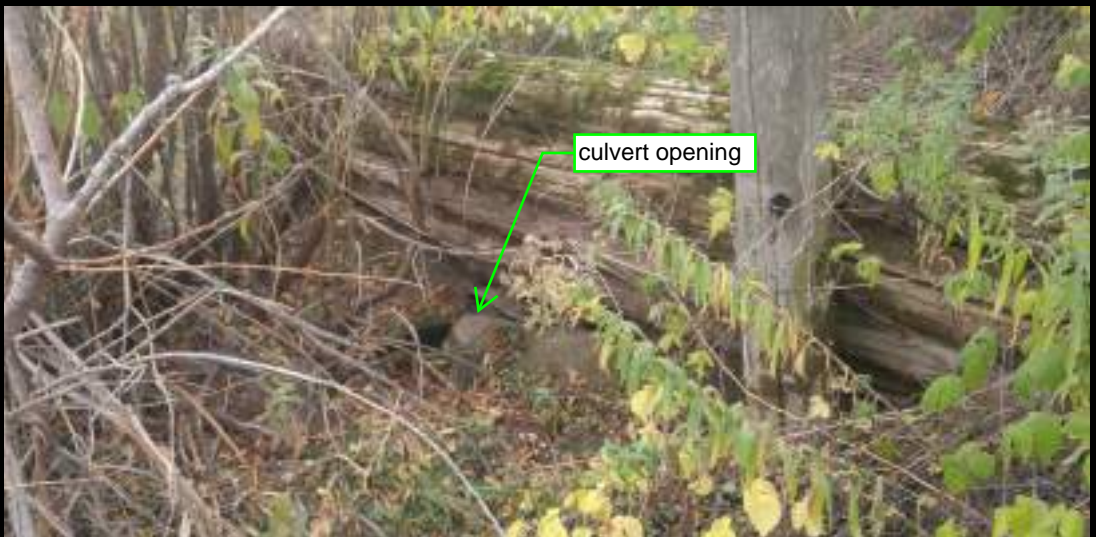
Photo 3

Downstream of driveway. Caved in culvert, almost completely closed in. Dry channel.

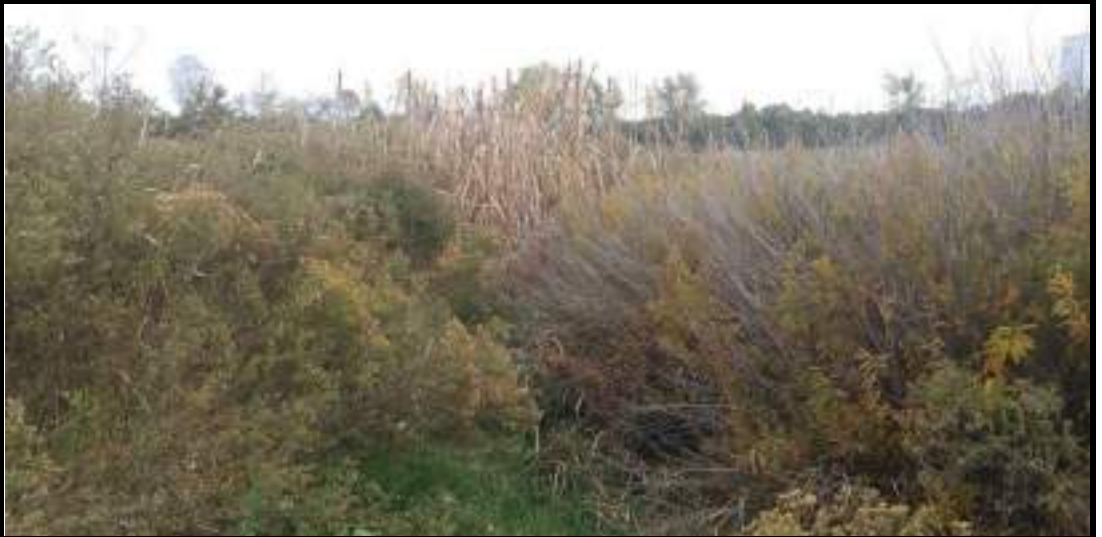
Photo 4

Downstream of
driveway culvert.
Grassed channel. Dry.

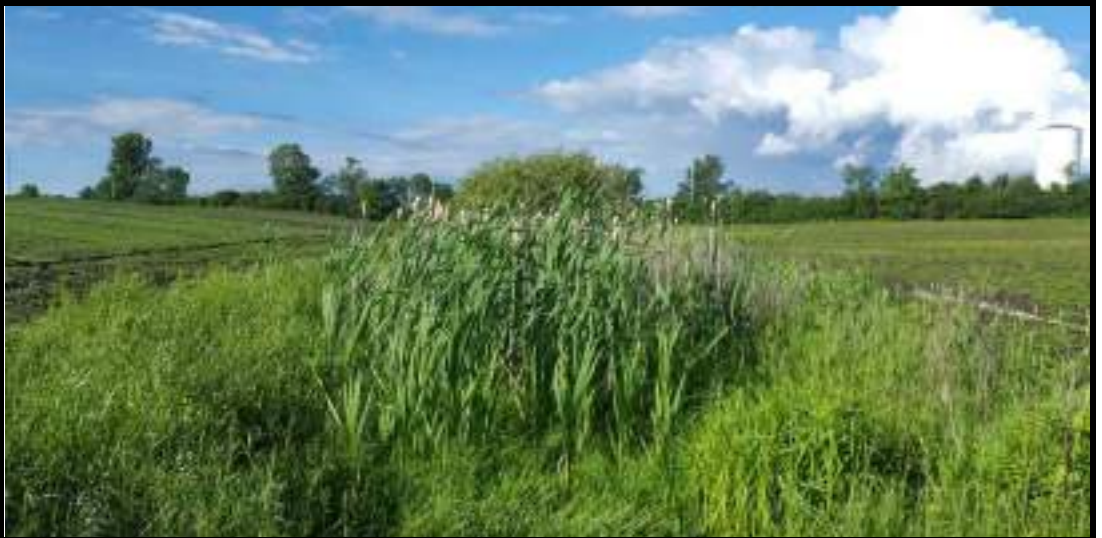
Photo 6

Downstream of
driveway channel at
WC-3, no flow
observed in channel.

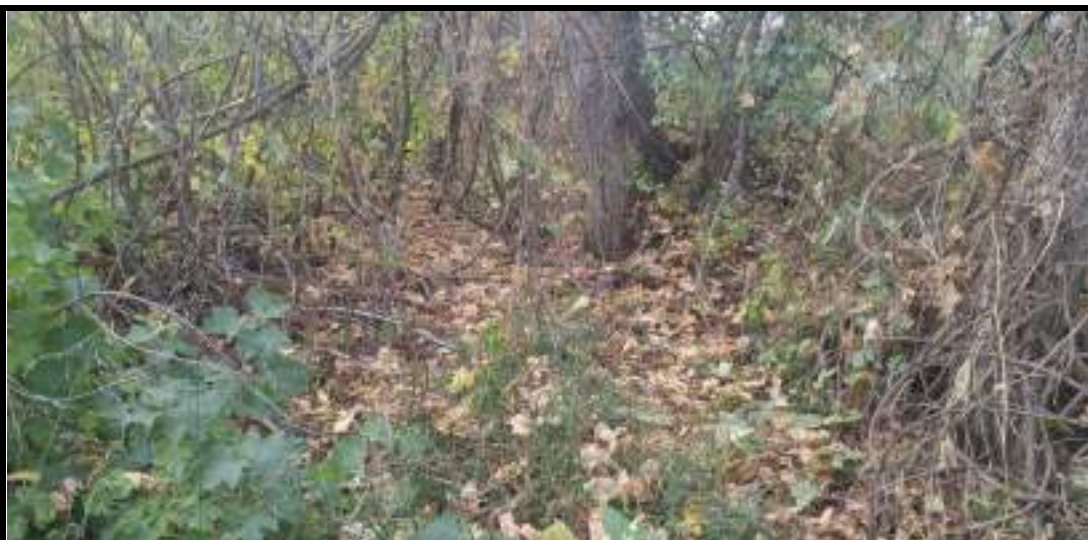
Photo 7

Entering hedgerow.
Channel contained
some bare substrate,
but was dry and
covered with leaf
litter.

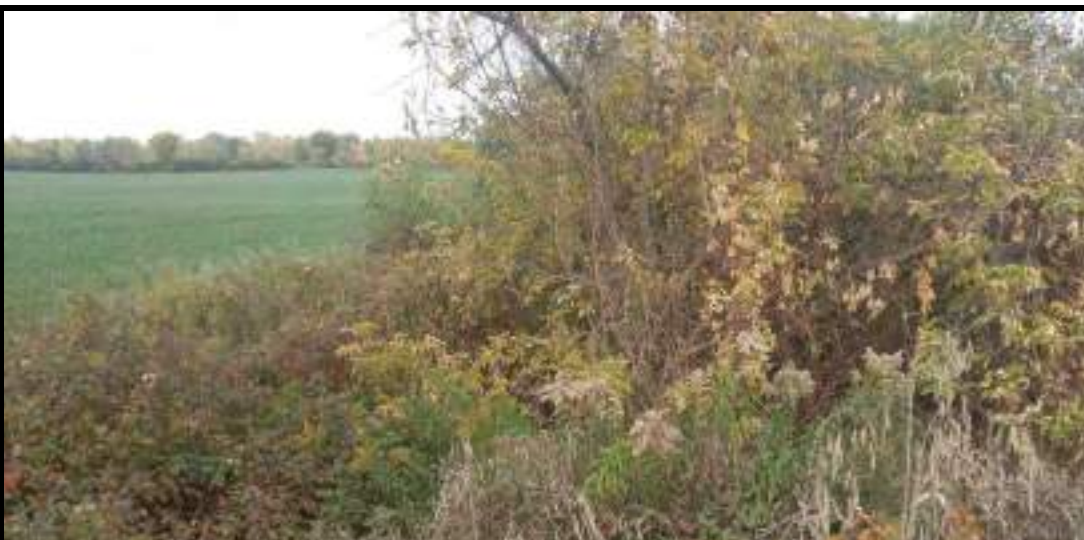
Photo 10

Hedgerow. Contained rocks/boulders along banks (from farm fields). Channel was overgrown.

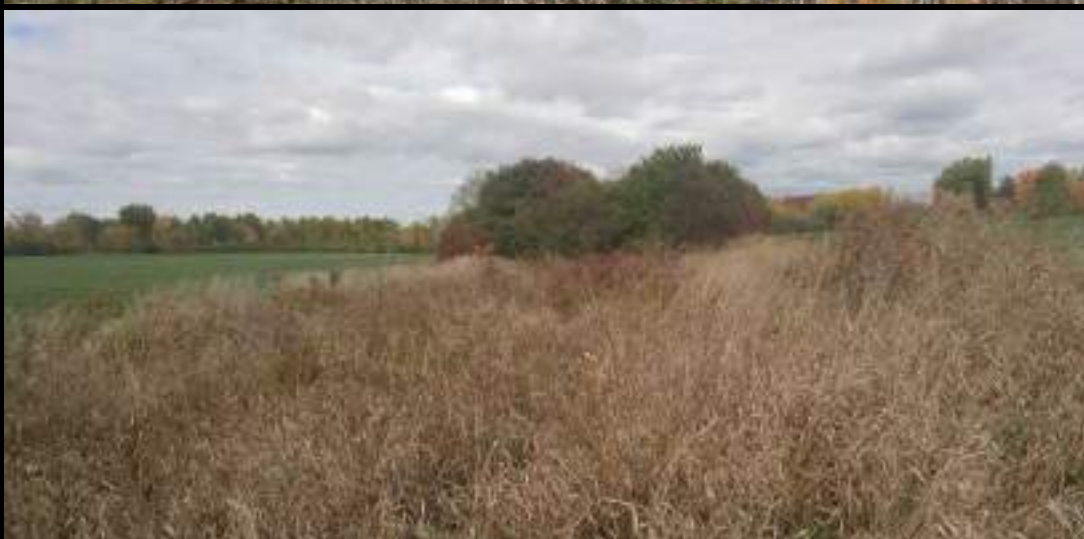
Photo 11

Grassed section of channel. Dry. Looking downstream.

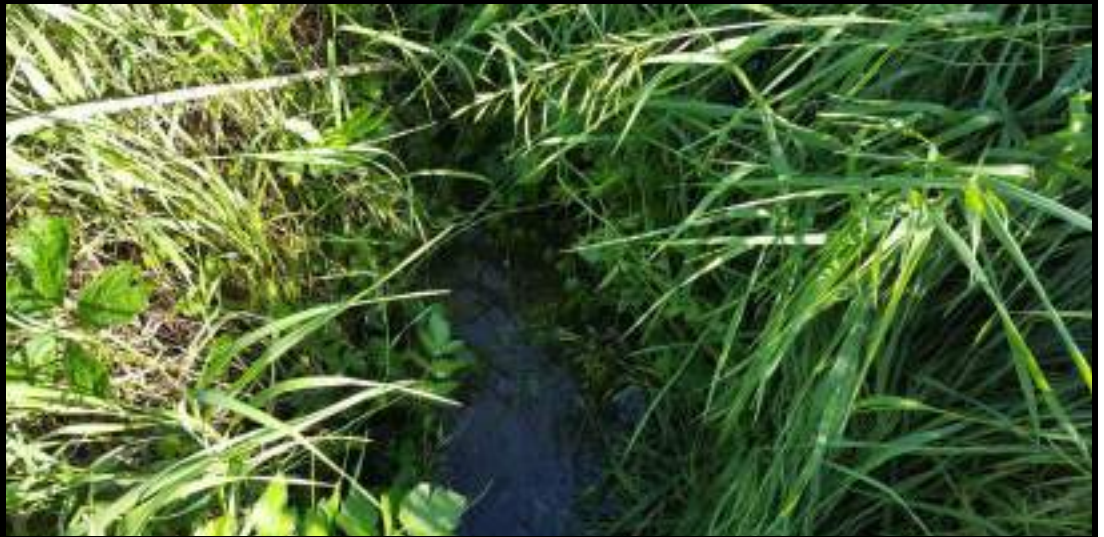
Photo 13

Flow observed in channel downstream of driveway at WC-4.

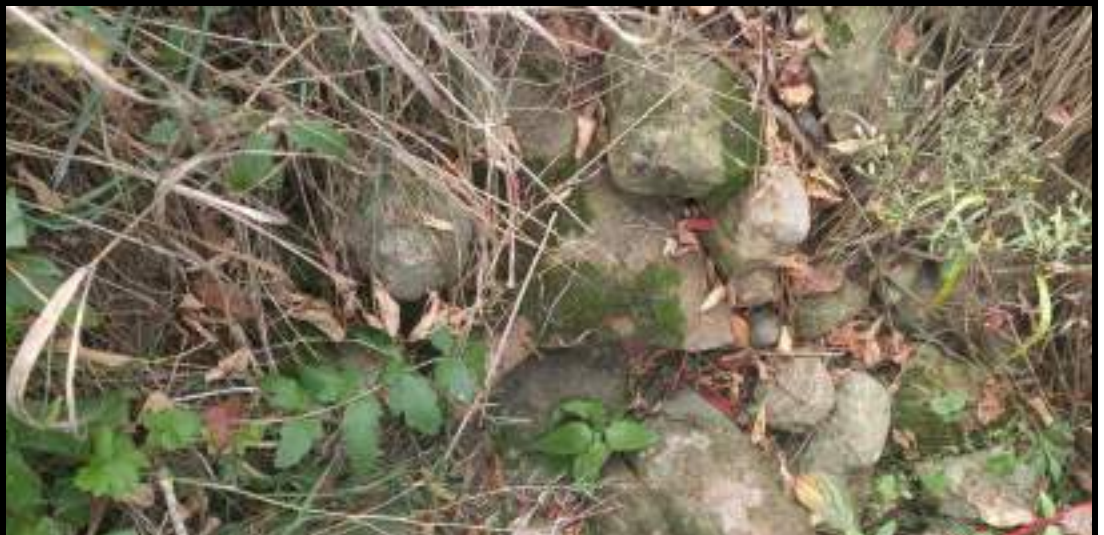
Photo 14

Substrate further downstream near laneway crossing. More cobble than bare substrate near the culvert entrance.

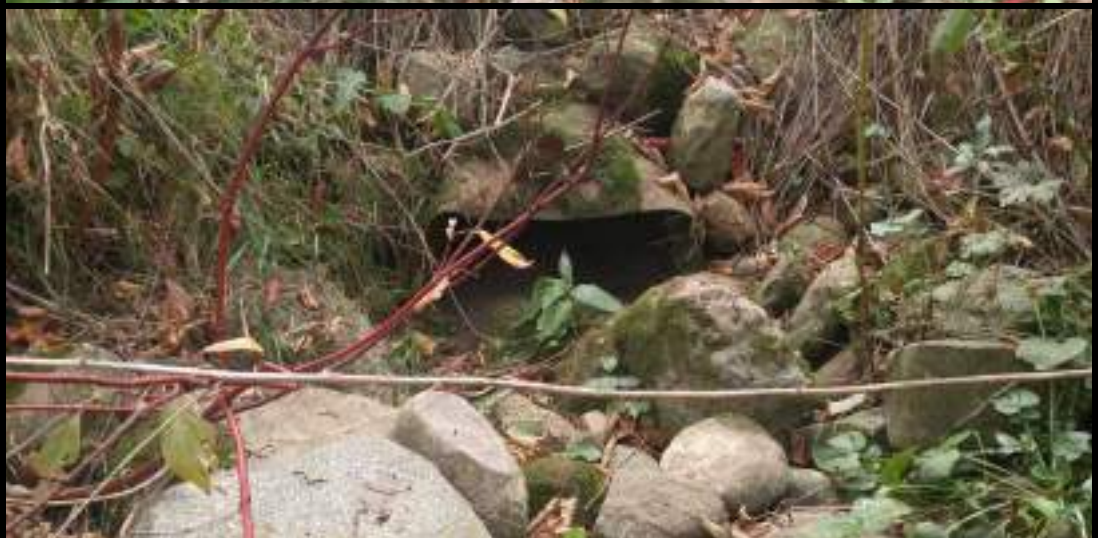
Photo 15

Partially plugged culvert looking upstream at laneway crossing.

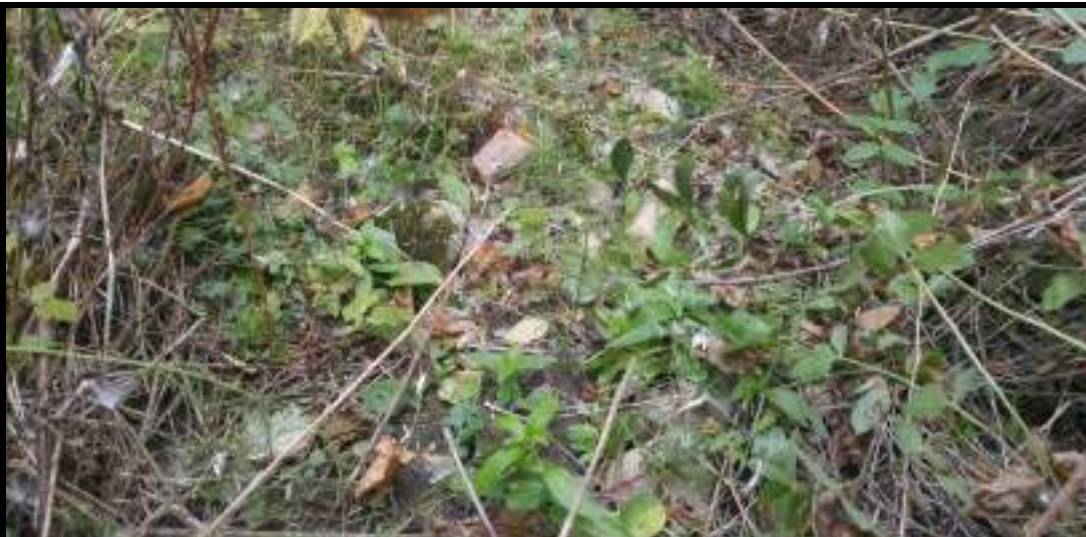
Photo 16

Substrate downstream of laneway culvert. Bare in some spots, contained weeds and some rocks.

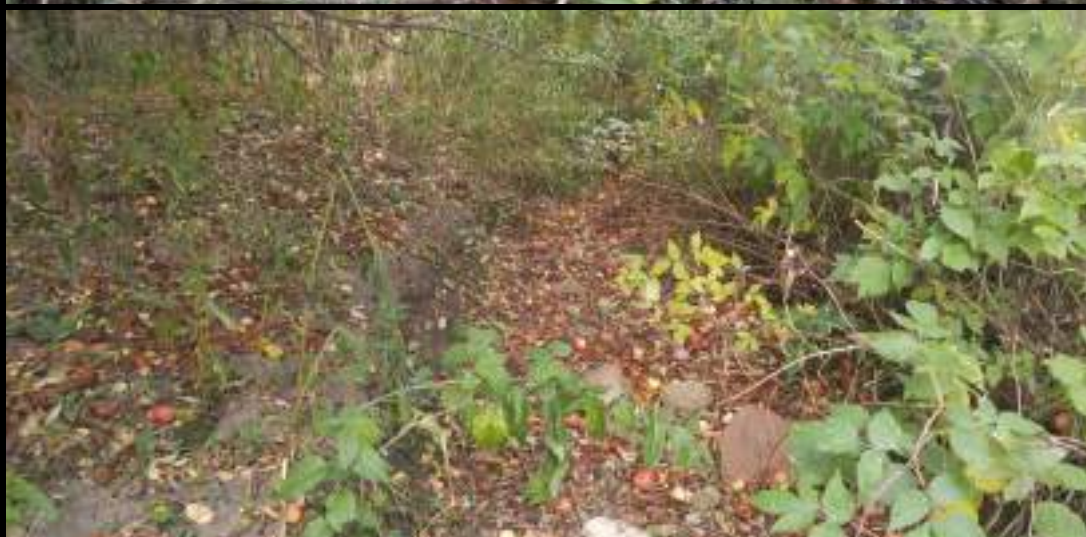
Photo 17

Channel downstream of laneway. Contained bare soil, eroded banks and apples from trees within hedgerow.

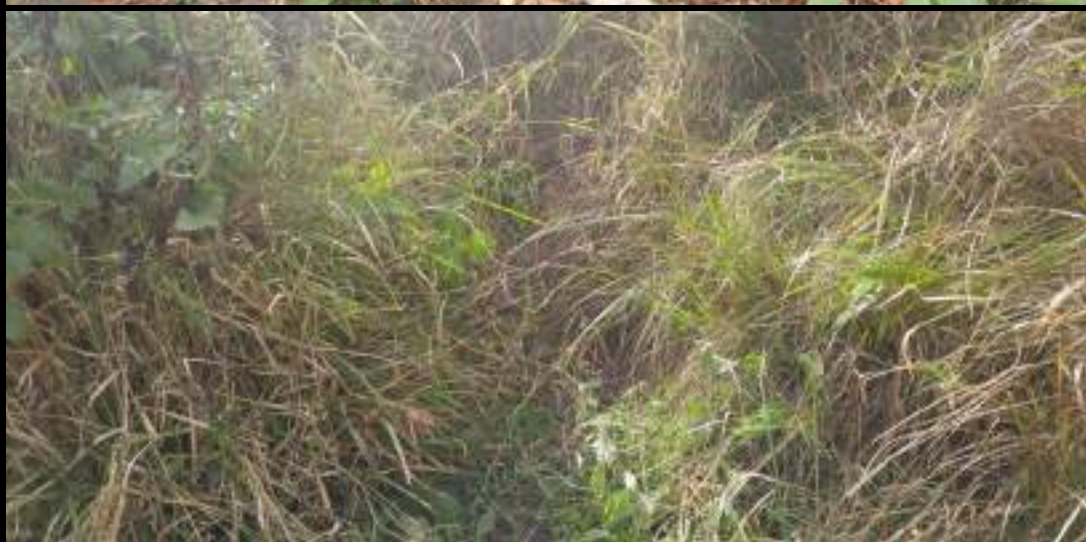
Photo 18

Confluence of Tributary B and C looking upstream into Tributary B. There is a steep drop of approximately 0.5-1 m from the bed of Tributary B to the bed of Tributary C, through this small grassed channel.

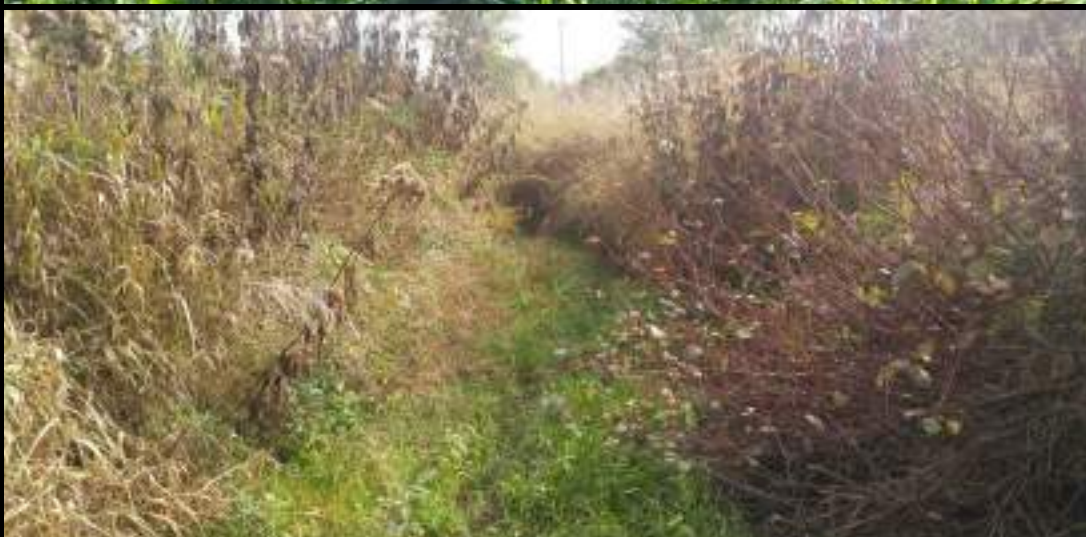
Photo 20

Tributary C looking
downstream toward
County Road 10 at
confluence with
Tributary B. Dry with
grasses in bed.

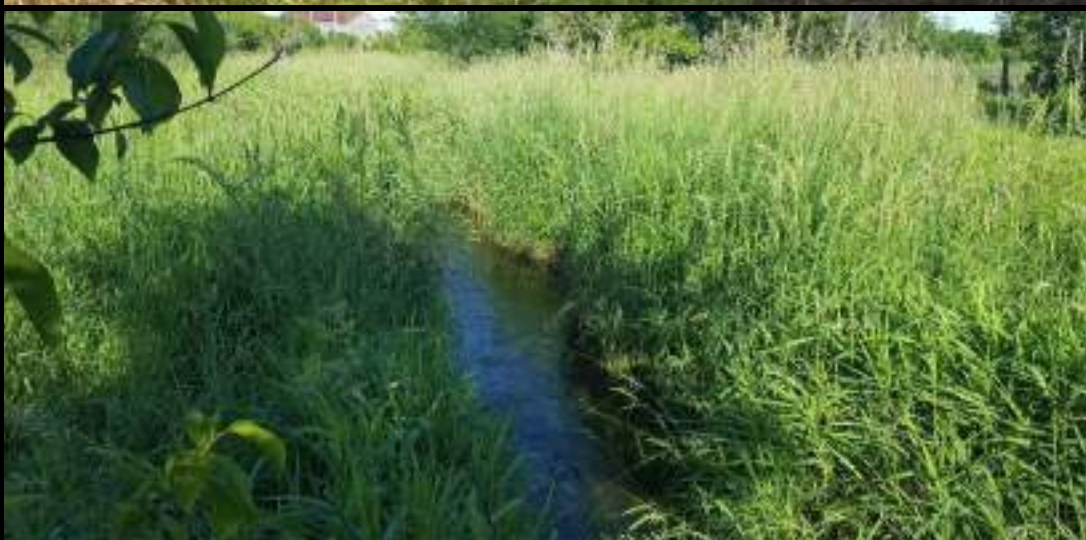
Photo 21

Tributary C looking
downstream toward
County Road 10 near
the confluence with
Tributary B, at WC-5.
Substantial flow.

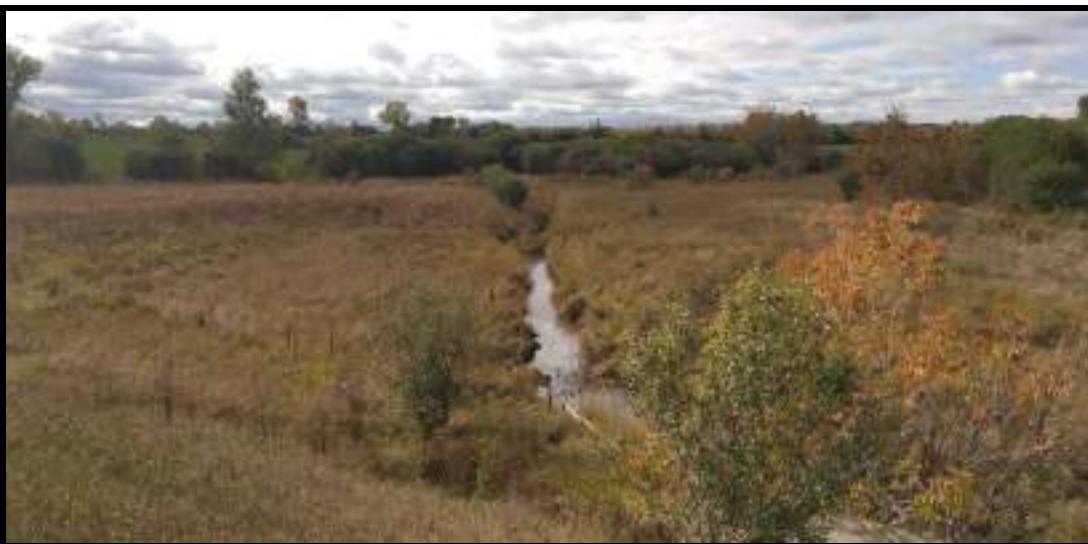
Photo 22

Looking upstream at
Tributary C from
bridge at County
Road 10. Evidence of
groundwater inputs
downstream of the
confluence of
Tributary C and B,
which was dry.

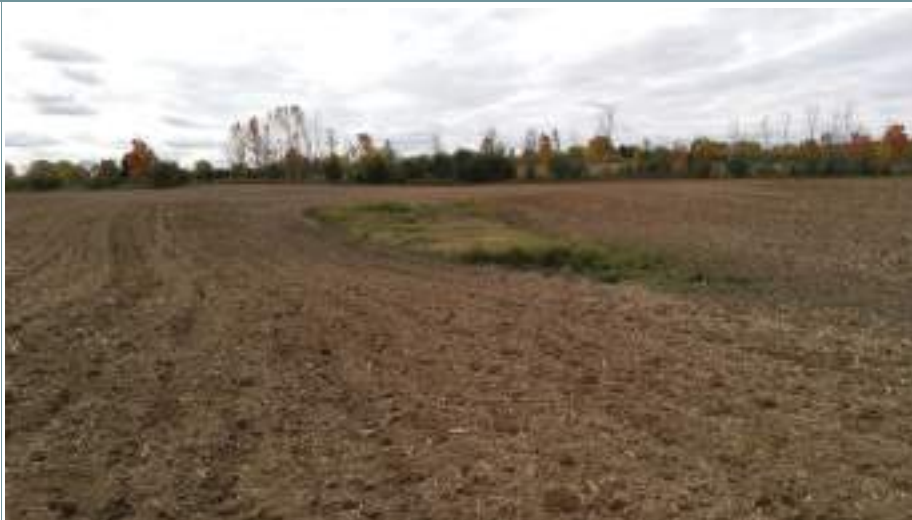
Ecological Land Classification Photos**Photo 16**

October 15, 2016

Isolated wetland
pocket

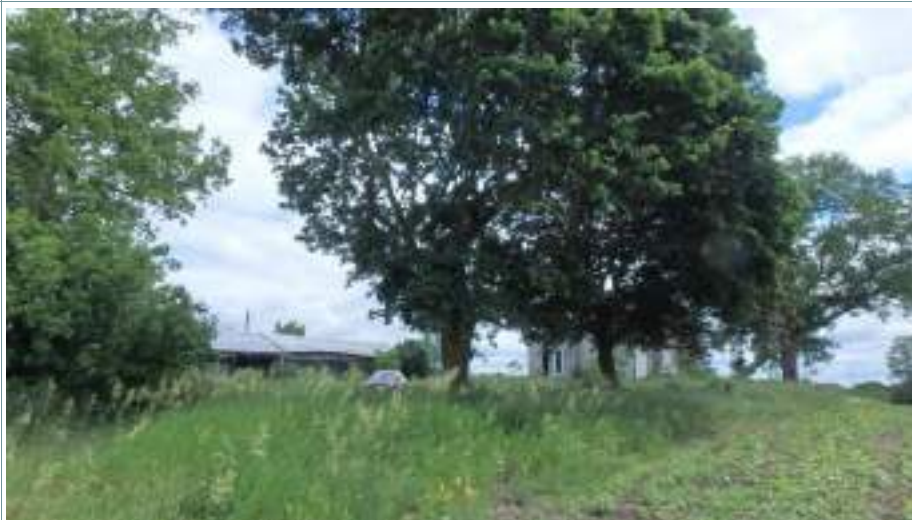
**Photo 17**

June 21, 2017

CVR_4

Rural Residential
