Geotechnical Investigation Report

**65 Northey's Bay Road,
North Kawartha, ON**

March 2, 2023

Cambium Reference: 15101-001

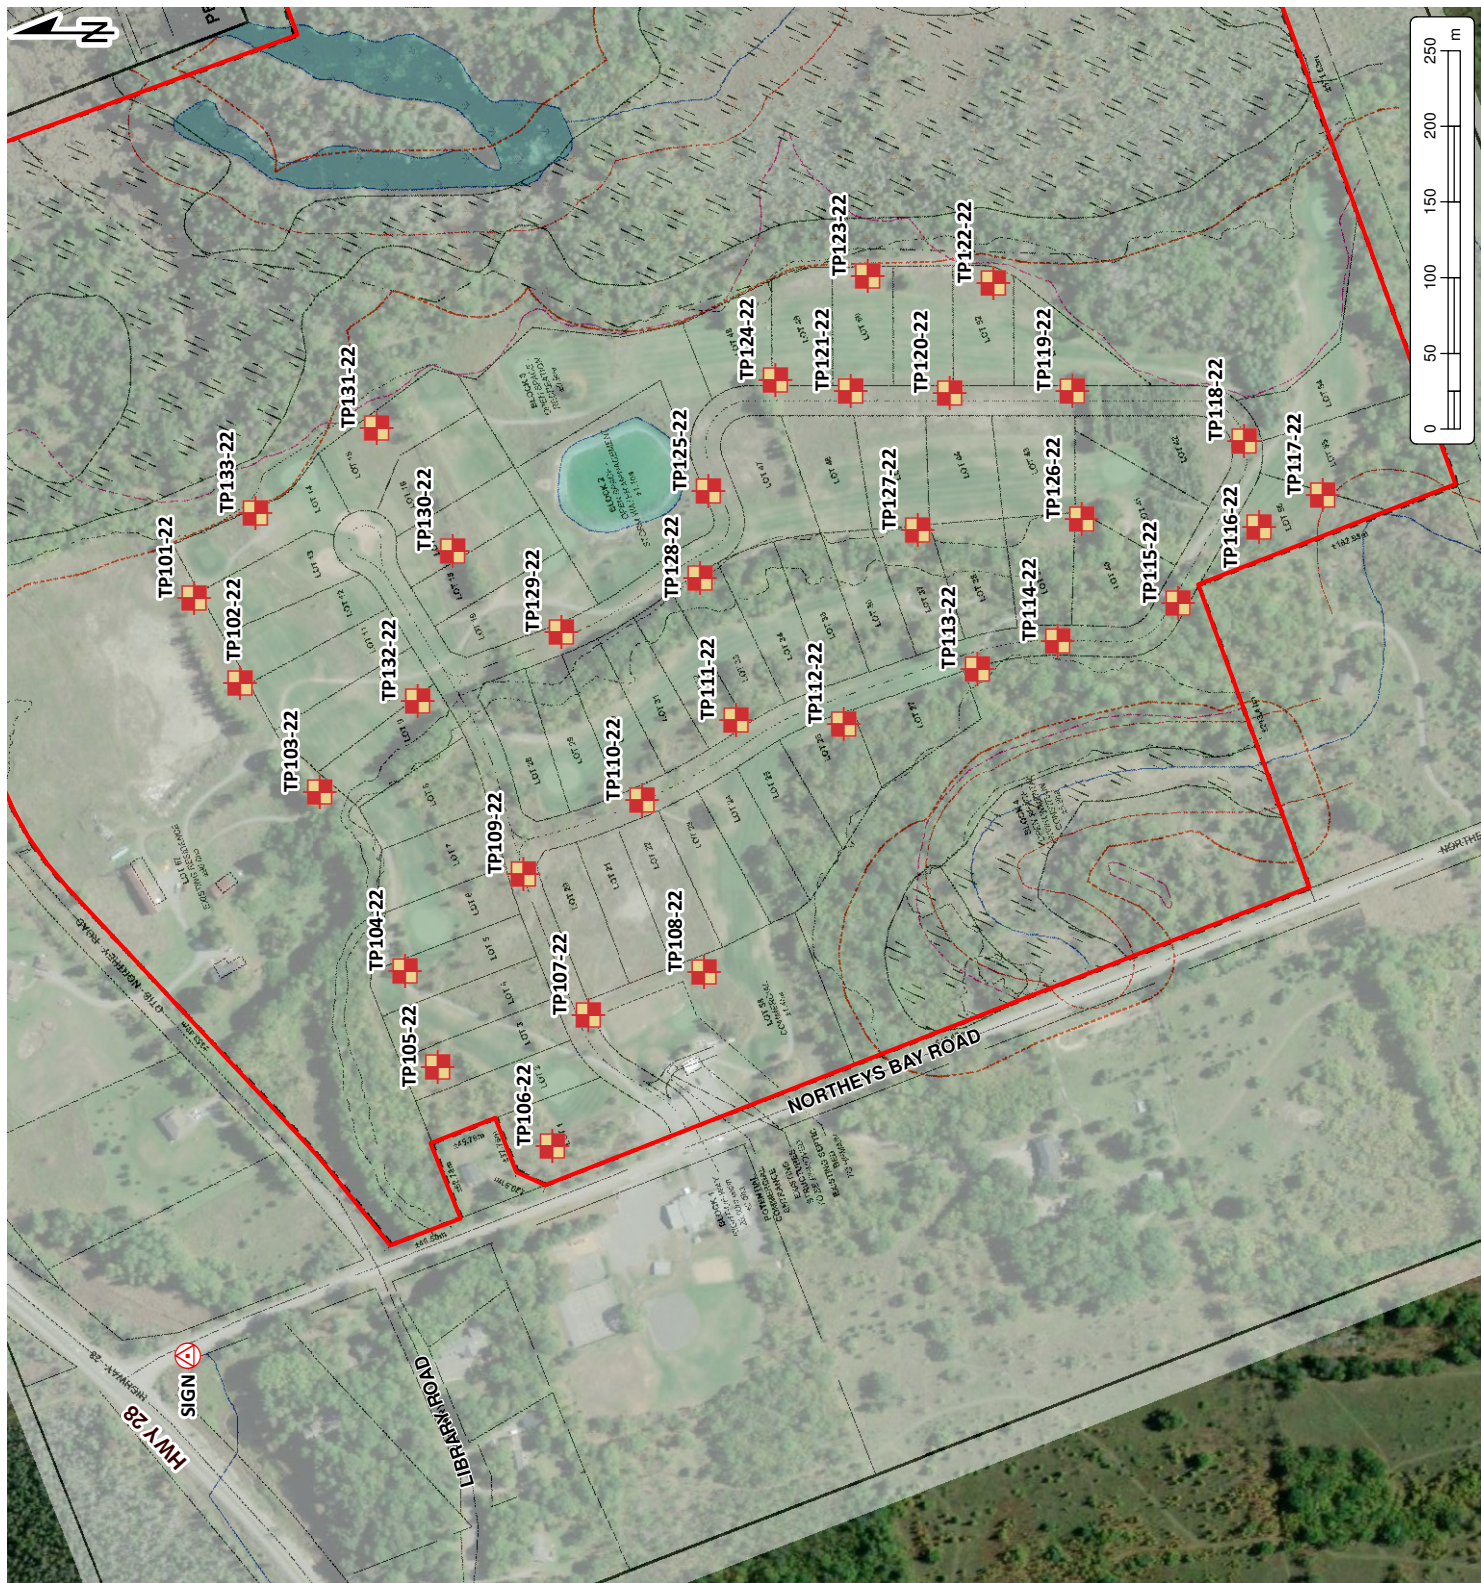
Project No.:	15101-001	Date:	November 2022
Scale:	1:5,000	Projection:	NAD 1983 UTM Zone 17N
Created by:	SJV	Checked by:	SNR
Figure:	2

A test pit investigation was conducted at the site on November 4, 2022, to assess subsurface conditions. A total of 33 test pits (numbered TP101-22 through TP133-22) were advanced across the site. Locations of the test pits relative to existing and proposed conditions are shown on Figure 2 – Test Pit Location Plan. Test pits all terminated due to practical refusal on the underlying bedrock and were advanced to depths ranging from surface refusal to 1.4 mbgs.

TEST PIT LOCATION
PLAN

It is anticipated that foundations for the proposed structures will be made on the underlying bedrock. Depth/Relative elevation to the top of sound bedrock is summarized on Table 1 of Section 4.1.5. Locations of each test pit is shown on Figure 1.
