**Millbrook Subdivision, 396 County Road 10, Fallis North, Township of Cavan Monaghan,  
County of Peterborough**

GHD Limited has prepared the following responses to the review of our Environmental Impact Study (dated August 7, 2025) by Stantec, the Township's peer reviewer for the first submission of the draft plan of subdivision for the property located at 396 County Road 10, Millbrook in the Township of Cavan Monaghan, known as Fallis North. The peer reviewer requested additional ecological information and clarifications on the Environmental Impact Study in their October 17<sup>th</sup>, 2025 peer review letter.

**Updated EIS Figure 1 - Natural Features,  
Surveys and Constraints**

**New Figure 2 - Natural Features and Site  
Plan Overlay**

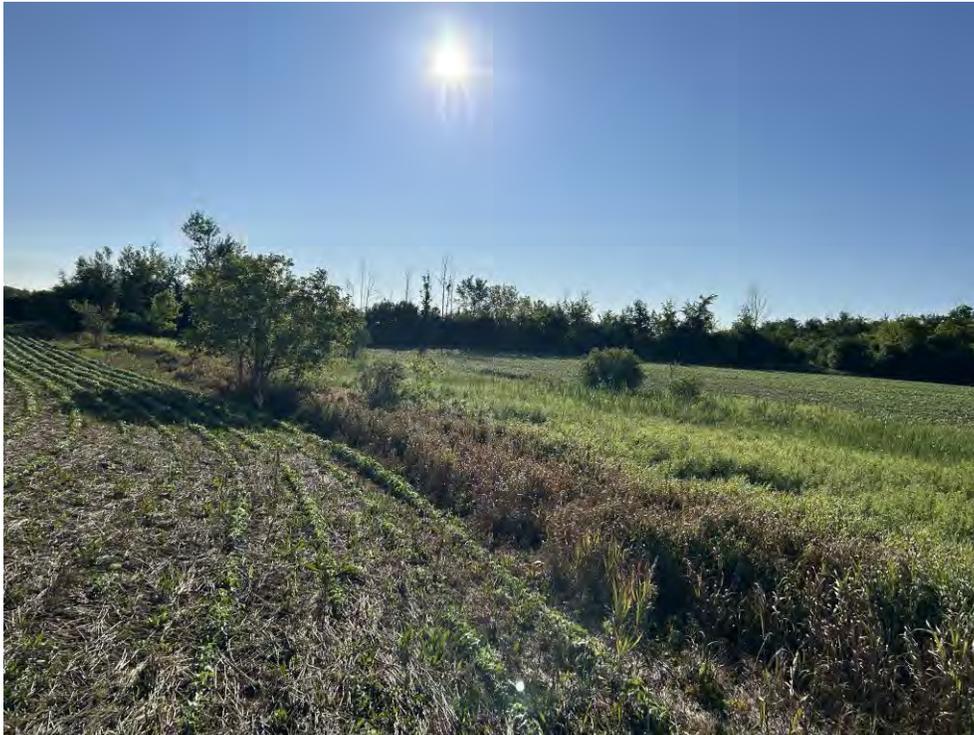
The areas labelled as Ag(soya) are currently being farmed for soya, as indicated by this photo taken in July 2025 of HDF1B:

**View of farm field facing south along HDF 2, facing south. Note field conditions.**

***GHD Response:*** As an actively farmed property, crops are regularly rotated. There was hay on part of Site in 2023, but left fallow or planted in soya in 2025. The location of the one southeastern field adjacent to HDF2A also was left fallow with some weedy pioneer species and was classified as CUM1-1. During our field surveys, bobolink and meadowlark were heard to the east of the Site in the large hayfields in 2025. No meadowlark or bobolink were seen or flushed on the Site during 2025 surveys. The patchiness of the fallow field did not provide suitable nesting habitat for those grassland species.

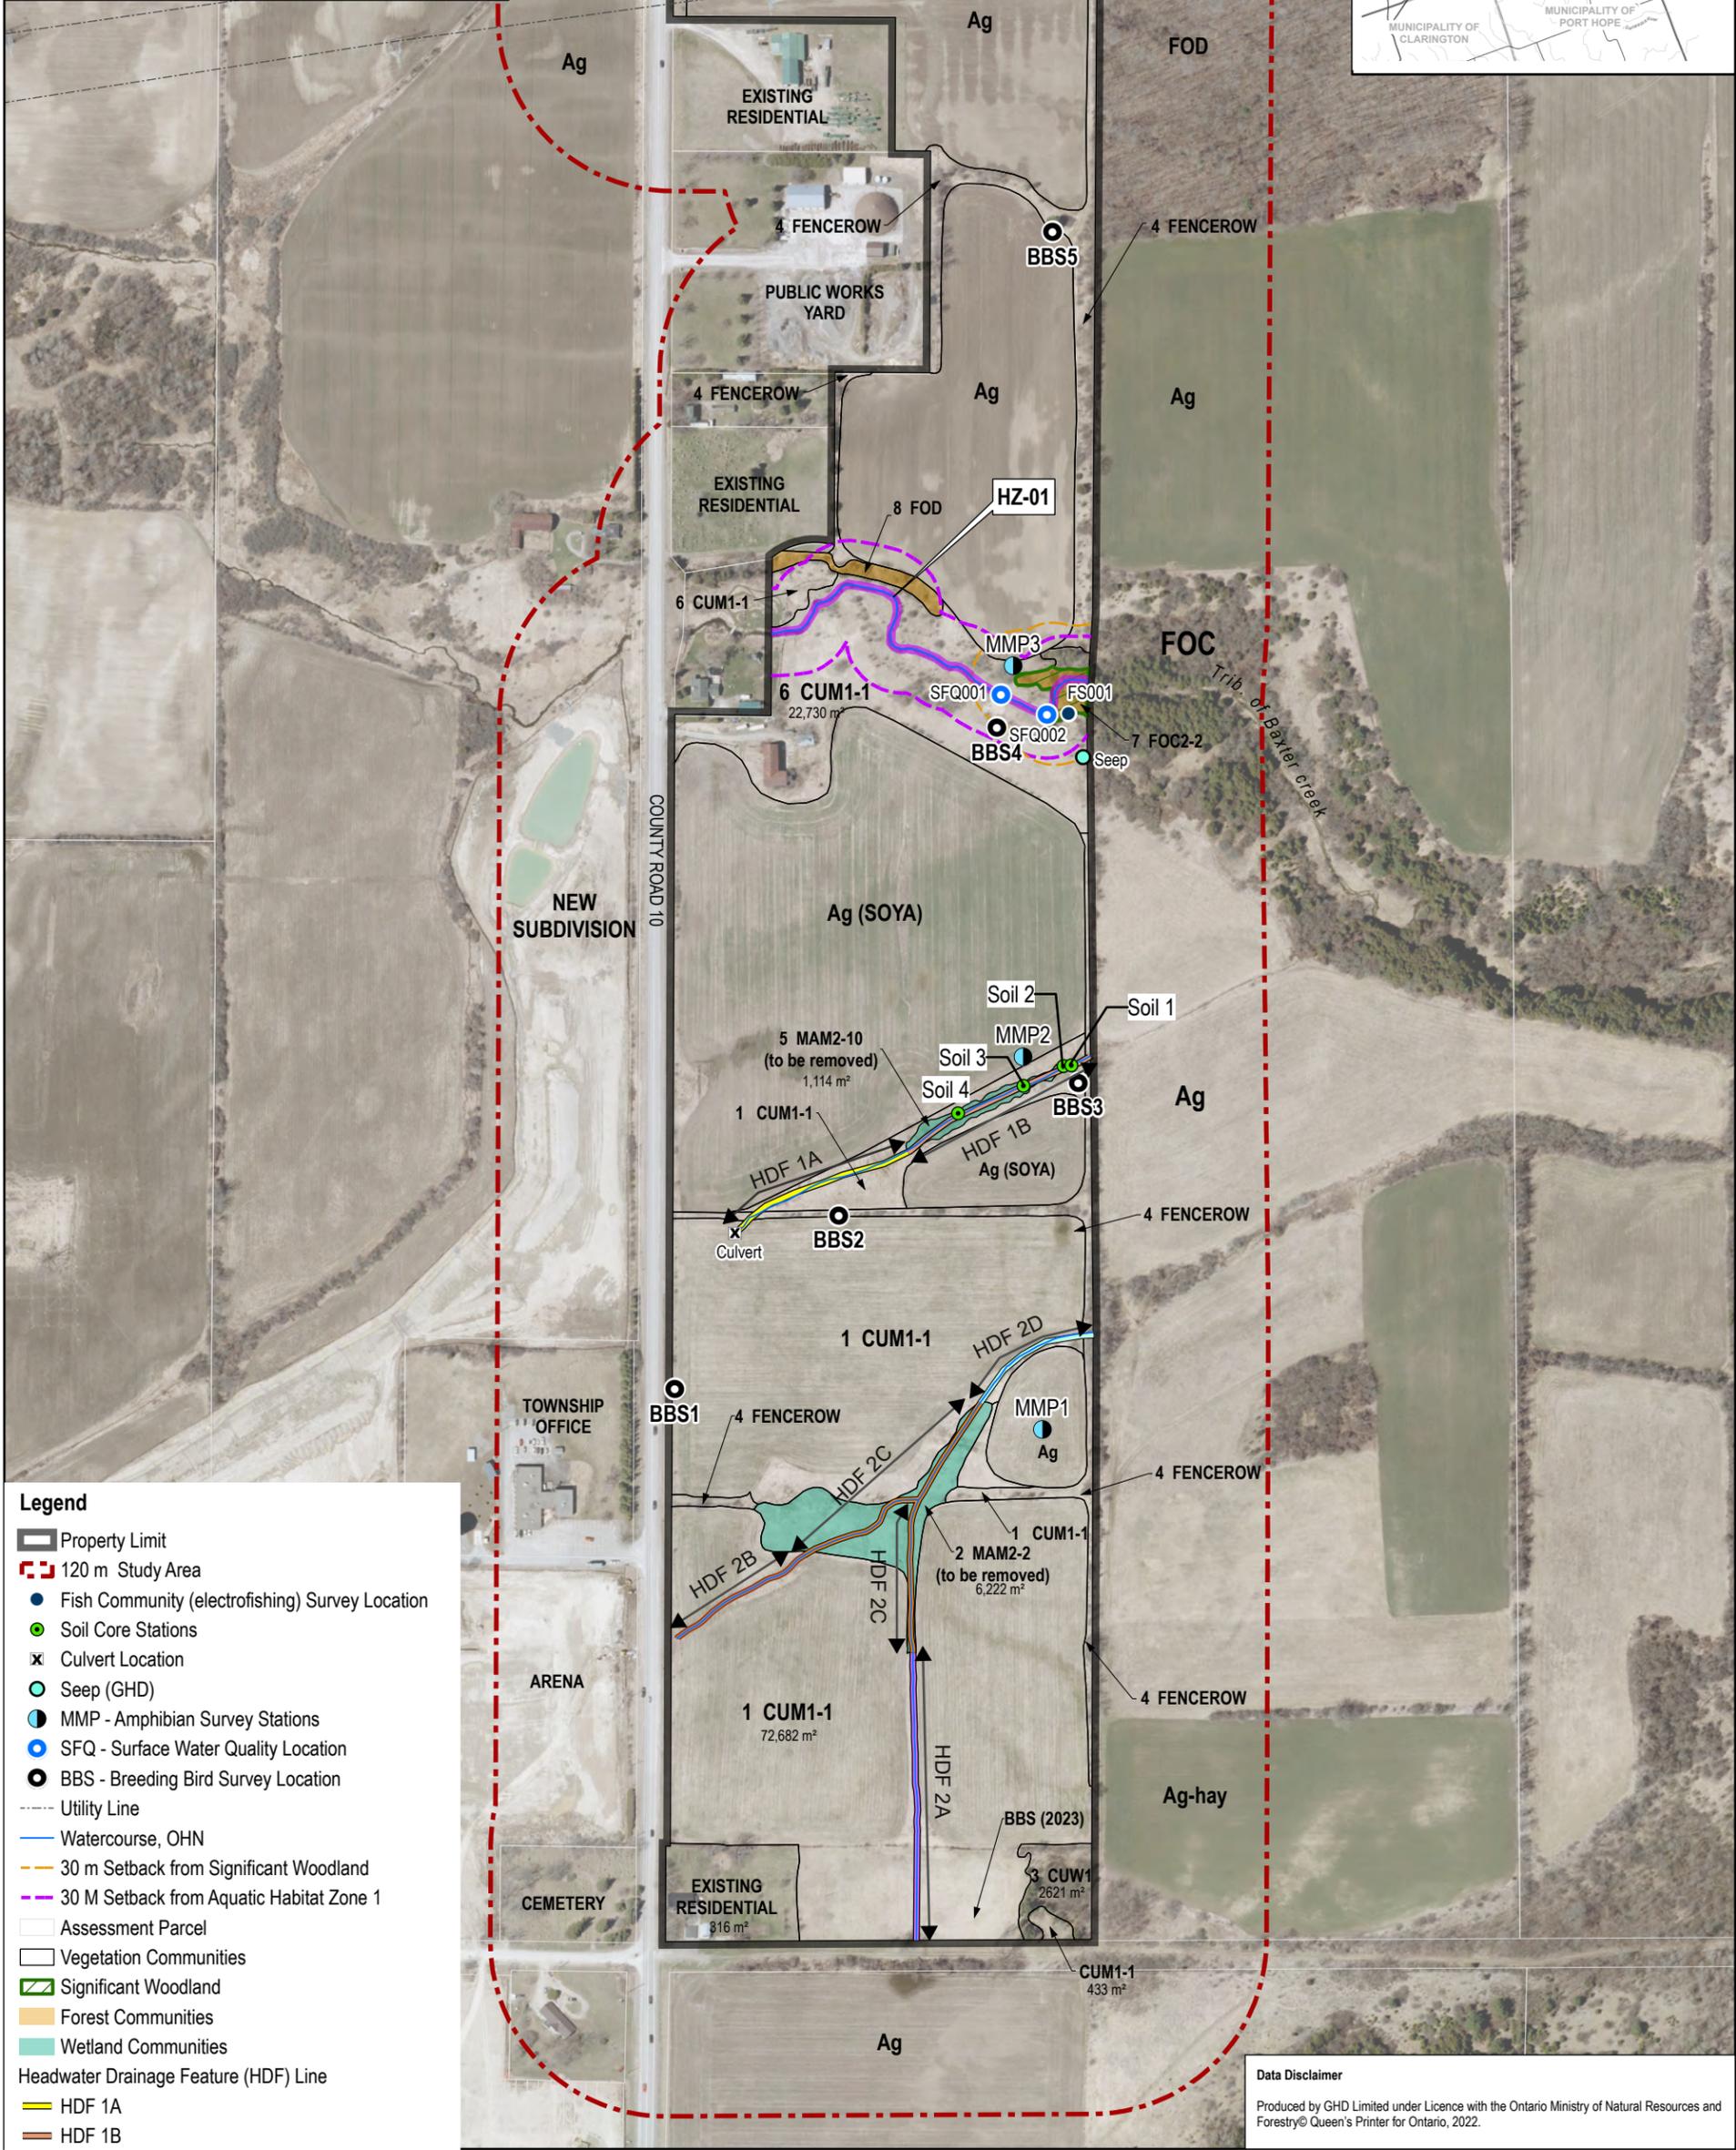
**Figure 1**

Charter Properties  
 Larmer Line & County Road 10, Fraserville, ON  
 Township of Cavan Monaghan  
 Environmental Impact Study  
**Preliminary Communities, Survey  
 Points and Constraints**

**GHD Response:** The latest Site Plan has been overlaid on our Figure 1 to show those uses and the impact of that infrastructure on the natural features and recommended buffers.

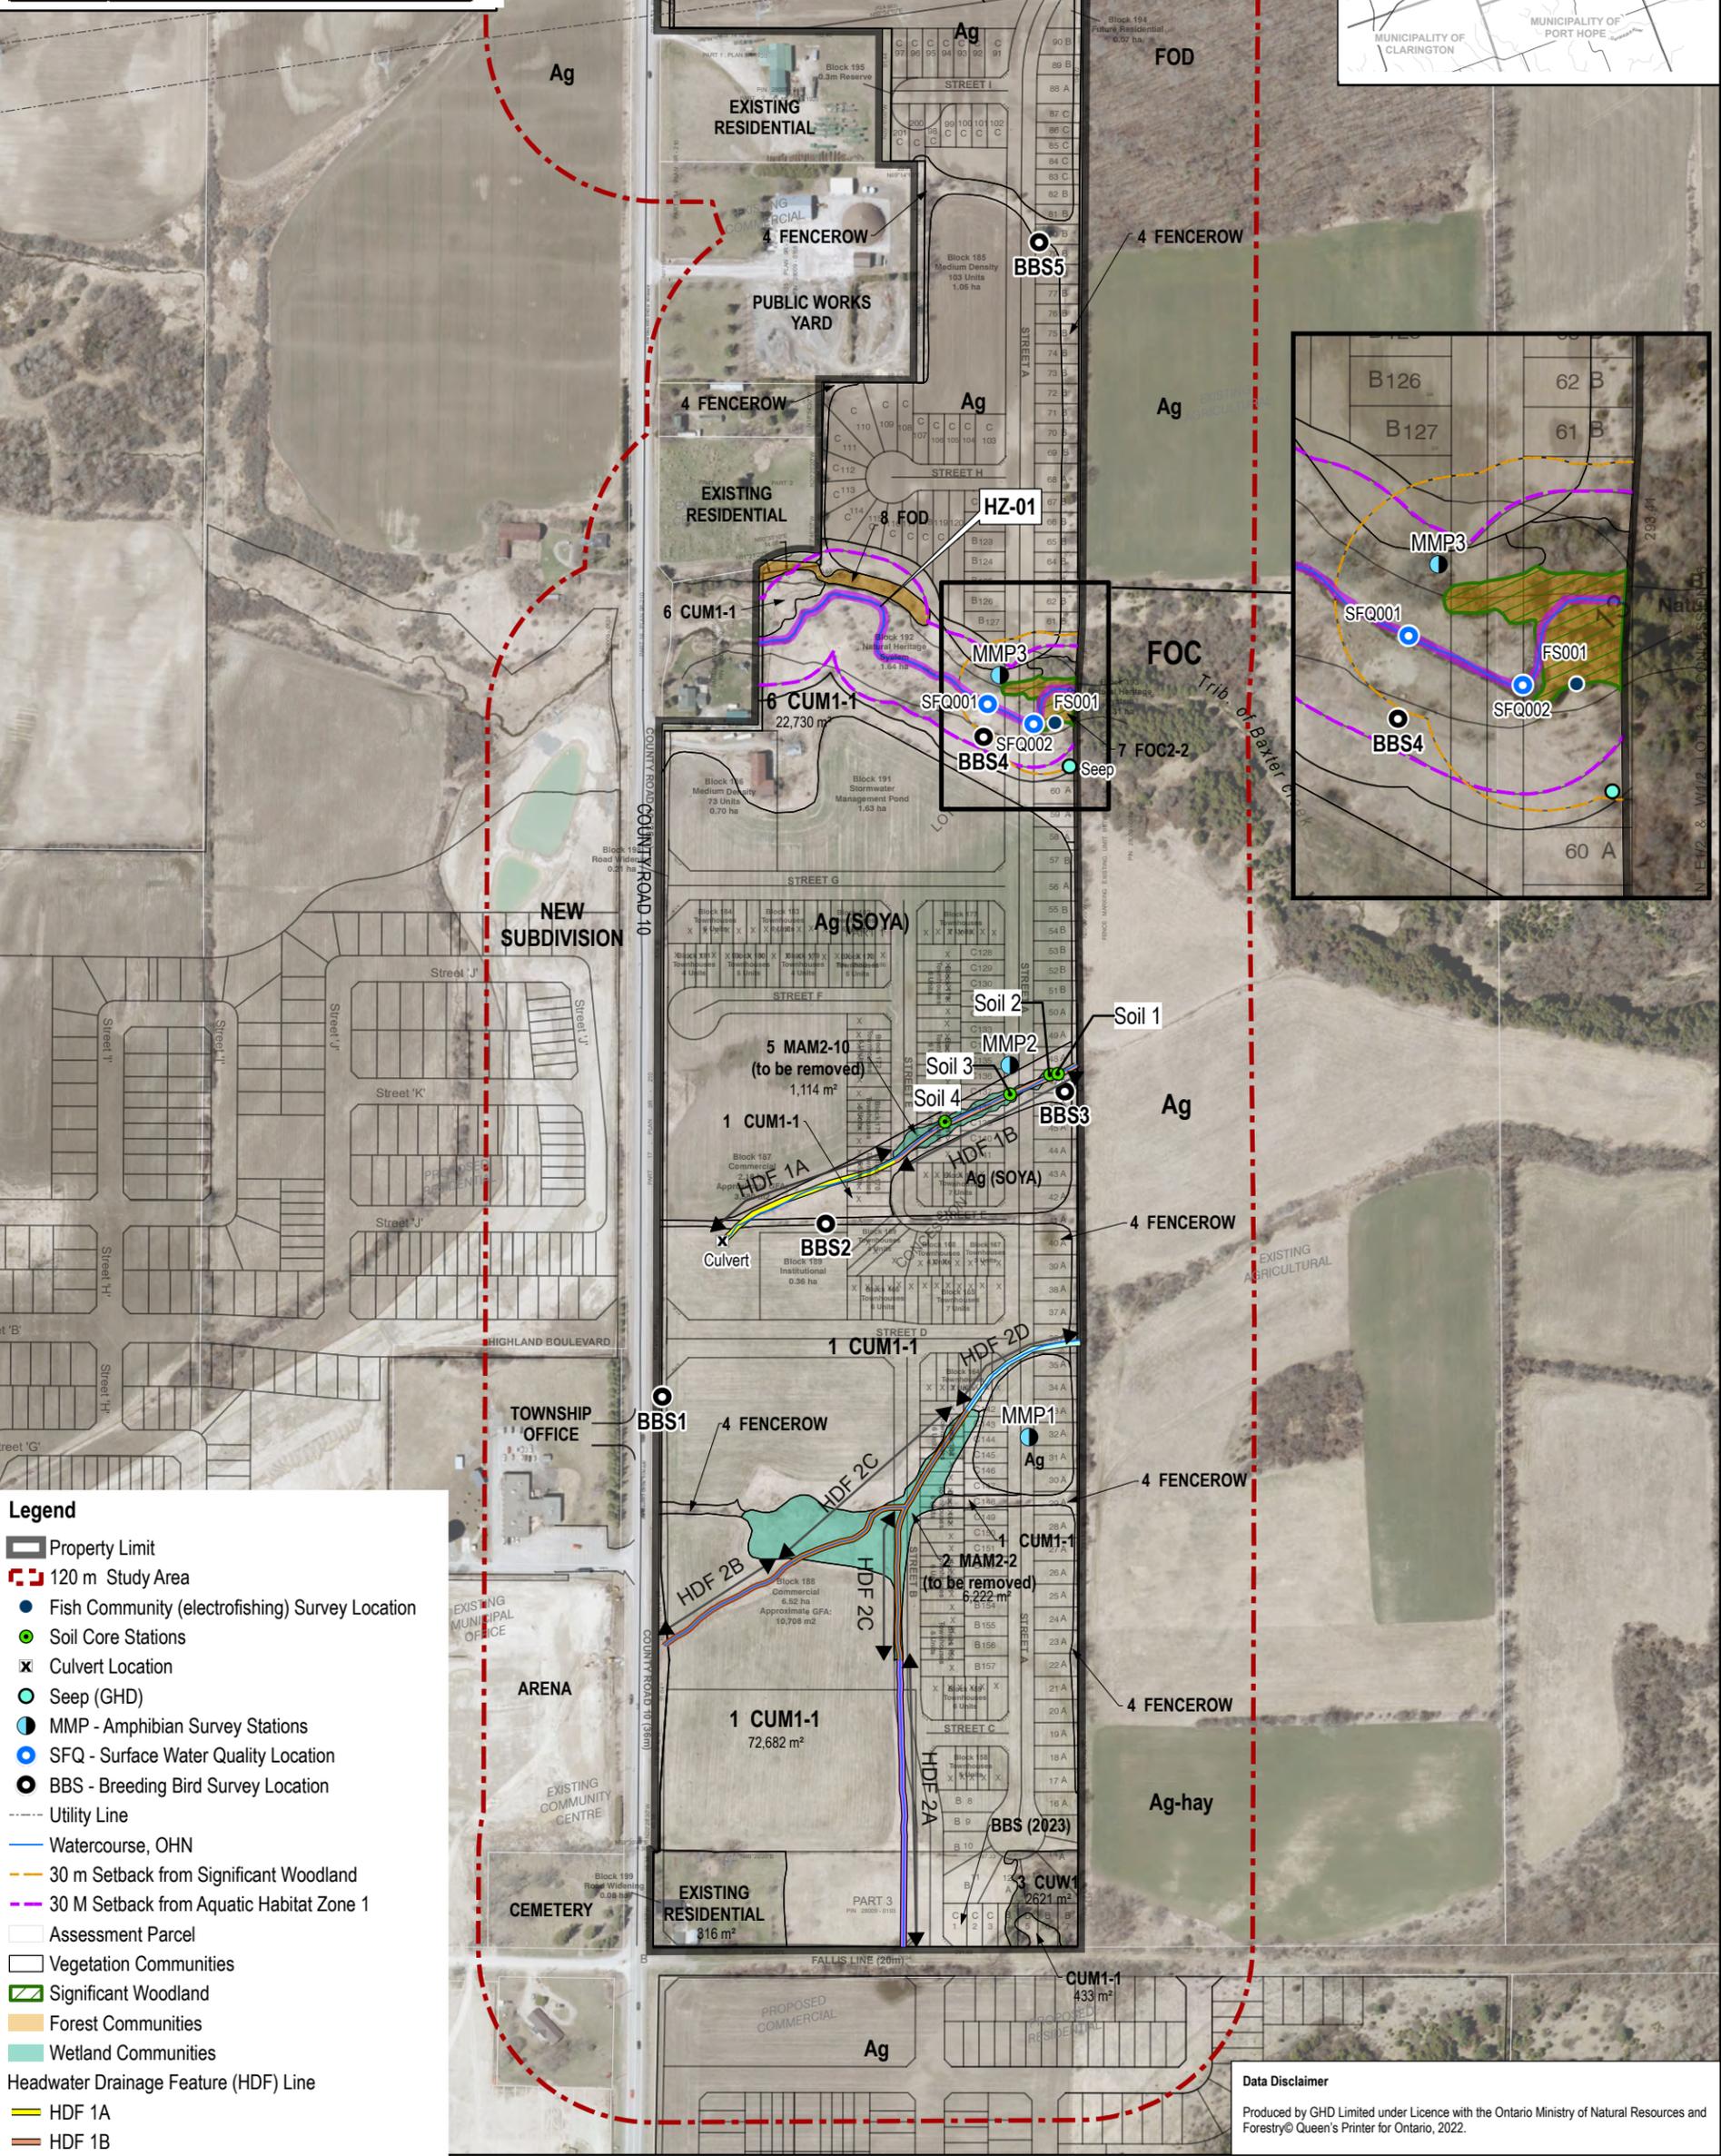
**Figure 2**

Charter Properties  
Larmer Line & County Road 10, Fraserville, ON  
Township of Cavan Monaghan  
Environmental Impact Study  
**Natural Features and  
site plan overlay**
