Phase One Environmental Site Assessment

Proposed Residential Development
787 and 825 Fallis Line
Millbrook, Ontario

Prepared For:
The Bromont Group

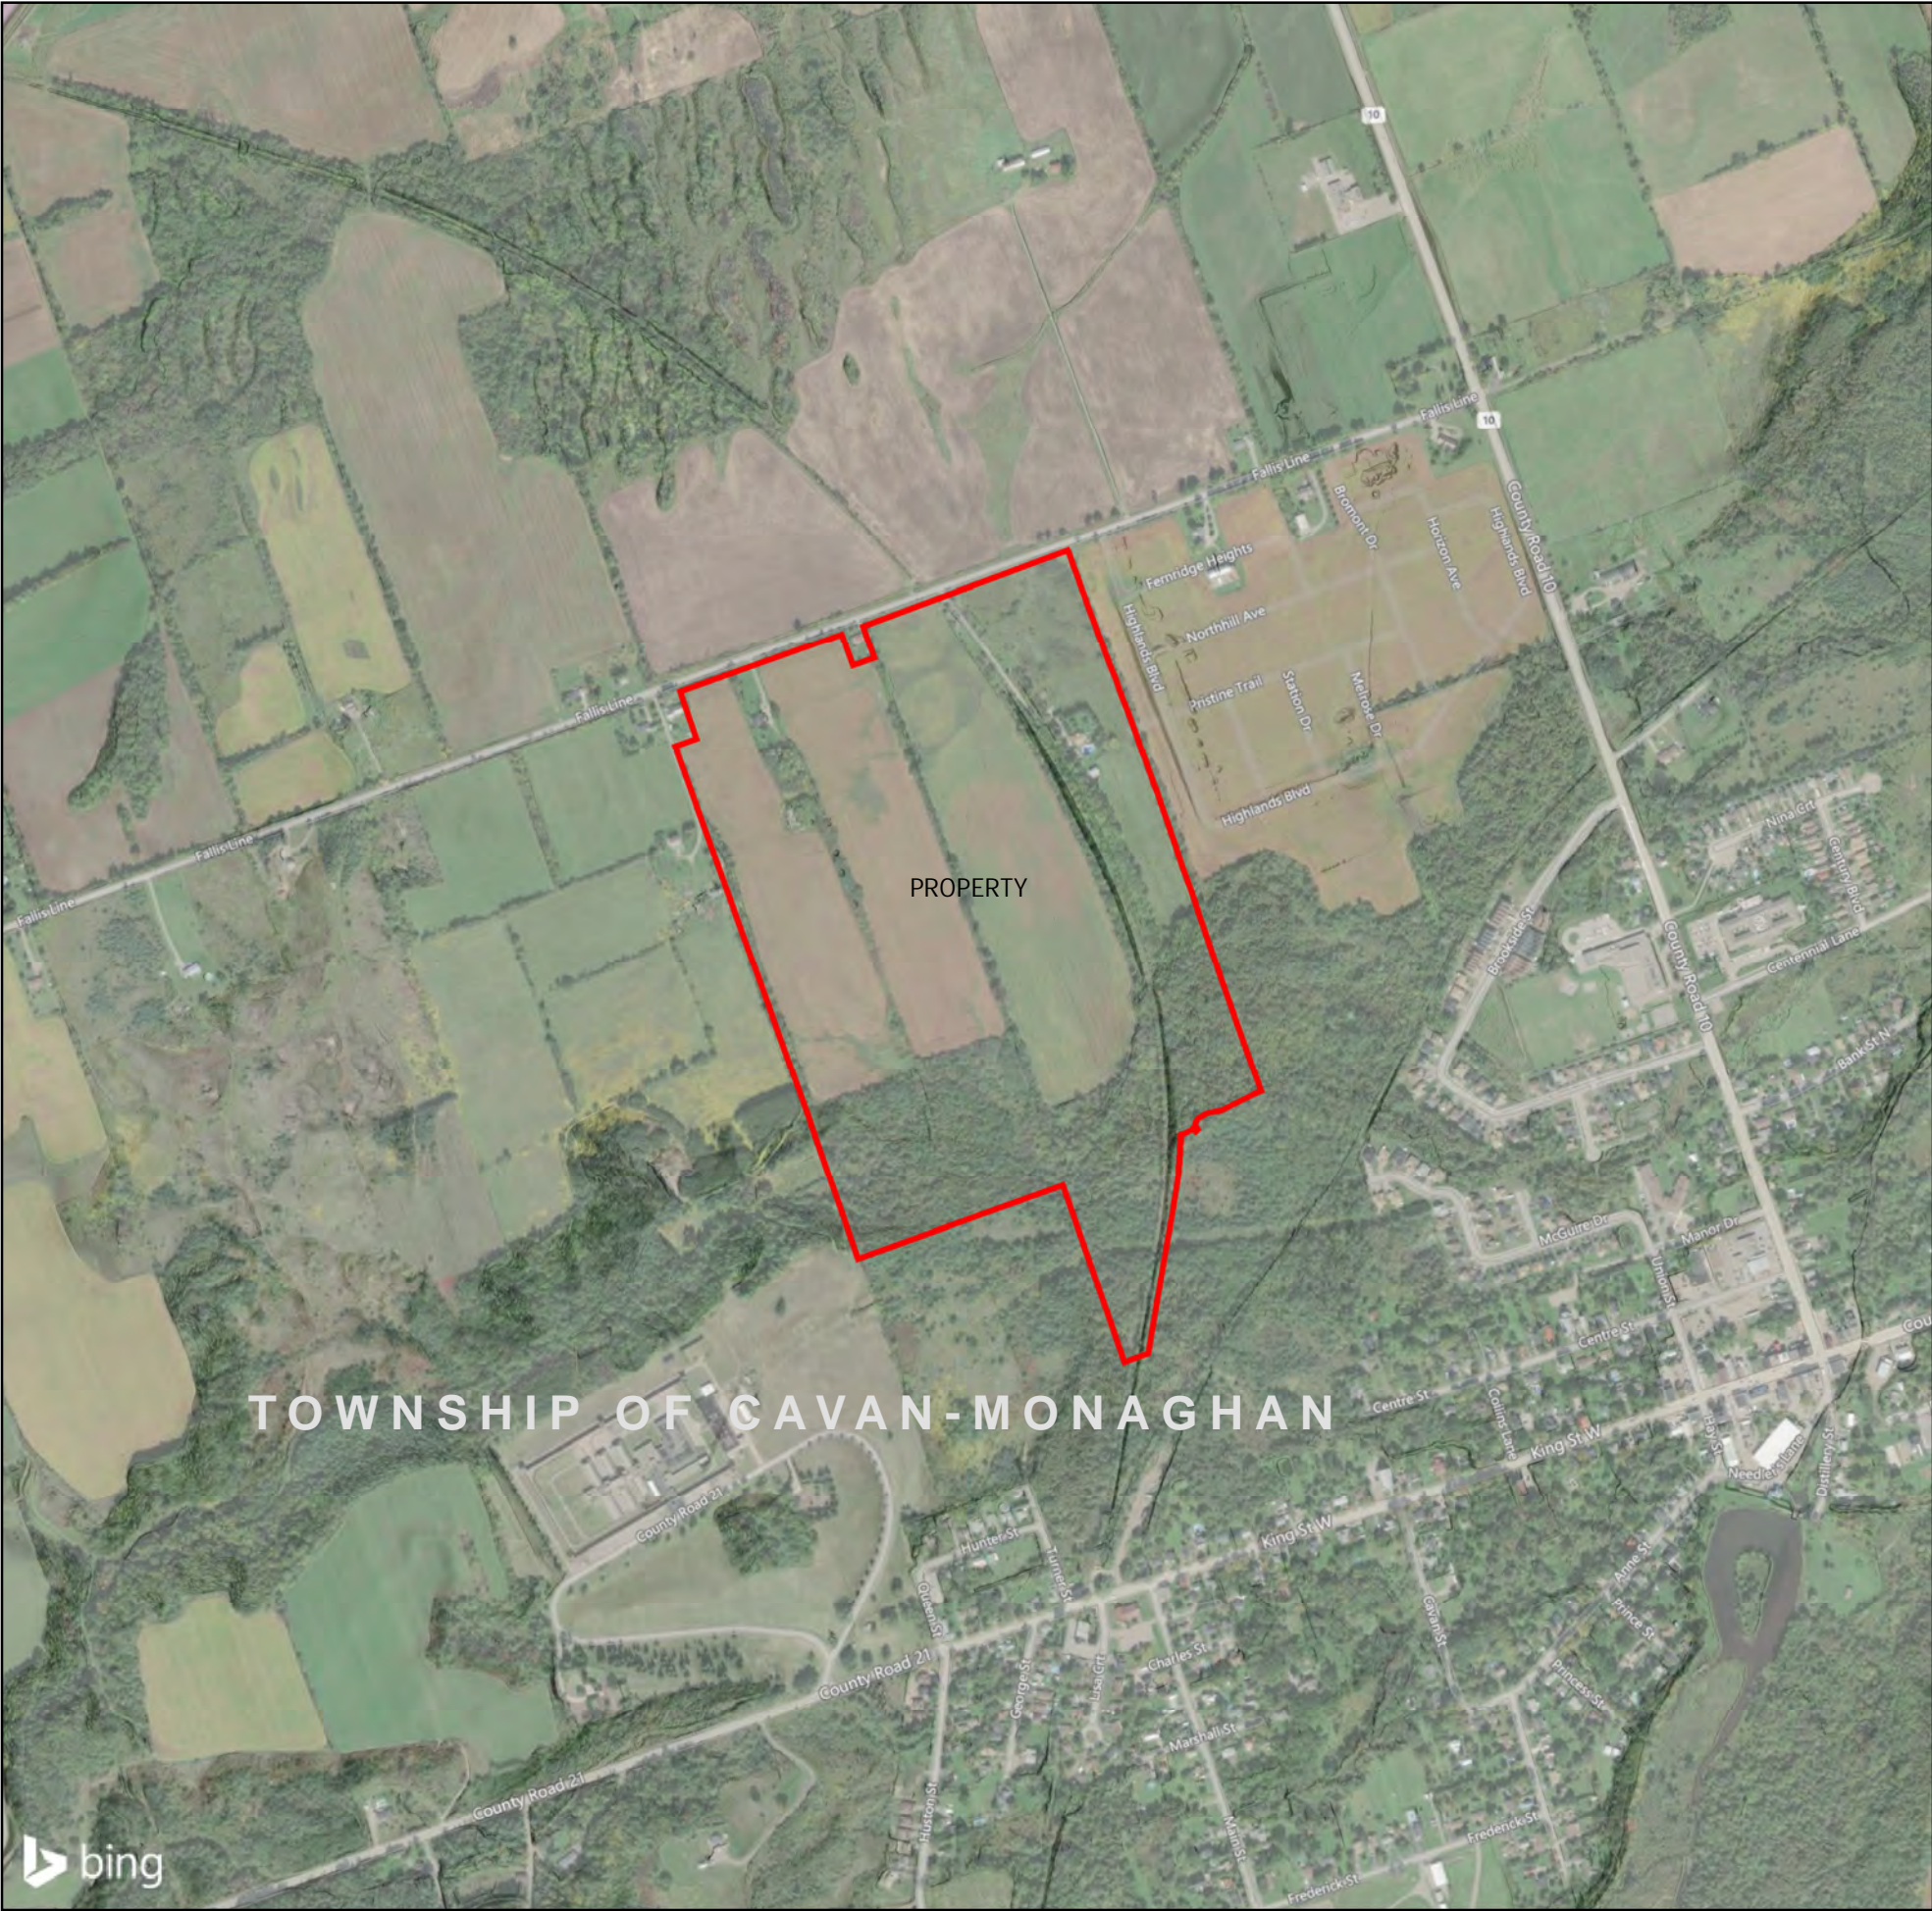
THE BROMONT GROUP	Project No.	11224019
	787 & 825 FALLIS LINE, MILLBROOK, ON	Revision No.	-
	TOWNSHIP OF CAVAN-MONAGHAN	Date	Mar 2021
	COUNTY OF PETERBOROUGH		
	ENVIRONMENTAL SITE ASSESSMENT		
	SITE LOCATION		FIGURE 1

The location is illustrated on the Phase One Site Location, Figure 1 using a recent aerial photo to show a detailed depiction of the Property as well as surrounding roads and watercourses. The Phase One Conceptual Site Model (CSM) showing the Property and Phase One Study Area (surrounding lands within 250 m) and potentially contaminating activities (PCAs) is provided as Figure 2. A CSM provided as Figure 3 further illustrates conditions at the Property. The Property, PCAs, and surrounding areas are discussed in detail in the following sections of this report.

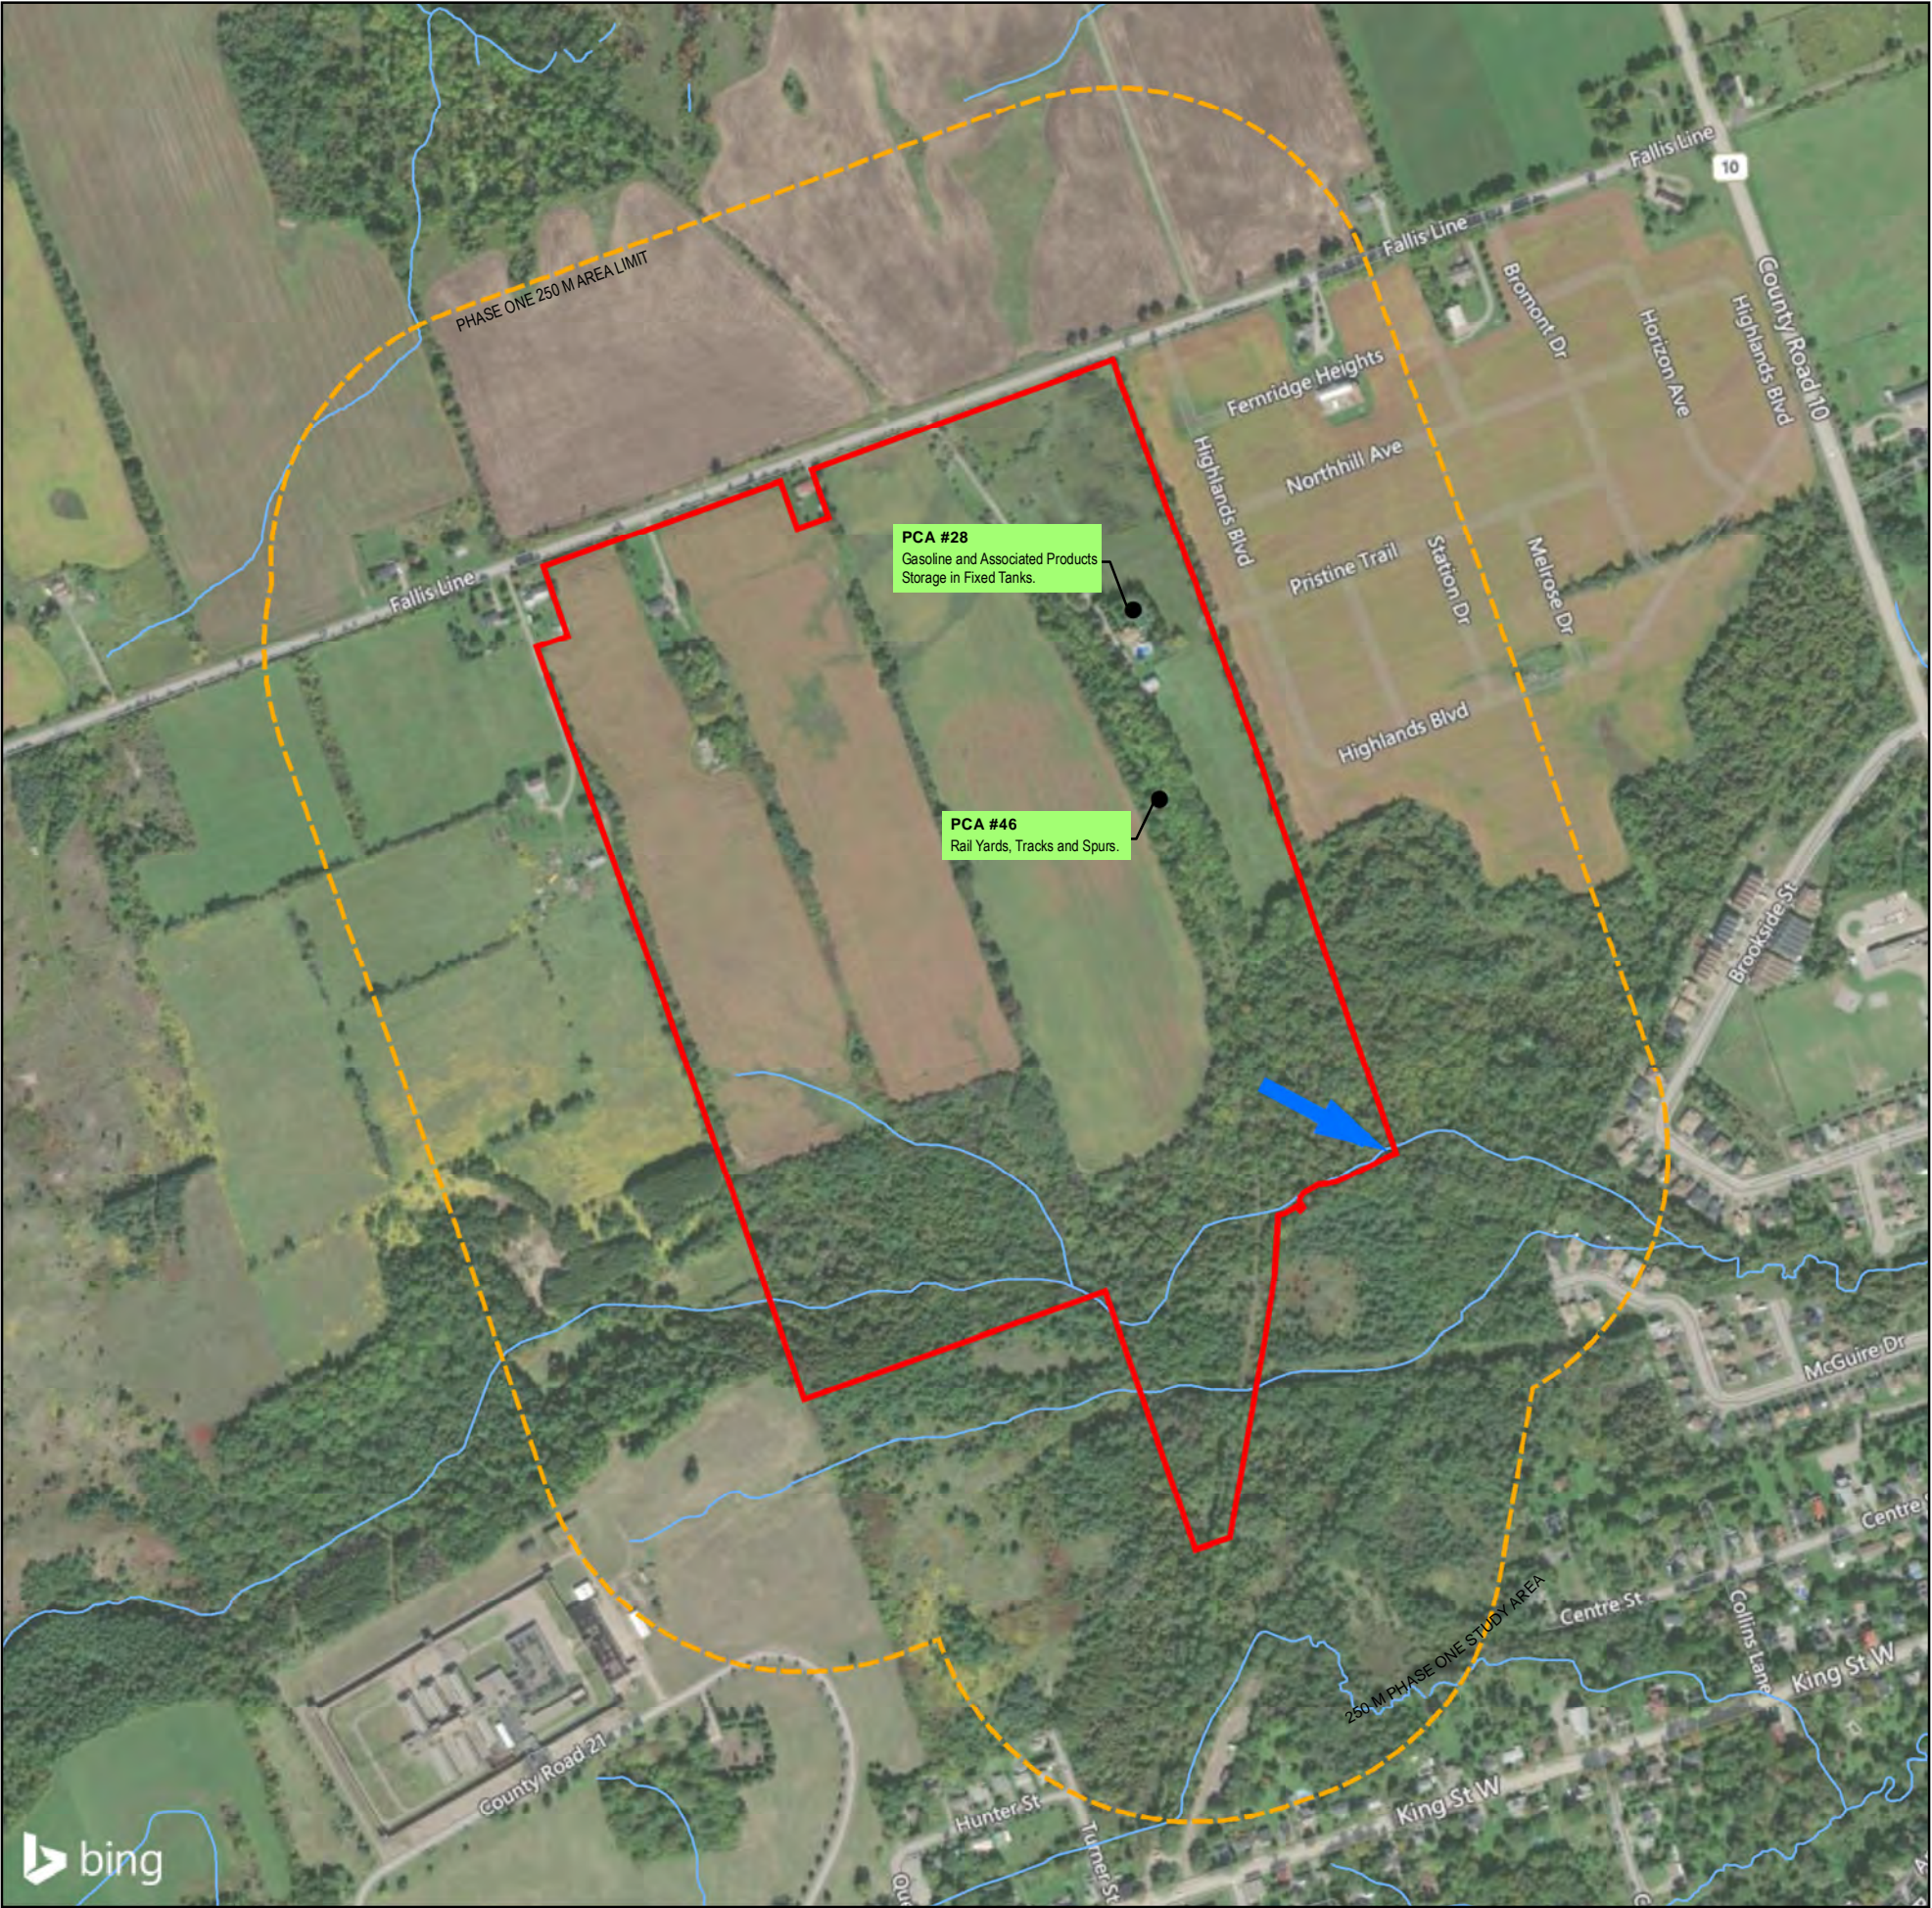
FIGURE 2

The surrounding area is generally residential and agricultural lots. The Phase One CSM – Study Area, Figure 2 illustrates the Study Area (lands within 250 m) and identifies any PCAs in this general area. The Phase One CSM – Property is presented as Figure 3 and further illustrates conditions at the Property.

POTENTIALLY CONTAMINATED AREAS (PCAs)

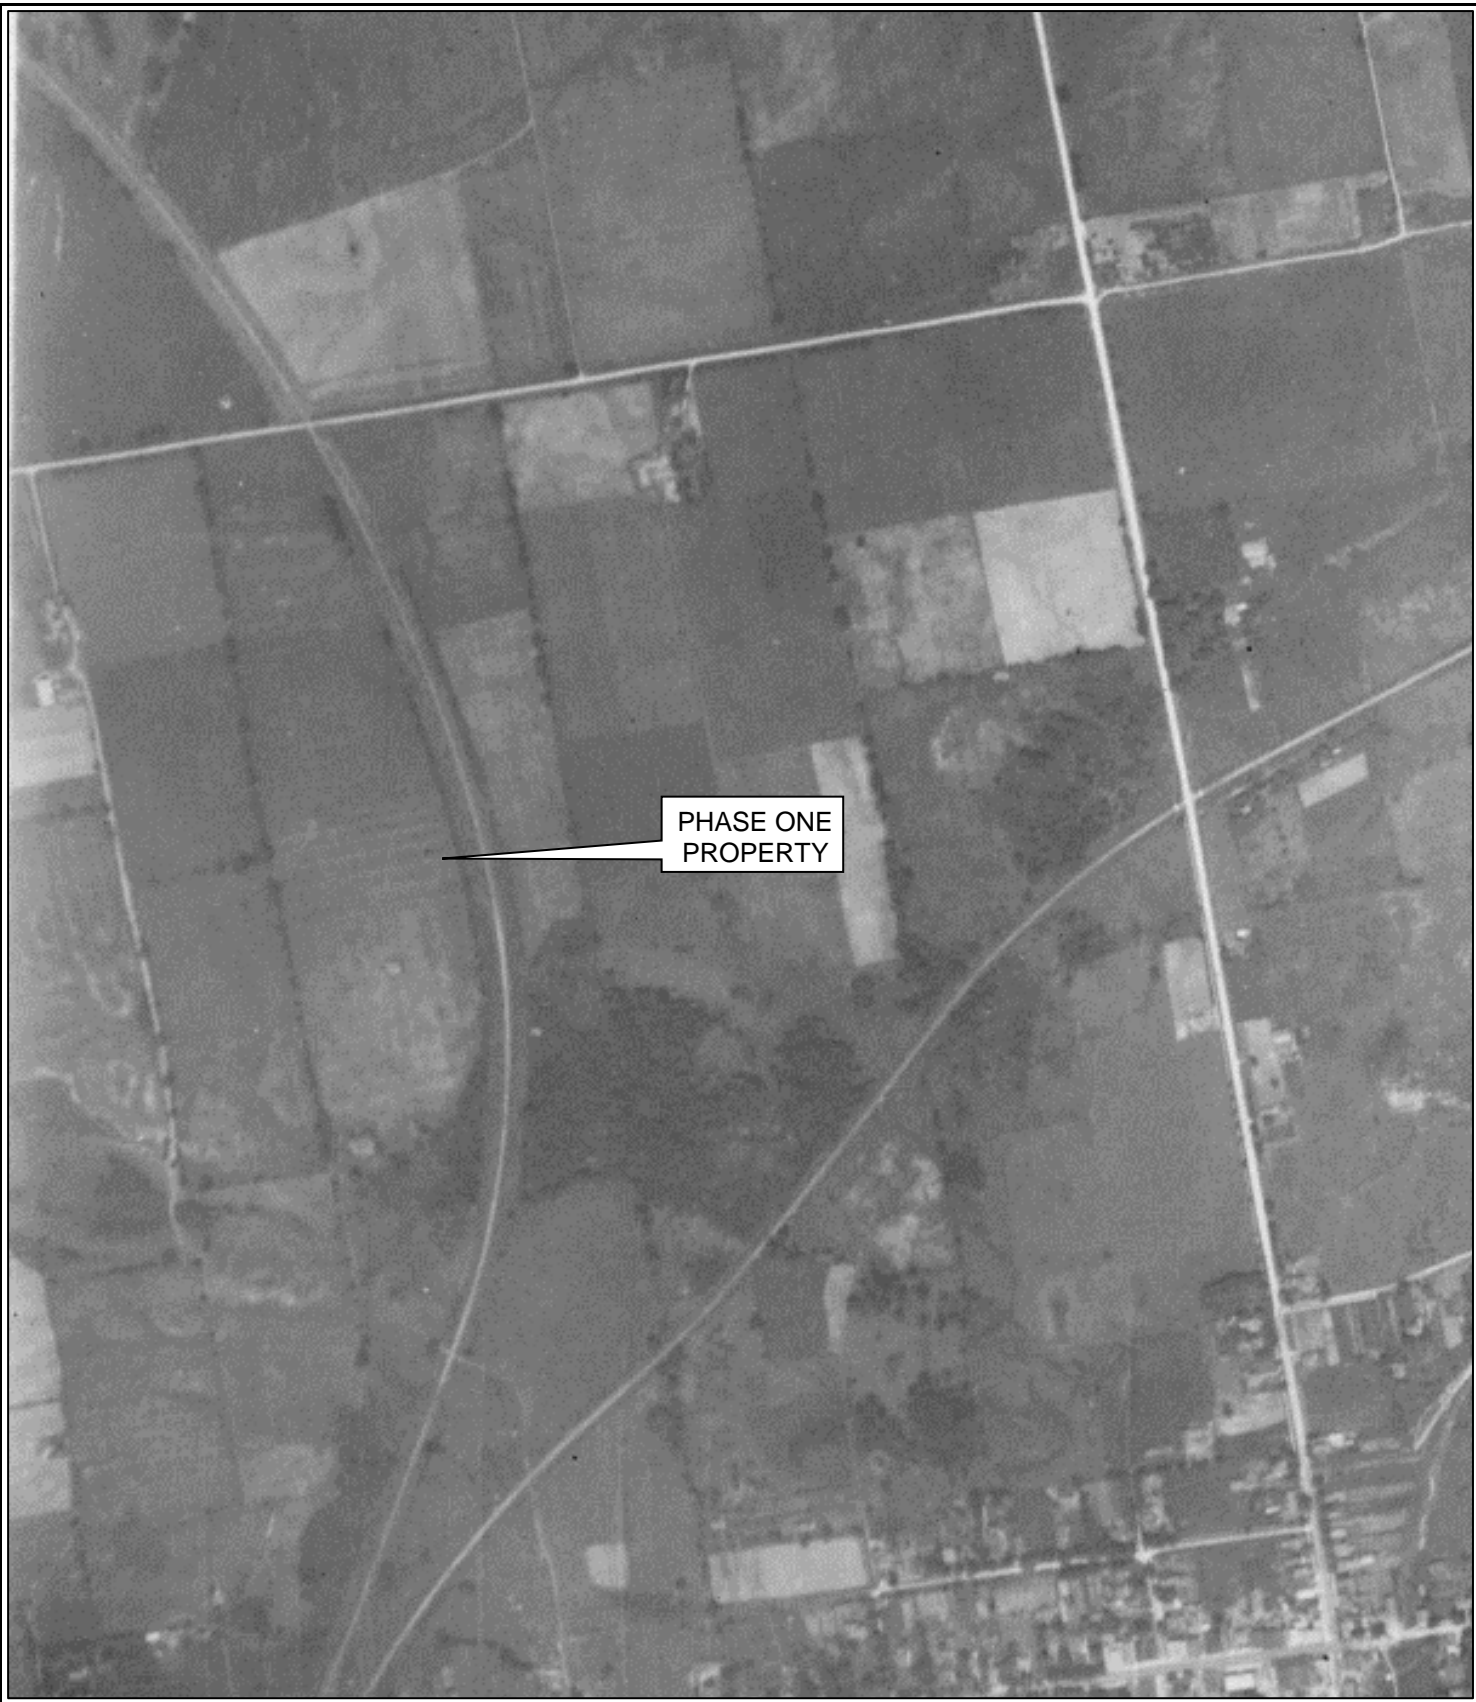
AERIAL PHOTOGRAPHY - 1928

Based on aerial photographs, the Property was developed for rural residential and agricultural use prior to 1928. A rail line historically ran through the Property as observed in historical aerial photographs.

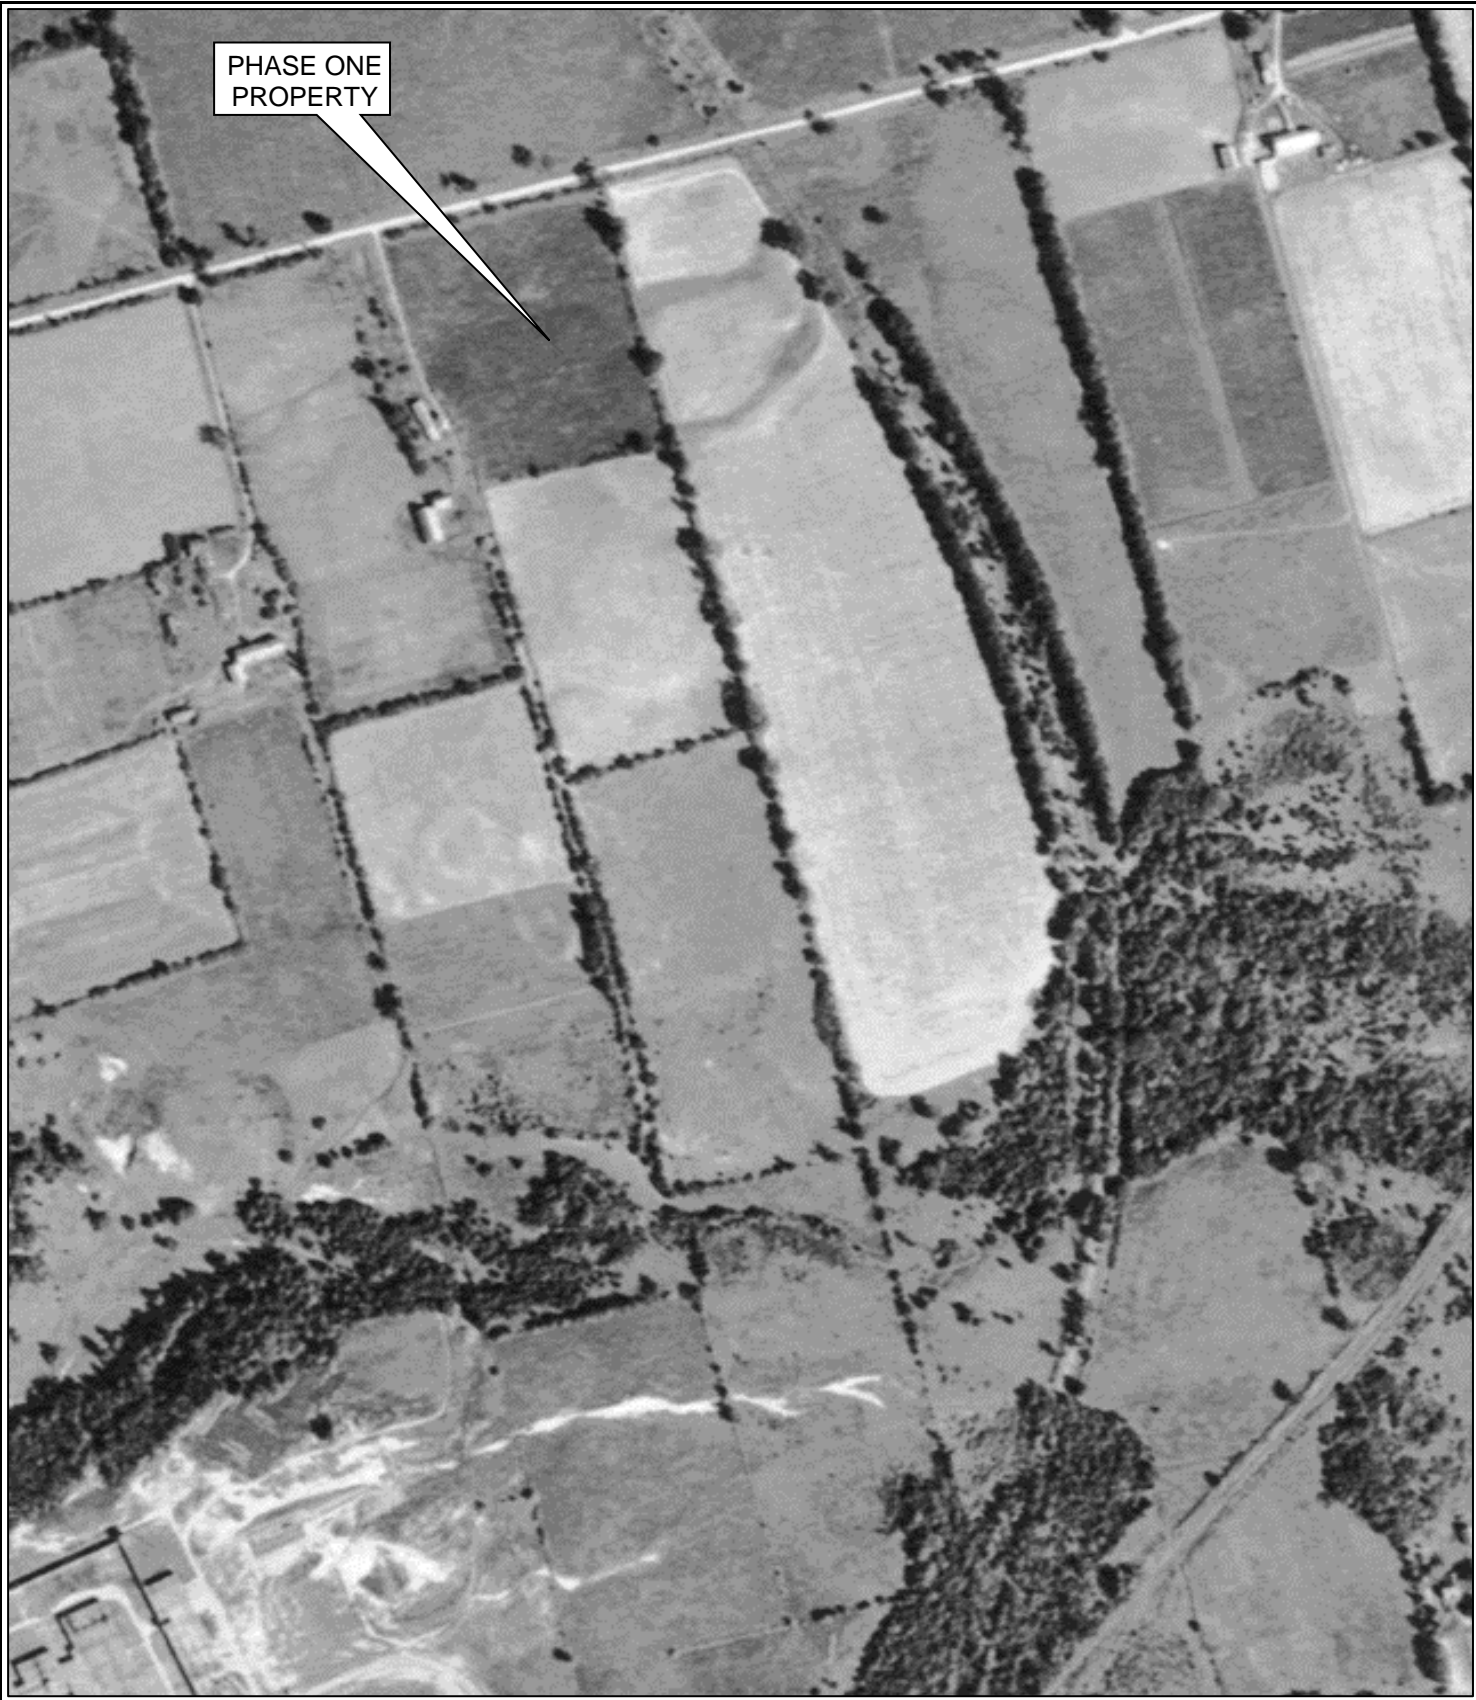
Source: National Airphoto Lab, dated 1960

The 1960 photograph shows the small structure in the area of the rail line as removed. Structures at 787 Fallis Line are observed. Structures on the adjacent lot to the west are observed. The rail line appears to have been removed.

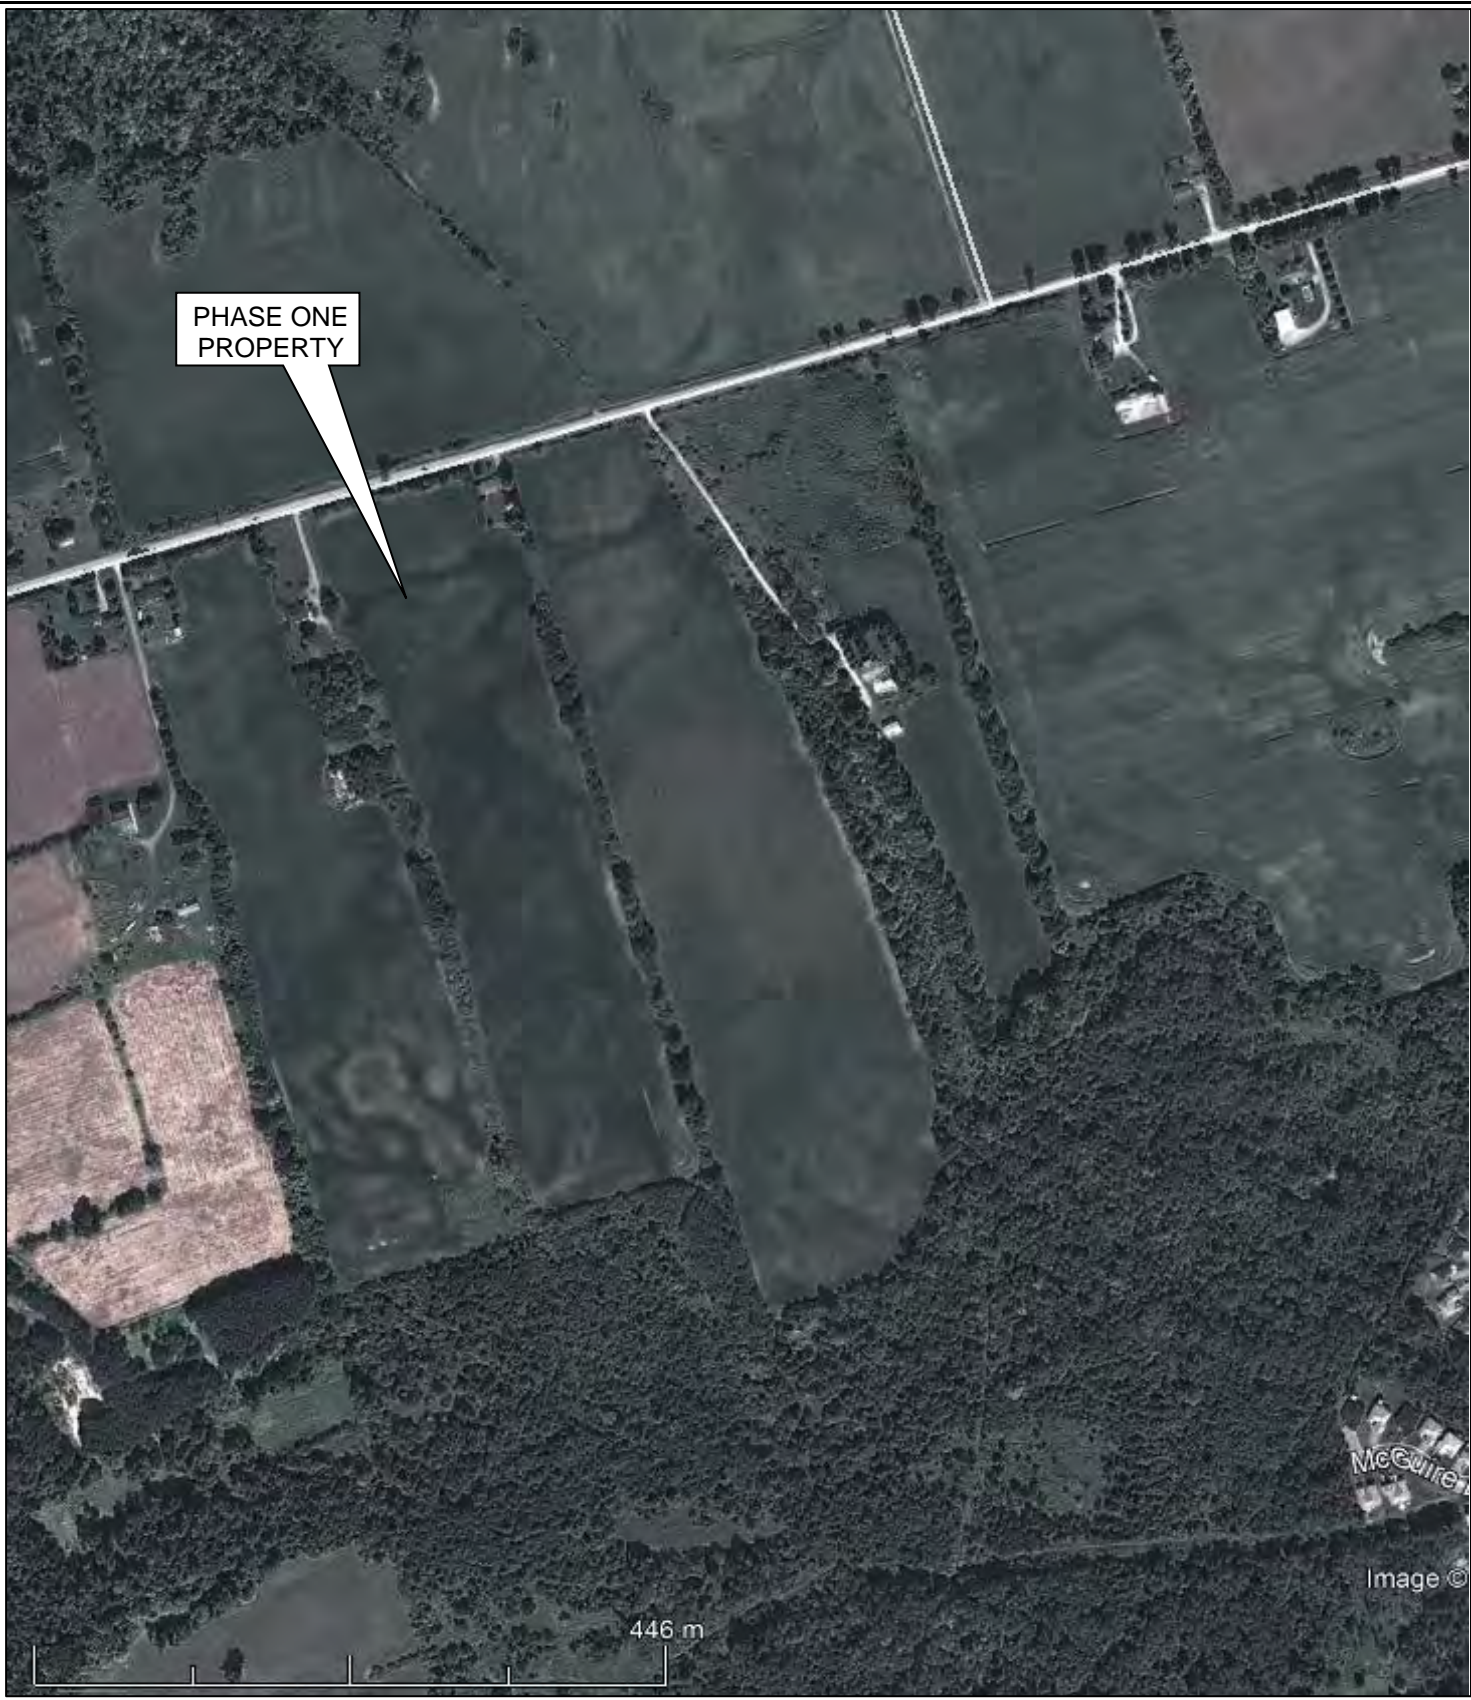
AERIAL PHOTOGRAPHY - 2012

The 2012 Google Earth image shows the construction of the residence at 825 Fallis Line. 787 Fallis Line supports several structures. The 2018 Google Earth image shows the Property as generally observed during the site reconnaissance. A small construction lay down area is present along the east side of the Property used for storage of equipment and supplies for the residential development under construction to the east. Construction of this adjacent residential subdivision is observed.

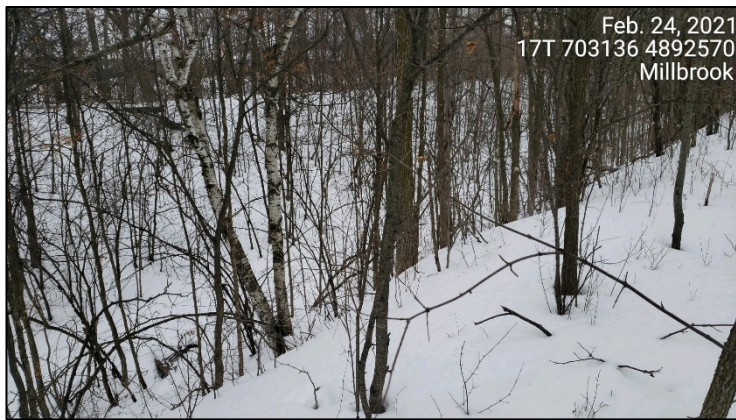
1. Rail Yards, Tracks and Spurs (PCA #46). This PCA was identified for a historical rail line which formerly ran through the Property. The rail line has been removed. As noted in our previous ESA, it was our opinion that the rail line did not result in an APEC. No new PCAs or APECs are identified relating to the former rail line.
2. Gasoline and Associated Products Storage in Fixed Tanks (PCA #28). This PCA was identified for a heating oil tank for the residence at 825 Fallis Line. A 2 L spill of heating oil was identified in the ERIS report from a spill that occurred in 2010. As noted in our previous ESA it was our opinion that the heating oil spill did not result in an APEC. No new PCAs or APECs are identified relating to the heating oil spill.

Photo 5 - View of overgrown area historically supporting a railway line.

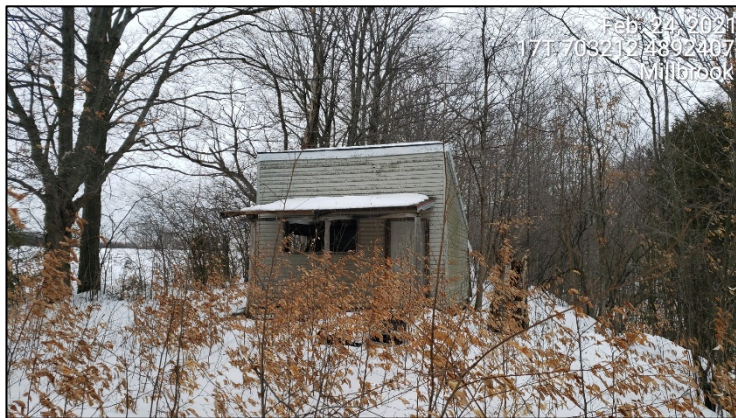
Photo 6 - View of small cabin structure on the Property.

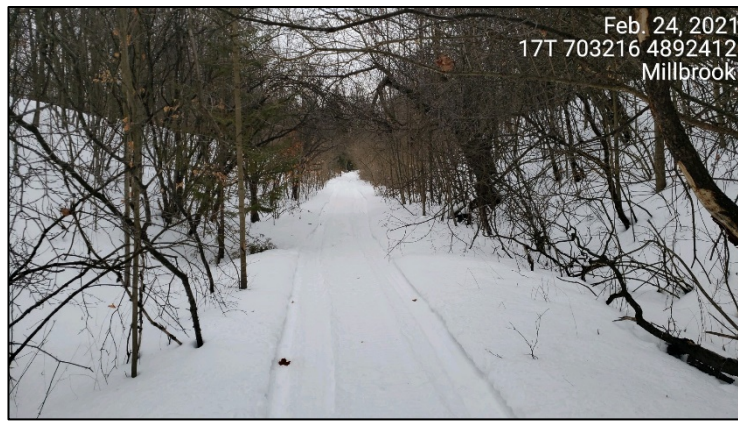
Photo 7 - View along historical rail line corridor.

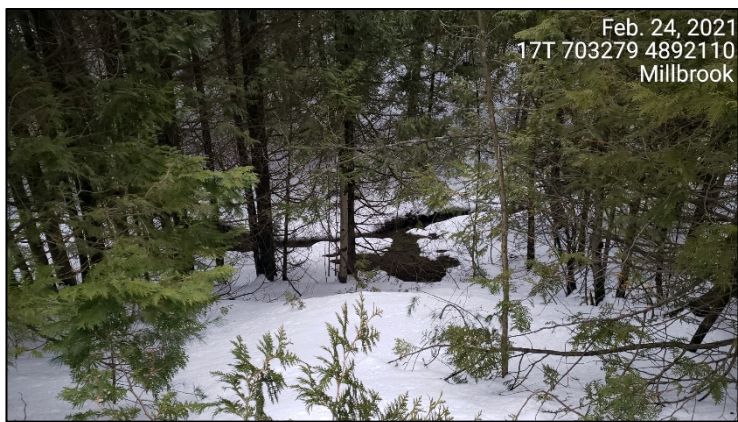
Topography: As depicted on the figures provided and observed during the site reconnaissance, the topography in the area slopes towards local low-lying tributaries of Baxter Creek and generally toward the south.

Photo 8 - View of low-lying tributaries of Baxter Creek on the Property.

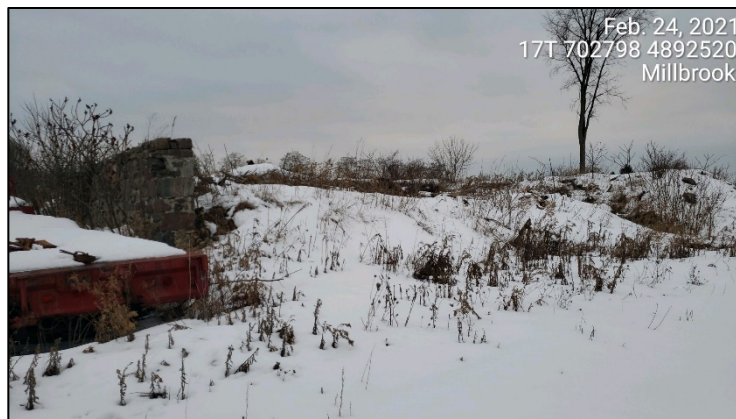
Photo 9 - View of foundation of previous barn at 787 Fallis Line.

The Property supports two (2) residential dwellings and several other barn / shed structures. Several small soil piles and rubble from a former barn were observed. While not of significant environmental concern, GHD recommends that these materials are disposed of appropriately. A small area of the Property is currently used as a temporary construction laydown area for the subdivision to the east. A 500-gallon temporary diesel aboveground storage tank (AST) was observed. No leaks or stains were observed and it is our understanding that the laydown area will be removed prior to development of the Property. The AST is not considered to be a significant environmental concern.
