October 2018

TOWER HILL DEVELOPMENTS INC.

Environmental Impact Study

Millbrook

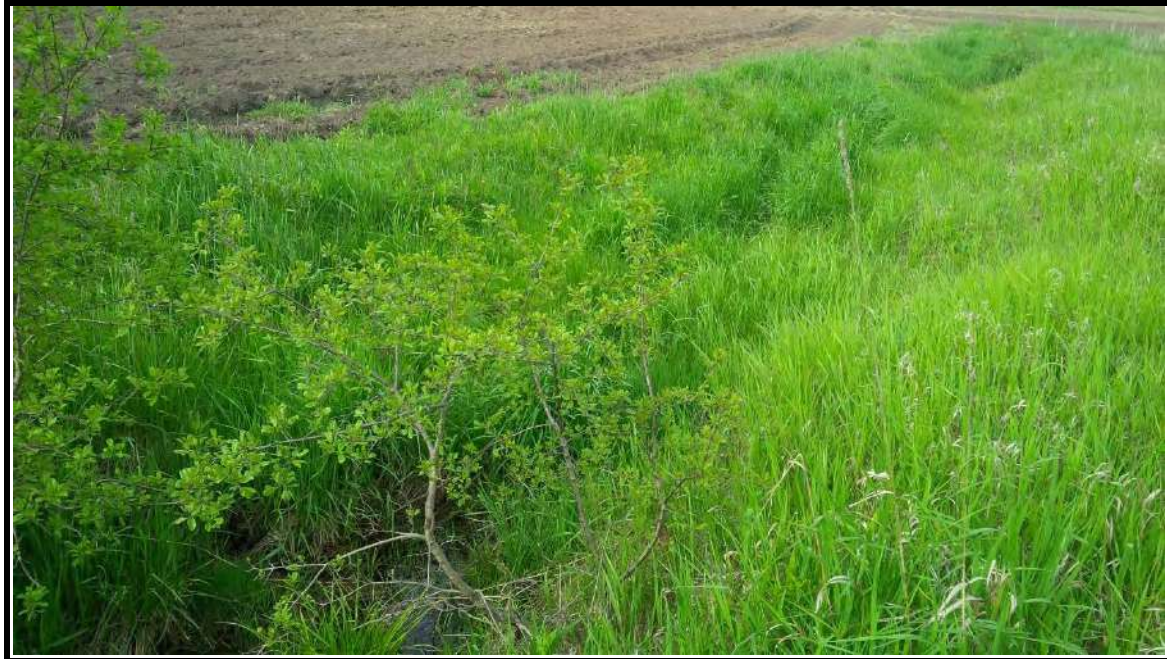
PHOTOGRAPH NO.: 1

COMMENT: Grassy, forbes-like channel, small cross-sectional geometry

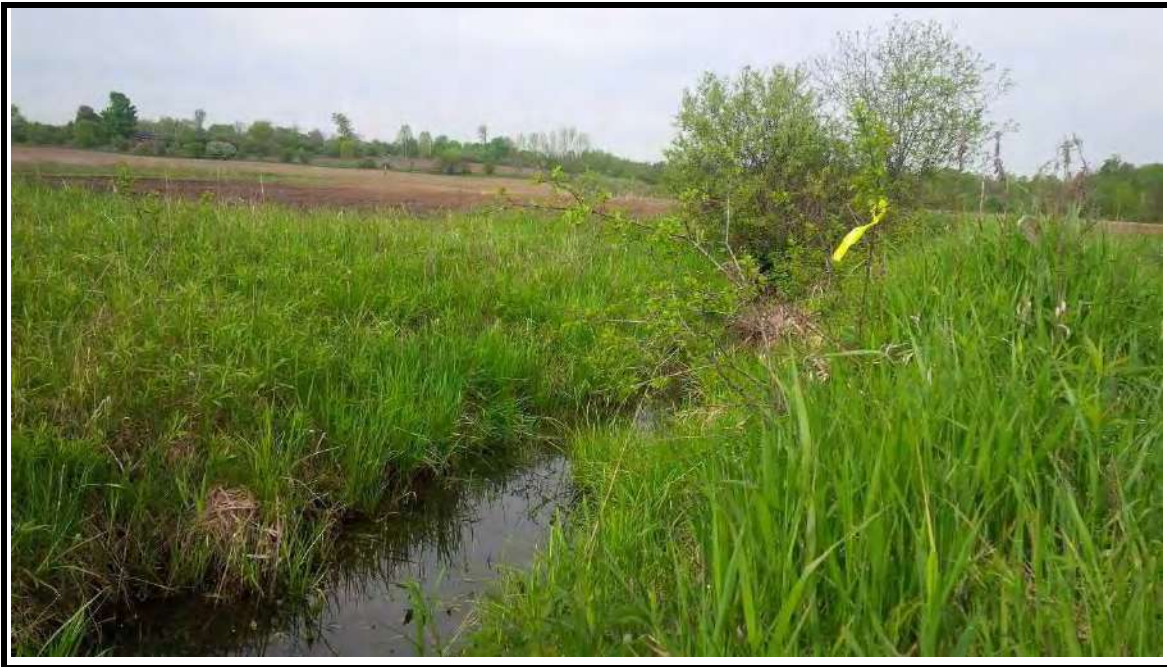
PHOTOGRAPH NO.: 2

COMMENT: Channel width has appeared to have naturally increased from upstream; banks are stable

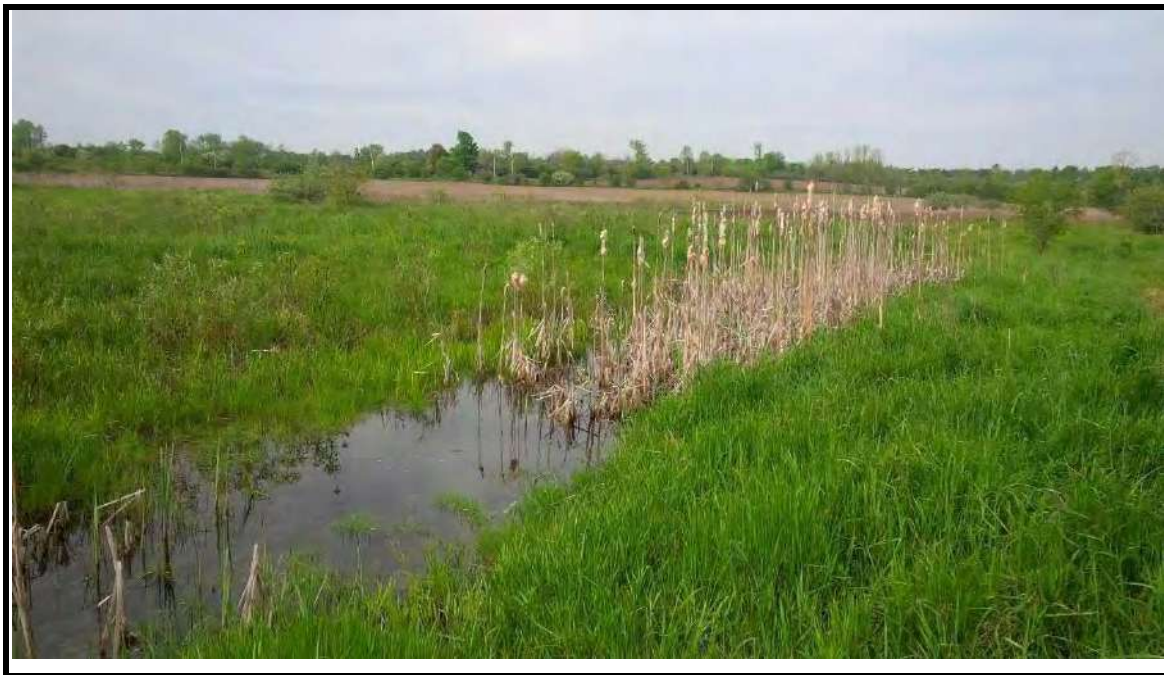
PHOTOGRAPH NO.: 6
FROM: Left Bank
LOOKING: Upstream at Cross-Section 3
COMMENT: Tall vegetation in channel (increase in roughness of the bed) is slightly narrower than the downstream pool; naturally, there is a greater water depth in the pool

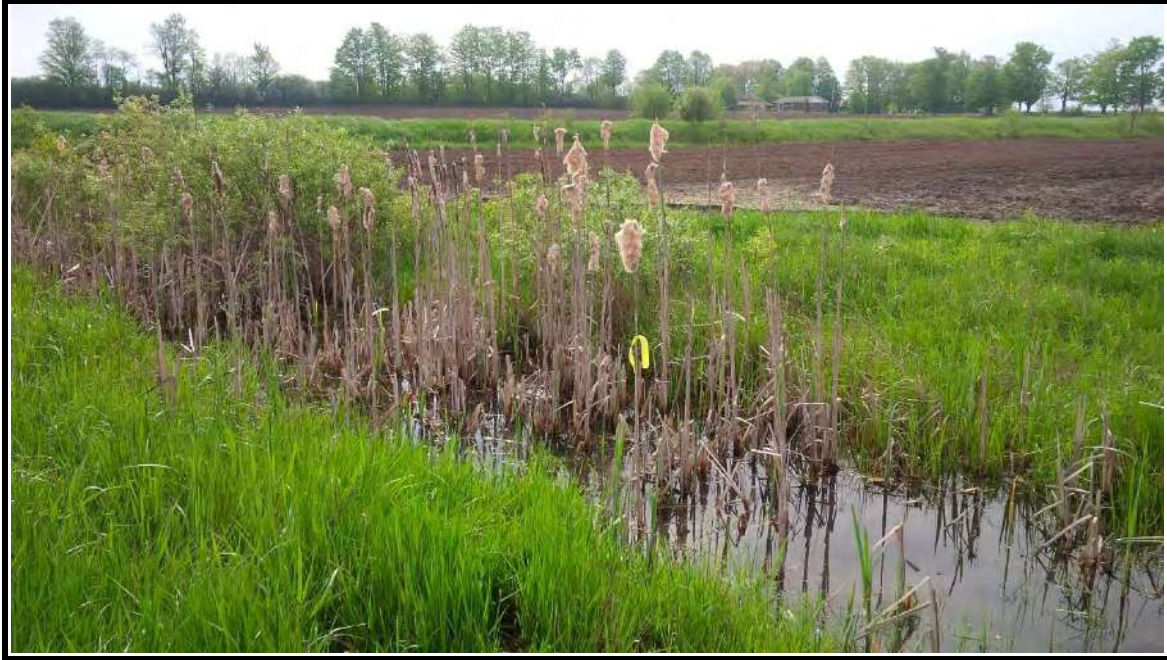
PHOTOGRAPH NO.: 7

COMMENT: Tall vegetation within the channel bed is seen again; downstream there is a small shrub on the right bank diverting flow to the left

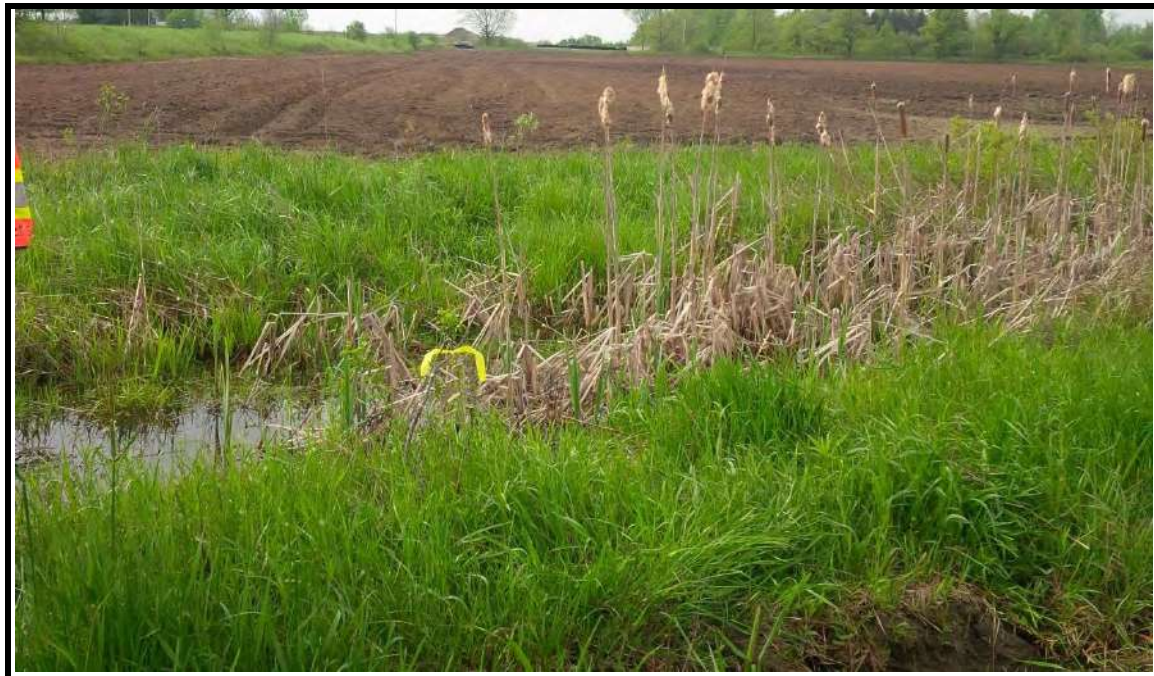
PHOTOGRAPH NO.: 8

COMMENT: Deeper pool is seen with less dense vegetation on the channel bed; width has increased

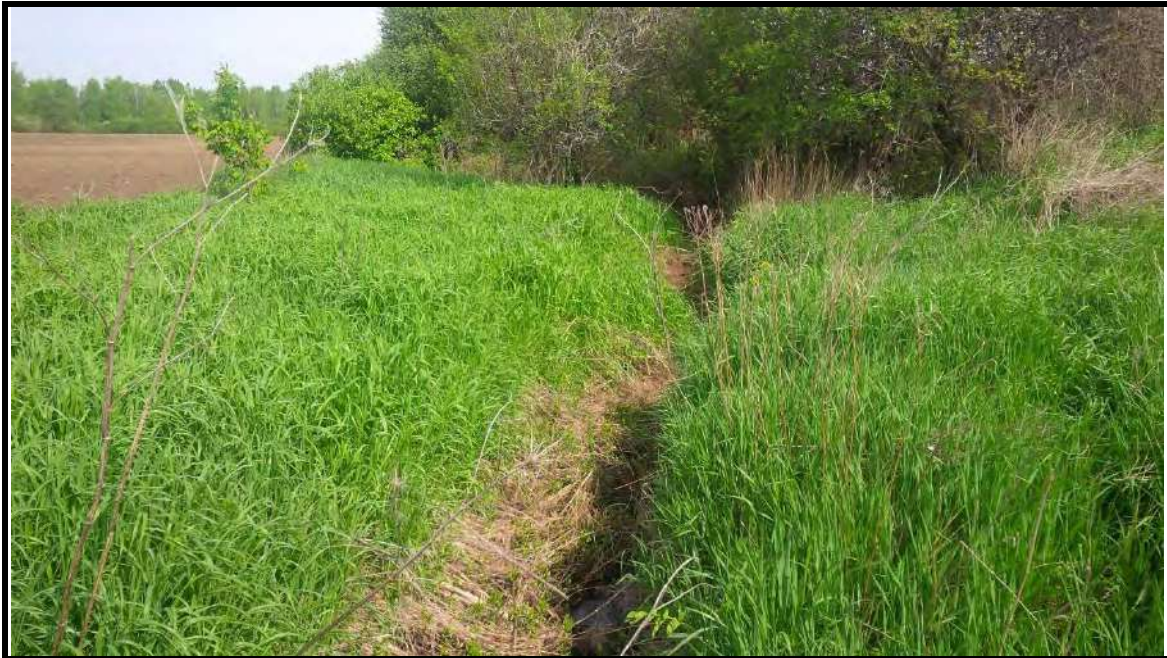
PHOTOGRAPH NO.: 34

COMMENT: Some toeing of banks; bed has degraded; lack of connection between banks and floodplains

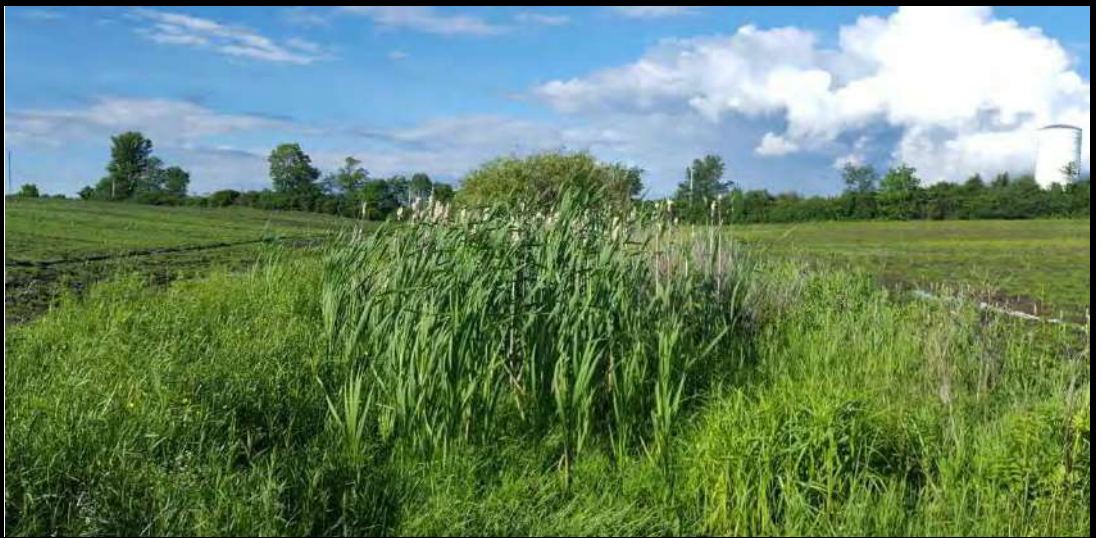
Photo 6

Downstream of
driveway channel at
WC-3, no flow
observed in channel.
