**Wetland Hydrology Shallow  
Groundwater Investigation**

**Part of Lot 27, Concession 10,  
Township of Otonabee-South  
Monaghan  
County of Peterborough, Ontario**

**Proposed Residential Development**

**D.M. Wills Project Number 19-10874**

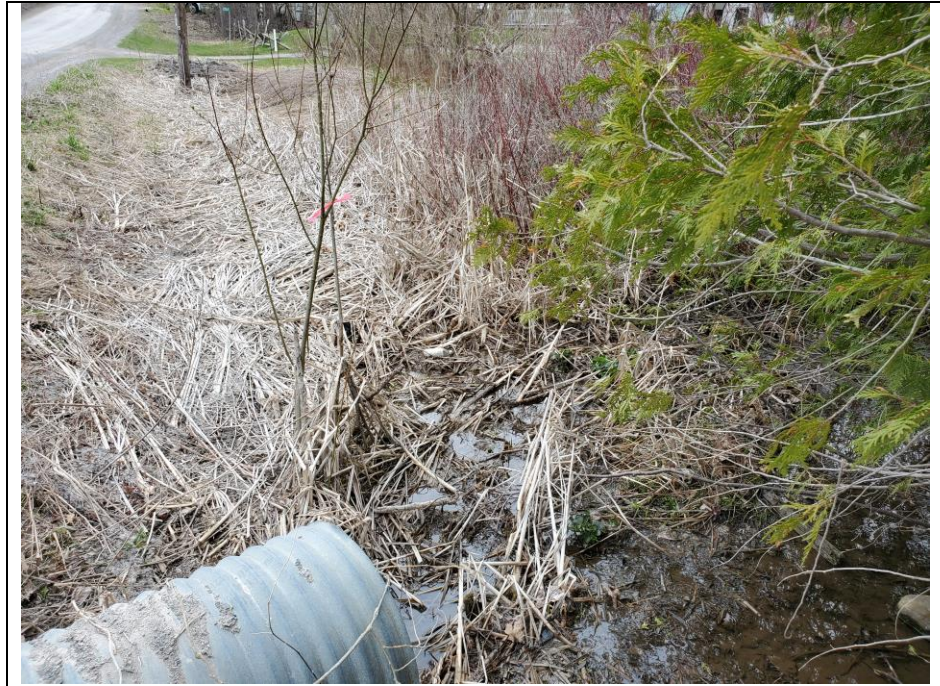
**Photograph No.:** 4

Drive-point DP20-03A  
and DP20-03B

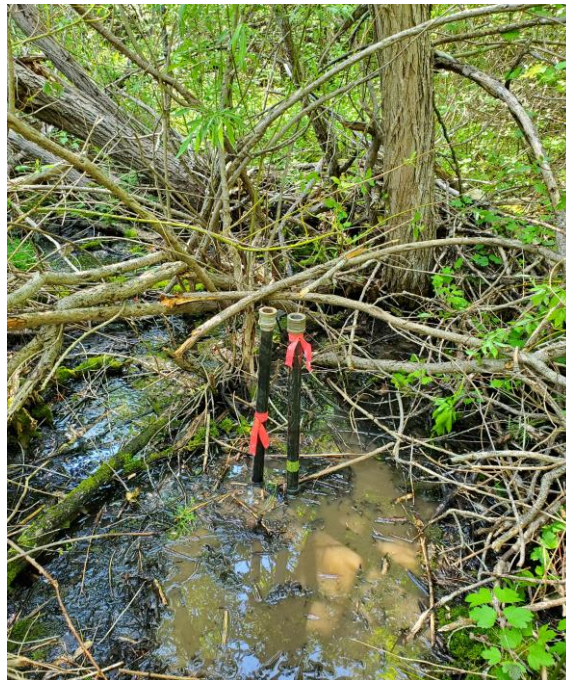
<b>Photograph No.:</b> 5
<b>Date:</b>  June 03, 2020
<b>Direction:</b>  East
<b>Description:</b> DP20-02 with backfilled test pit TP20-01 in background

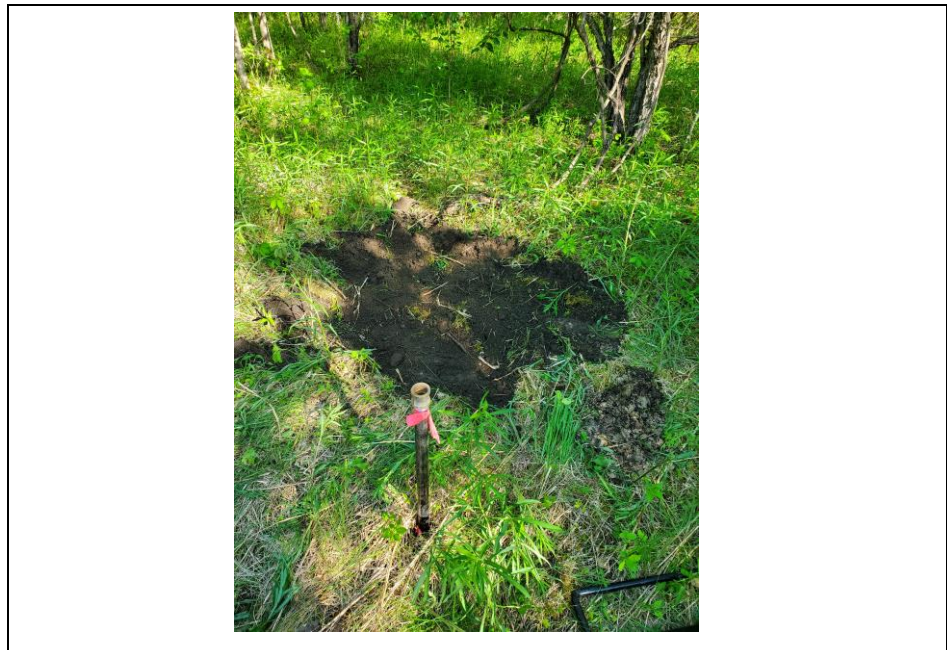
<b>Photograph No.:</b> 6
<b>Date:</b>  June 03, 2020
<b>Direction:</b>  Down
<b>Description:</b> Test pit stratigraphy in TP20-01

The encountered soil stratigraphy in TP20-01 included a thin layer of topsoil underlain by dark brown silty sand with organic material, and a basal layer of light brown silty sand till with some clay, trace gravel, and occasional cobbles. Photographs showing the test pit and encountered stratigraphy are included in **Appendix C**.

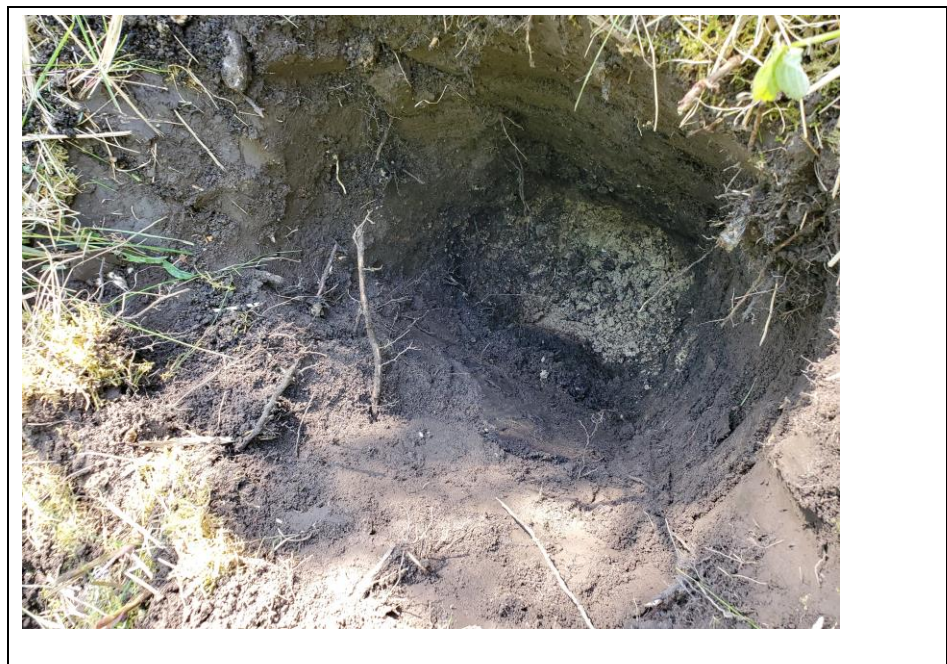
<b>Photograph No.:</b> 7
<b>Date:</b>  June 03, 2020
<b>Direction:</b>  North
<b>Description:</b> Drive-point DP20-01A and DP20-01B

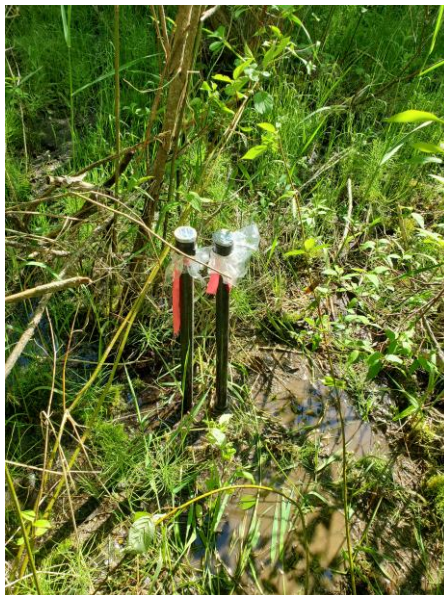
<b>Photograph No.:</b> 8
<b>Date:</b>  June 11, 2020
<b>Direction:</b>  West
<b>Description:</b> Drive-point DP20-03A and DP20-03B

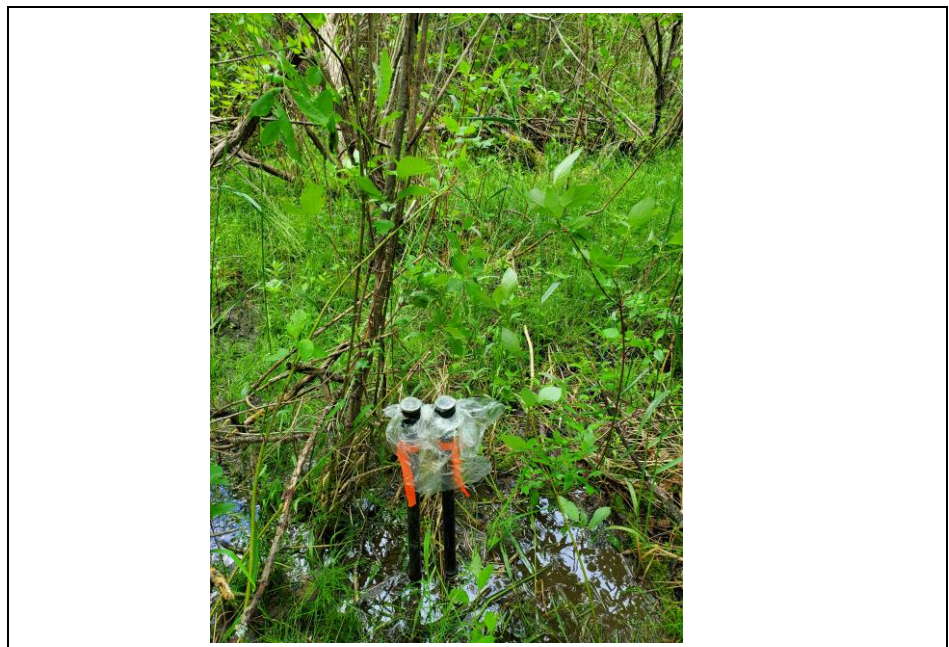
<b>Photograph No.:</b> 11
<b>Date:</b>  June 11, 2020
<b>Direction:</b>  N/A
<b>Description:</b> Glacial till material in auger hole HA20-02

In general, the encountered stratigraphy consisted of a thin (0.25 m thick) layer of dark brown silty sand and organic material with underlying glacial till that was described as silty sand, some clay, and trace gravel. Boreholes were advanced within the Subject Wetland boundary and all encountered soils were described as saturated to much wetter than the plastic limit at the time of the investigation.

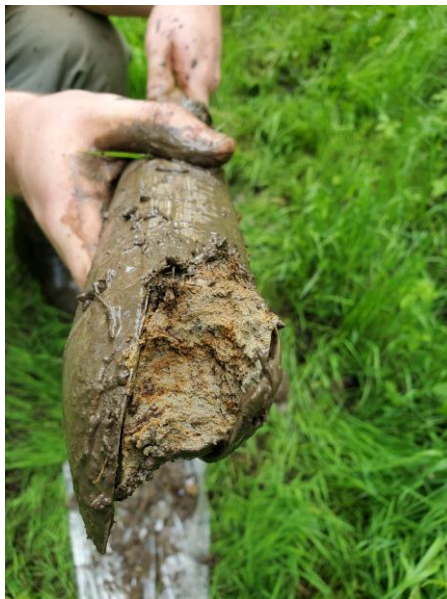
<b>Photograph No.:</b> 12
<b>Date:</b>  June 11, 2020
<b>Direction:</b>  North
<b>Description:</b> Advancing drive- point DP20-02

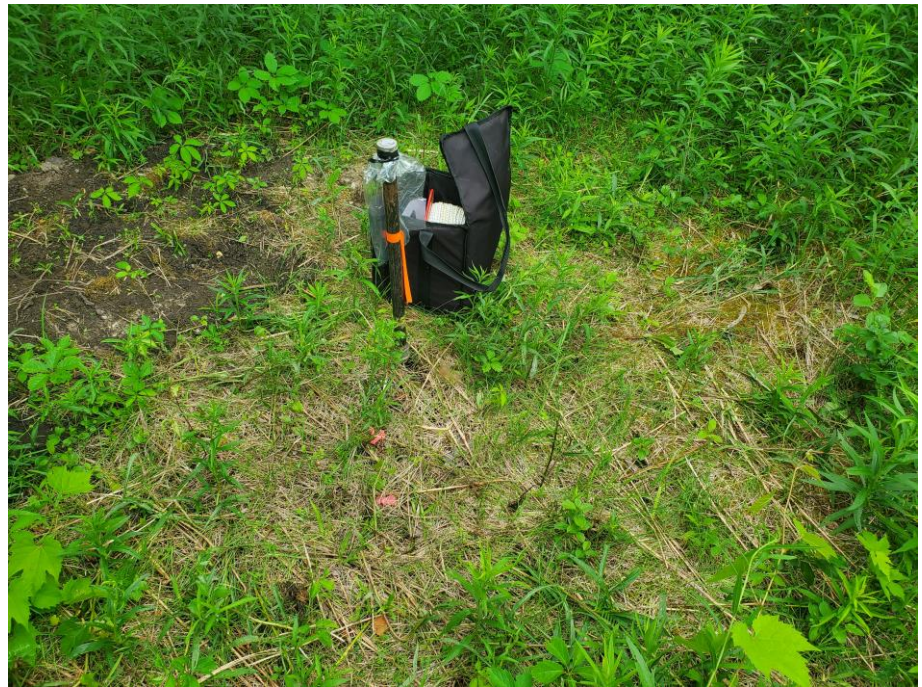
<b>Photograph No.:</b> 16
<b>Date:</b>  July 21, 2020
<b>Direction:</b>  West
<b>Description:</b> Drive-point DP20-03A and DP20-03B

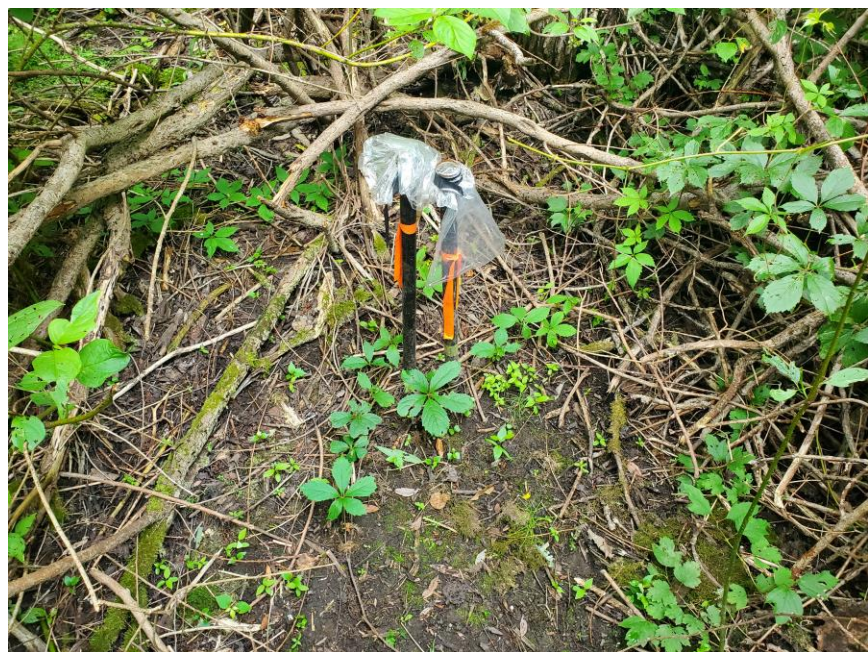
<b>Photograph No.:</b> 17	 
<b>Date:</b>  July 21, 2020	
<b>Direction:</b>  West	
<b>Description:</b> Drive-point DP20-01A and DP20-01B

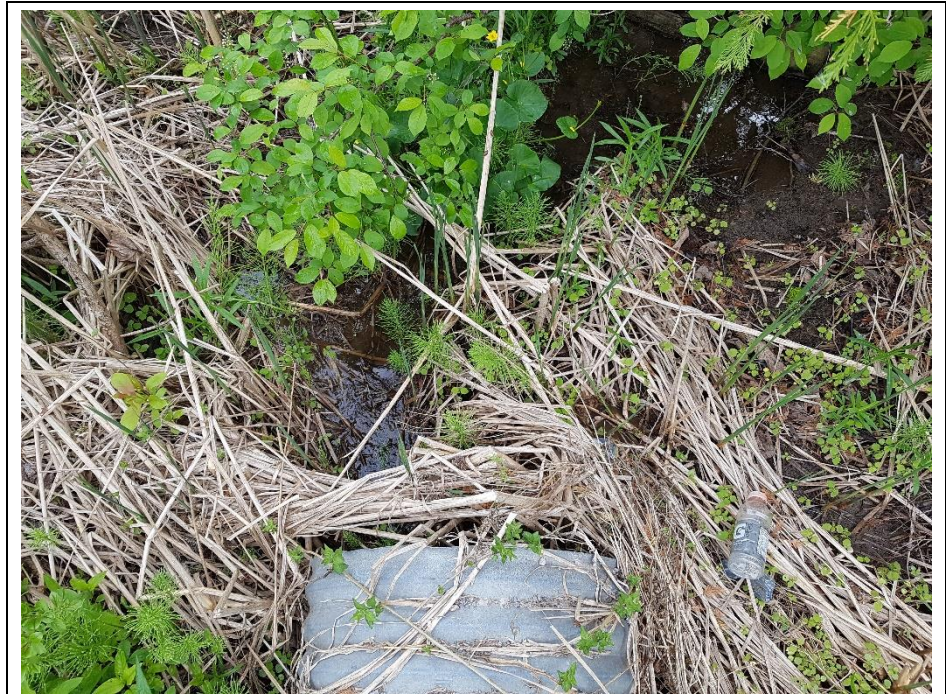
<b>Photograph No.:</b> 20
<b>Date:</b>  June 03, 2020
<b>Direction:</b>  Northwest
<b>Description:</b> Surface water flowing north at northern side of Subject Wetland. Finger points in direction of flow, as indicated by vegetation orientation and movement.

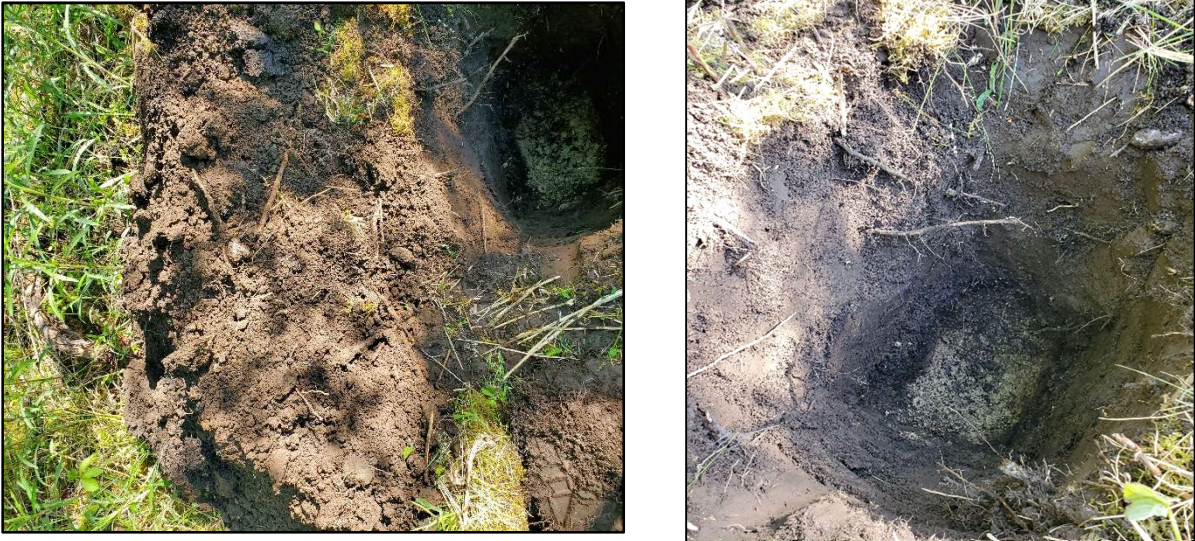
### Test Pit Log – TP20-01

Depth (mbeg)	Soil Description
0.0 – 0.6	Topsoil – Dark brown silty sand, rootlets, occasional cobble, moist.
0.6 – 0.7	Dark brown silty sand, organics, wet.
0.7 – 0.85	Till – Light brown silty sand, some clay, trace gravel, occasional cobble, saturated.
<b>Grab Sample Summary</b>	
<ul style="list-style-type: none"><li>GS-01 collected at approximately 0.50 mbeg.</li><li>GS-02 collected at approximately 0.65 mbeg.</li><li>GS-03 collected at approximately 0.80 mbeg.</li></ul>	
<b>Groundwater</b>	
<ul style="list-style-type: none"><li>Grab sample saturated at 0.80 mbeg.</li></ul>	
<b>Additional Notes</b>	
<ul style="list-style-type: none"><li>Test pit terminated at 0.85 mbeg.</li><li>Test pit backfilled and compacted using shovel following completion of stratigraphic logging and sampling.</li></ul>	
<b>Test Pit Photos</b>
