Phase 1 Assessment of Potential Karst

Proposed 1919 Estates Subdivision, Phase 1

Bobcaygeon, Ontario

Project 21- 1-6814

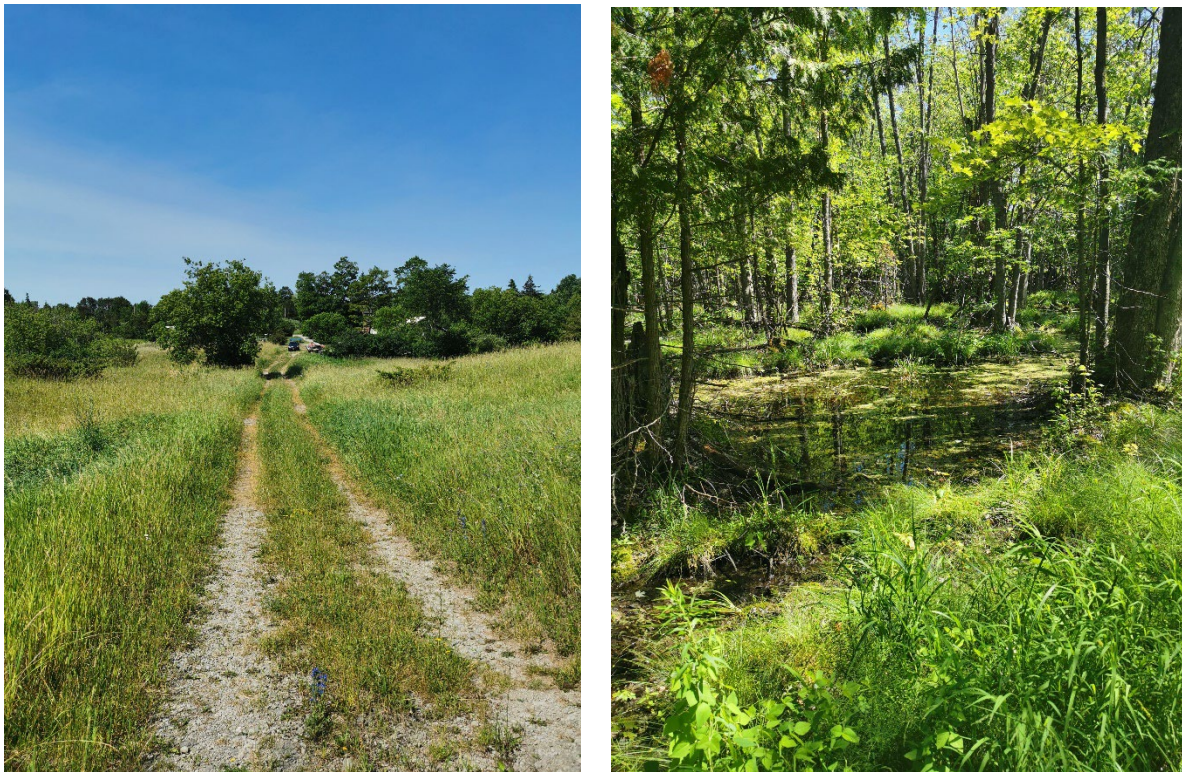
Figure 1 – Site Photos **Left panel:** Looking to the west toward Highway 49 and the access to the property; **Right panel:** a view of the wetland area in the central portion of the site (looking to the south).

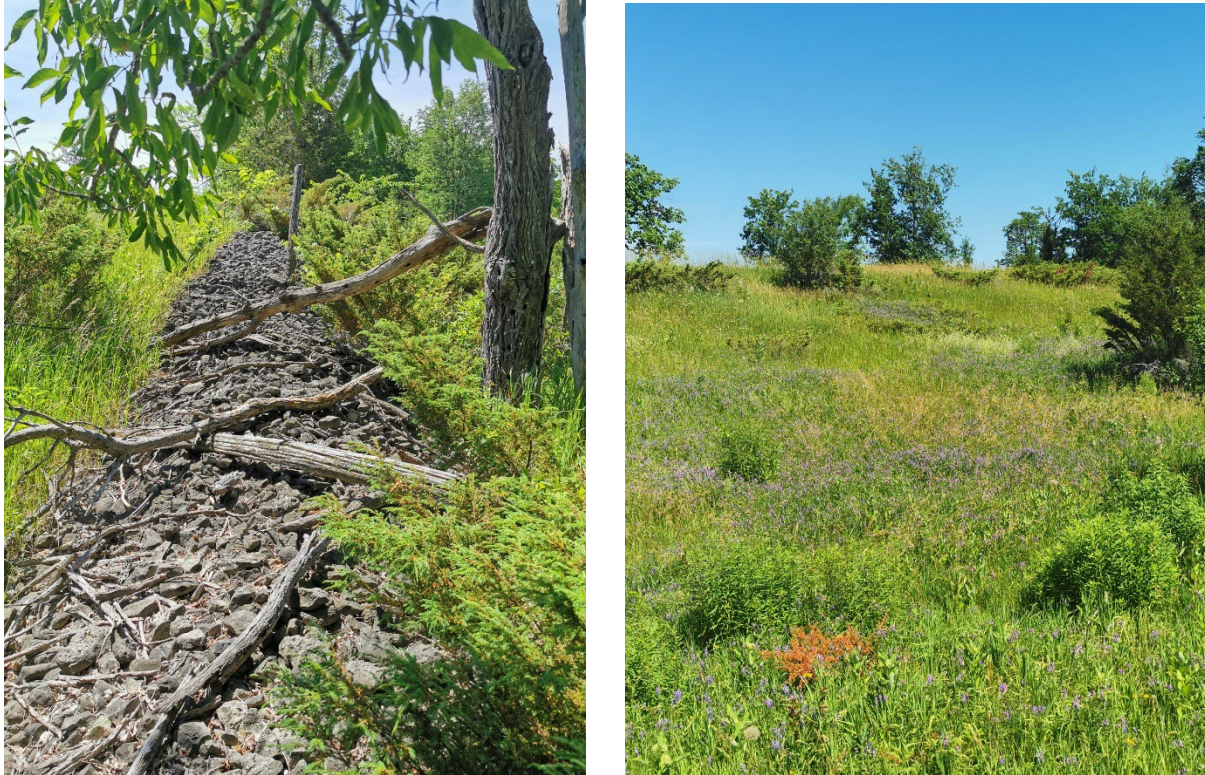
Figure 2 – Site Photos **Left panel:** Looking to the south along a north-south oriented fence line in the eastern portion of the property. Fencerows were typically piled with grey-weathering angular to subangular limestone clasts removed from the fields during more than a century of farming activity at the site; **Right panel:** a view of a typical area of closed drainage characterized by lush vegetation but no indications of standing water accumulation.

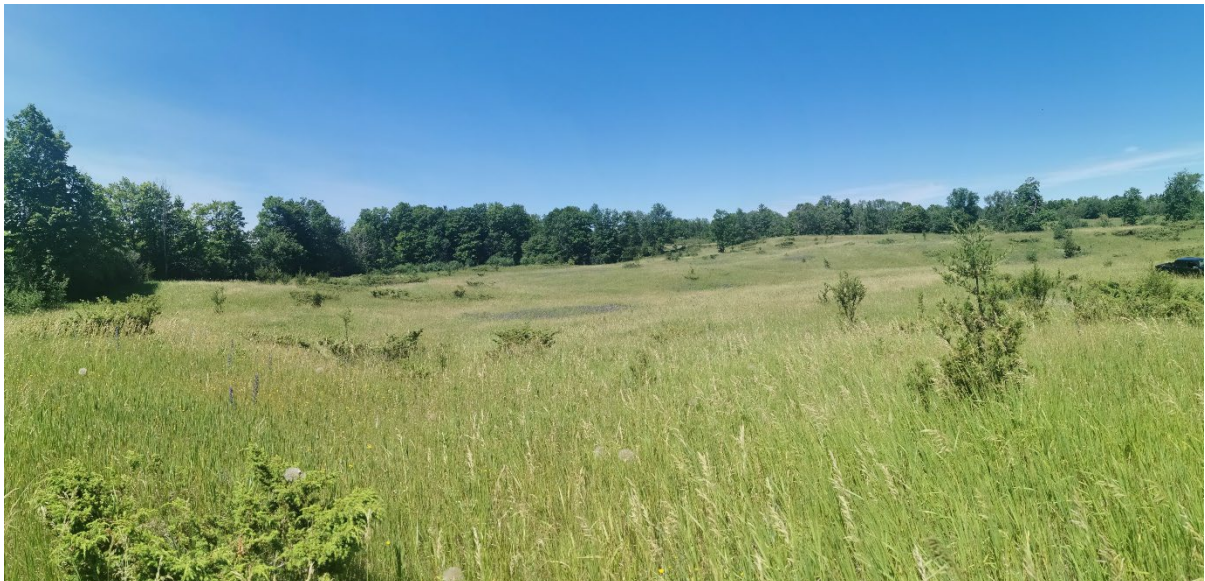
Figure 3 – Panoramic photo of the central portion of the site showing typical hummocky topography.

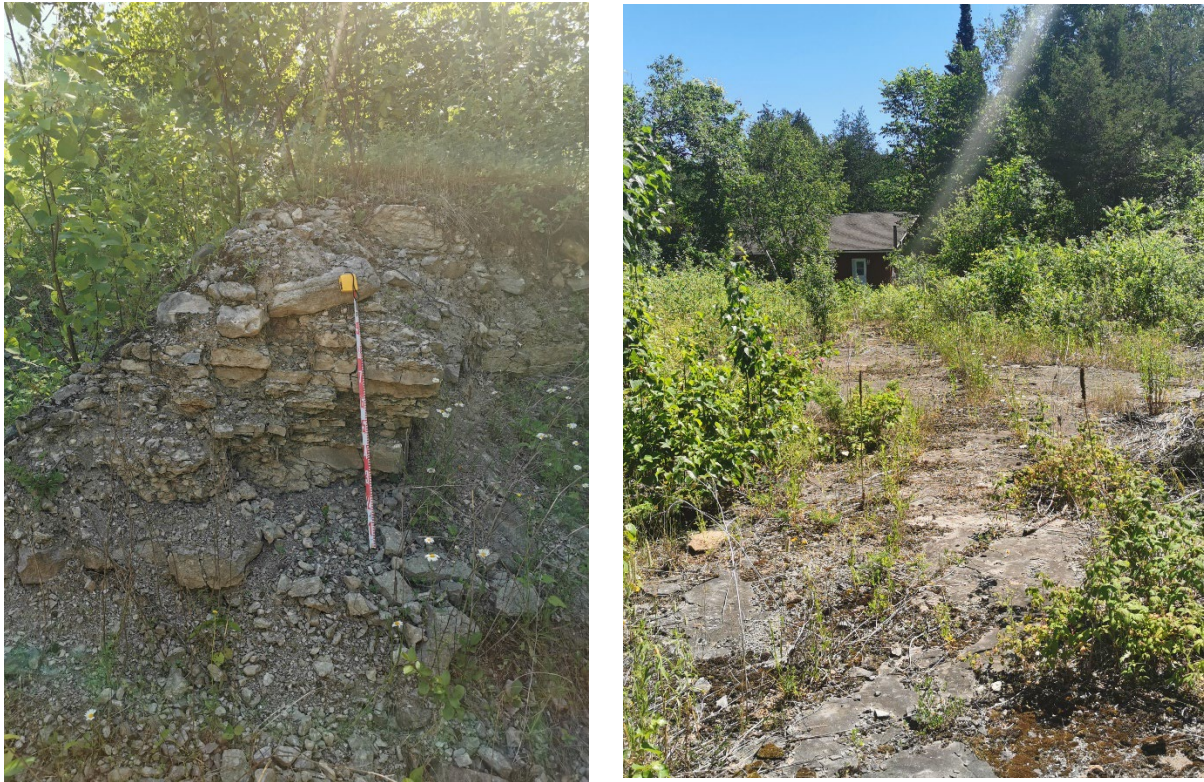
The Bobcaygeon Formation overlies the Gull River and forms the upper bedrock over the eastern half of the property. It is a light grey-brown to blue-grey to grey-brown, fine- to coarse-textured fossiliferous limestone. Thin shale interbeds and partings are encountered within the limestone and these increase in abundance upward while crinoidal grainstones and nodular textures are more common in the lower part of the Formation. Armstrong and Rhéaume (1994) subdivide the Bobcaygeon Formation into an upper, middle and lower member with the upper member forming the uppermost bedrock beneath the eastern half of the property. Several outcrops of this formation were identified in the northeast corner of the property. In this area, limestone of the upper Bobcaygeon forms a flat, sparsely jointed pavement with a “step” upward in elevation to the south.

Bedrock exposed in the “step” is a highly fractured and weathered grey-brown, fine-textured limestone with individual limestone layers typically thinner than 150 mm and separated by numerous shaley layers. Minimal solution widening (circa 1 to 2 mm) was noted in the bedrock joints and no cavities/voids were noted in the limited extent of the vertical exposure. Photos of the Bobcaygeon Formation outcrop are shown in Figure 4.

Figure 4 – Bedrock outcrop in the northeastern corner of the property. **Left Panel:** an exposure on the face of a low step or scarp **Right Panel:** jointed limestone pavement
