Geotechnical Investigation Report - Part of Lot 19, Concession 19, Township of Galway-Cavendish and Harvey, County of Peterborough, Ontario

May 1, 2024

Prepared for:
Jeffrey Homes

Cambium Reference: 17986-002

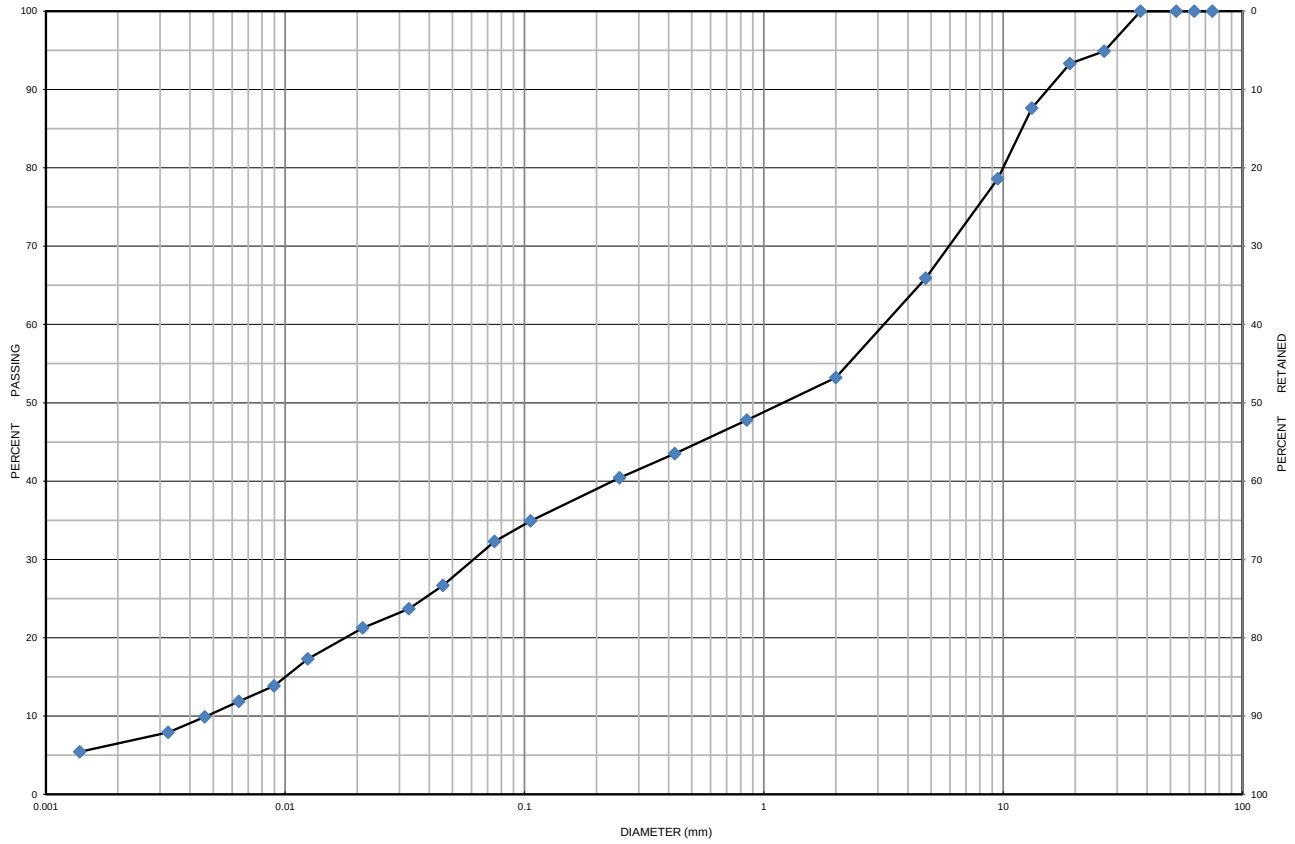
Location: *BH 101-23 SS 4* **Depth:** *2.3 m to 2.9 m* **Lab Sample No:** *S-23-1845*

Borehole No.	Sample No.	Depth	Gravel	Sand	Silt	Clay	Moisture
BH 101-23	SS 4	2.3 m to 2.9 m	34	34	25	7	7.5

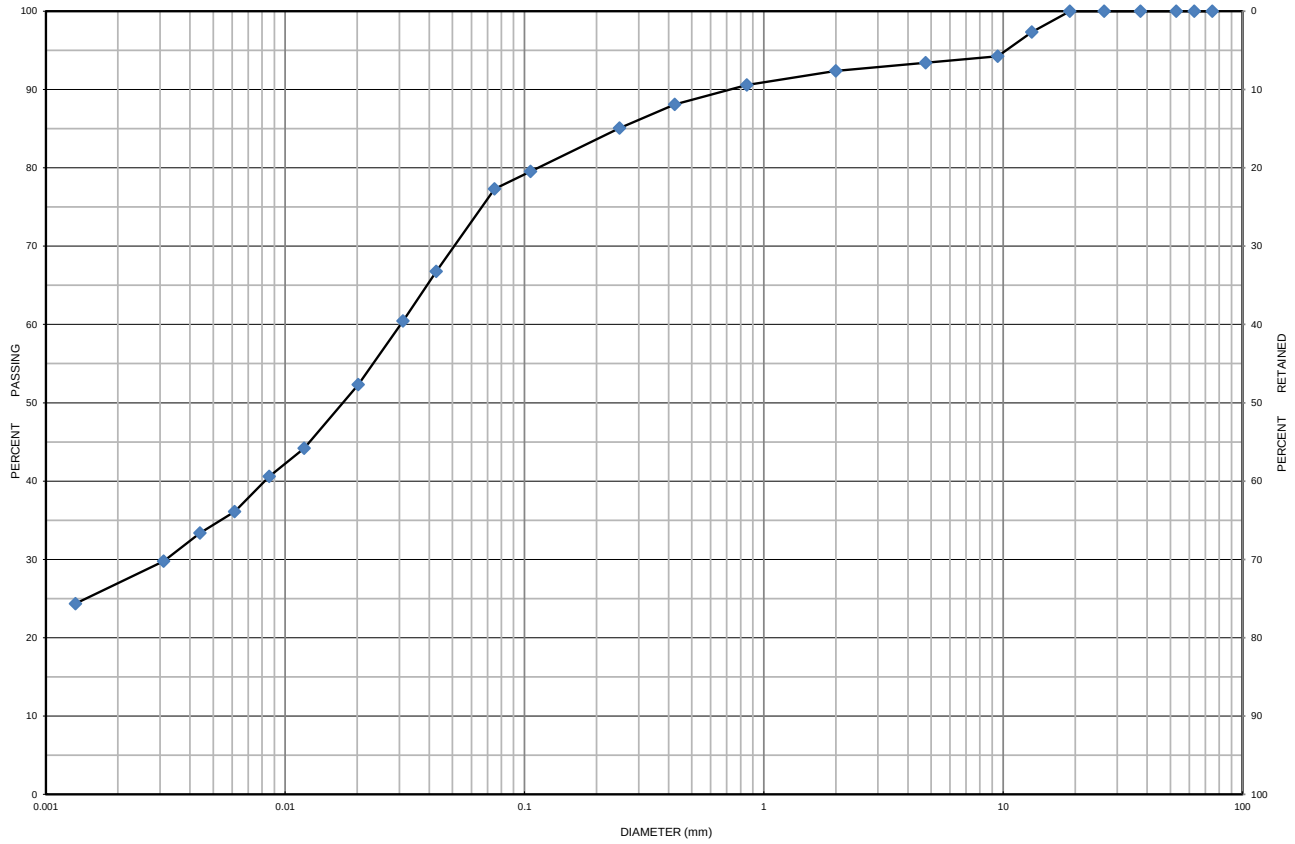
Location: *BH 102-23 SS 2* **Depth:** *0.8 m to 1.4 m* **Lab Sample No:** *S-23-1846*

Brown clayey silt, with some sand and trace gravel, and occasional cobbles, was encountered immediately below the topsoil in boreholes BH101-23 and BH102-23. Trace amounts of organics were found within the clayey silt soil in BH102-23. The clayey silt material extended to depths 0.70 mbeg and 1.45 mbeg, respectively. The clayey silt soil was generally found to be drier than the plastic limit (DTPL) at the time of investigation. SPT blow counts within the clayey silt provide evidence of generally soft to stiff relative consistencies.

Borehole No.	Sample No.	Depth	Gravel	Sand	Silt	Clay	Moisture
BH 102-23	SS 2	0.8 m to 1.4 m	7	16	50	27	22.3

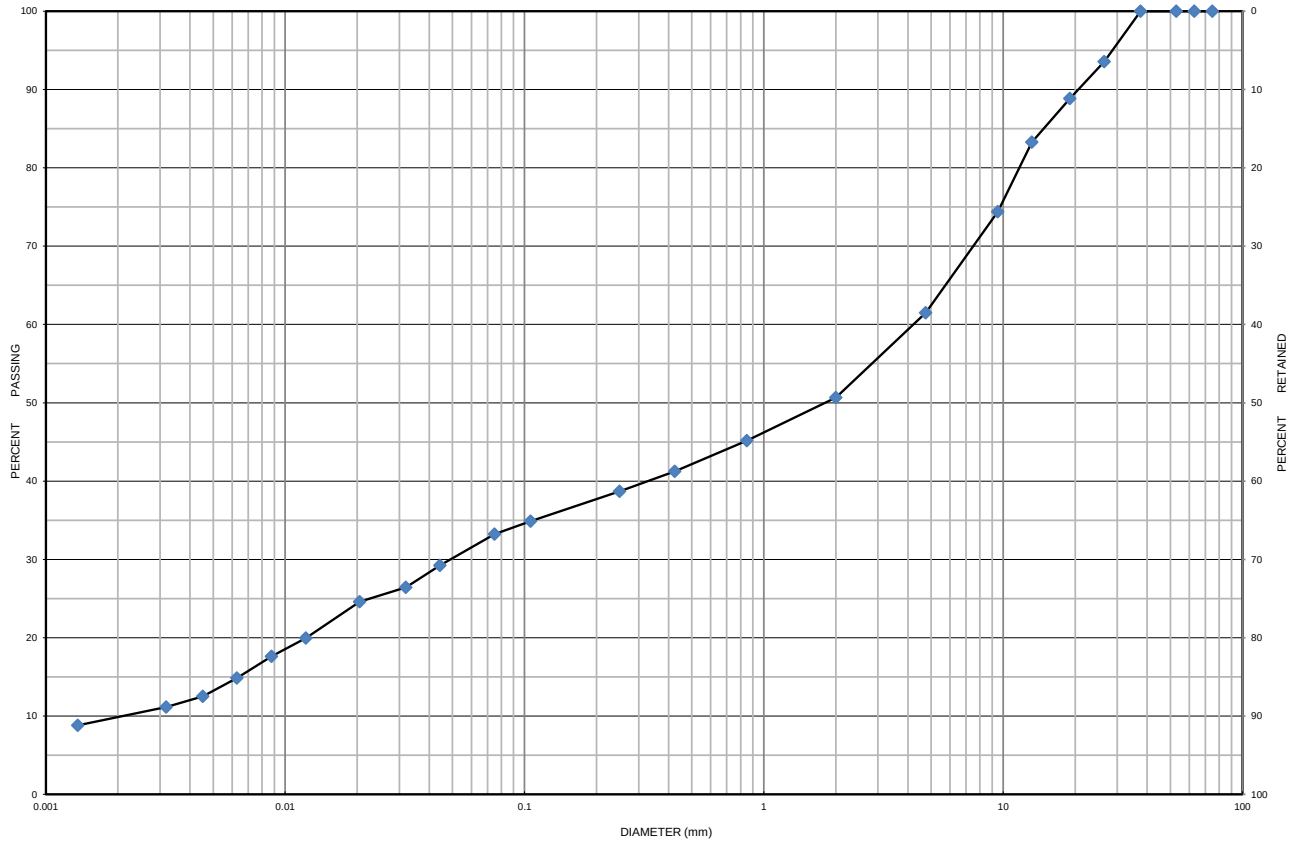
Location: *BH 105-23 SS 3* **Depth:** *1.5 m to 2.1 m* **Lab Sample No:** *S-23-1847*

Borehole No.	Sample No.	Depth	Gravel	Sand	Silt	Clay	Moisture
BH 105-23	SS 3	1.5 m to 2.1 m	39	28	23	10	6.2

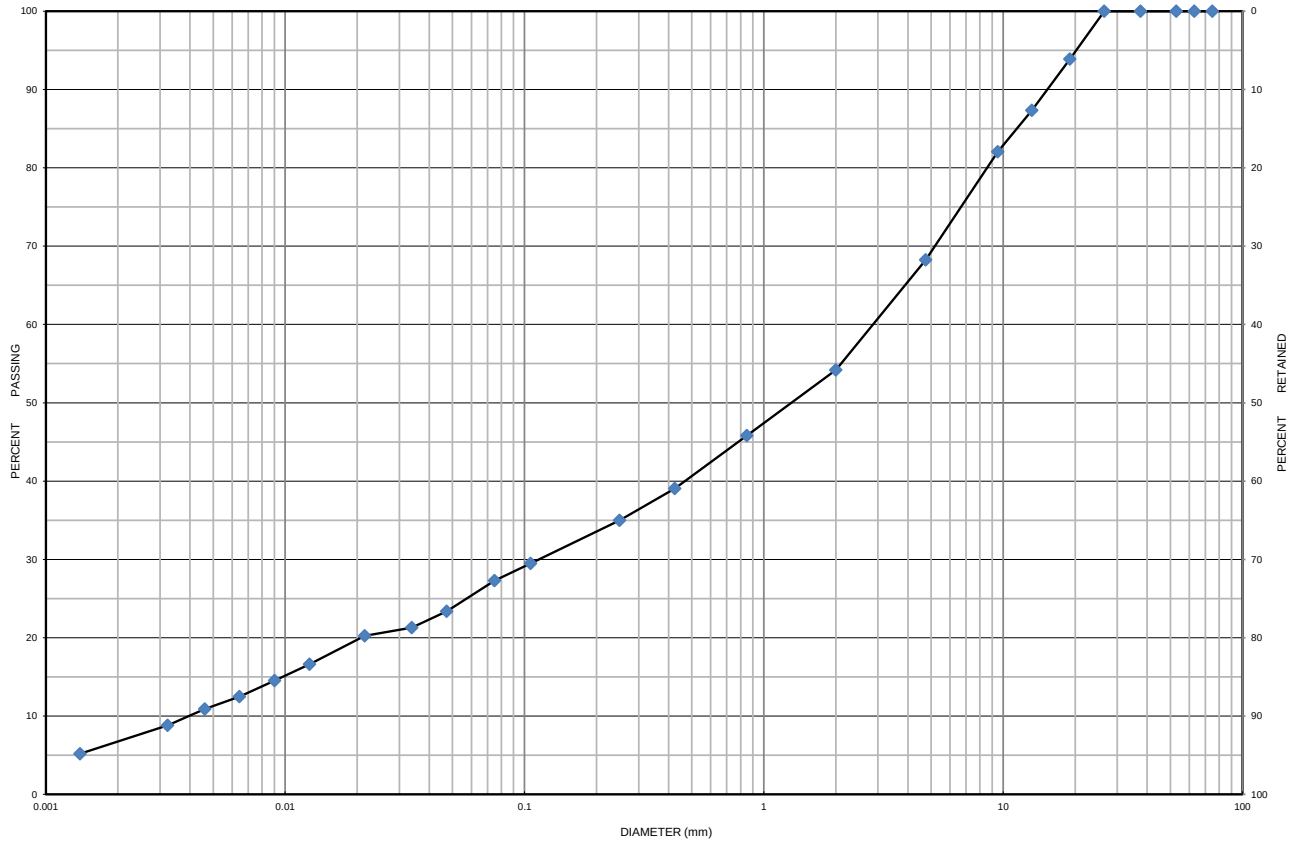
Location: *BH 108-23 SS 3* **Depth:** *1.5 m to 2.1 m* **Lab Sample No:** *S-23-1848*

Borehole No.	Sample No.	Depth	Gravel	Sand	Silt	Clay	Moisture
BH 108-23	SS 3	1.5 m to 2.1 m	32	41	20	7	3.6

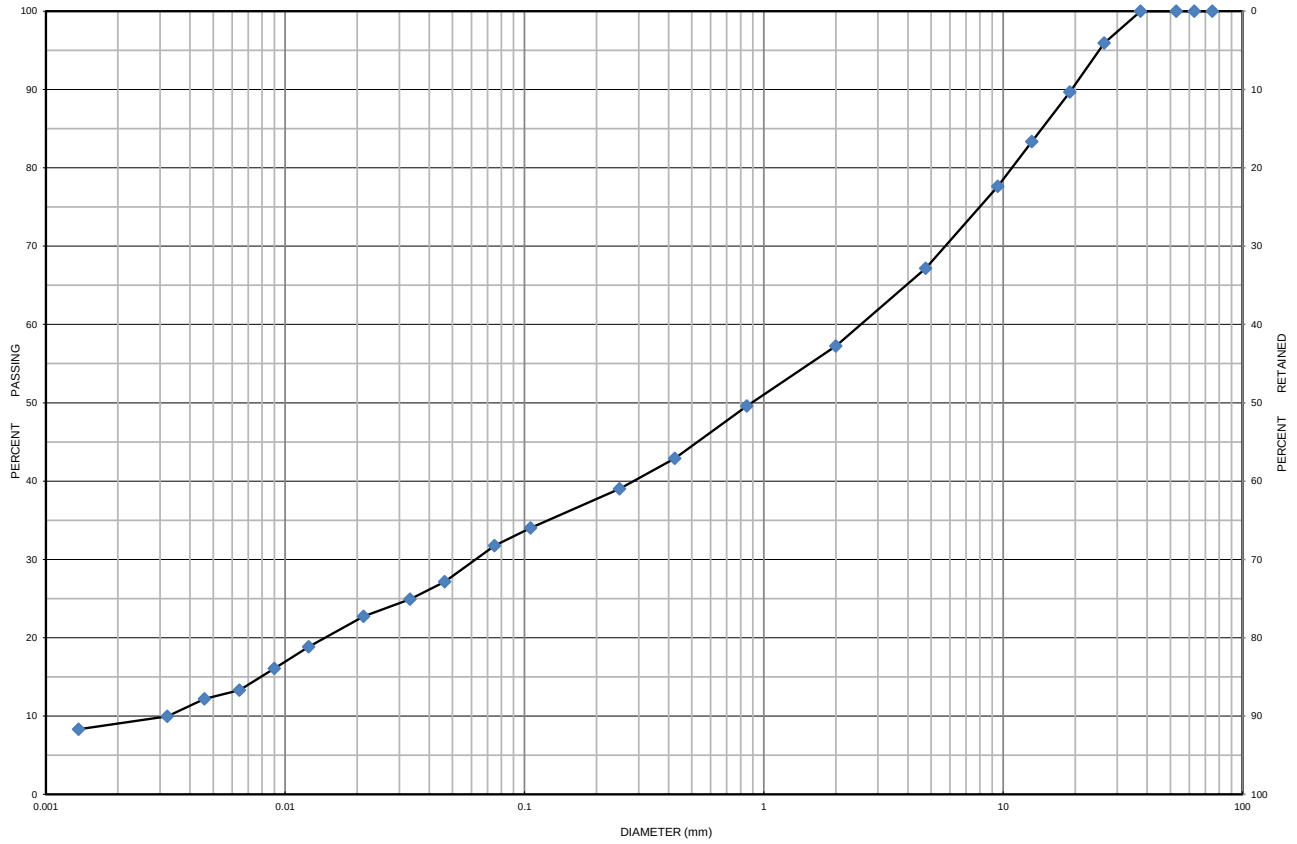
Location: *BH 109-23 SS 4* **Depth:** *2.3 m to 2.9 m* **Lab Sample No:** *S-23-1849*

Borehole No.	Sample No.	Depth	Gravel	Sand	Silt	Clay	Moisture
BH 109-23	SS 4	2.3 m to 2.9 m	33	35	23	9	5.5

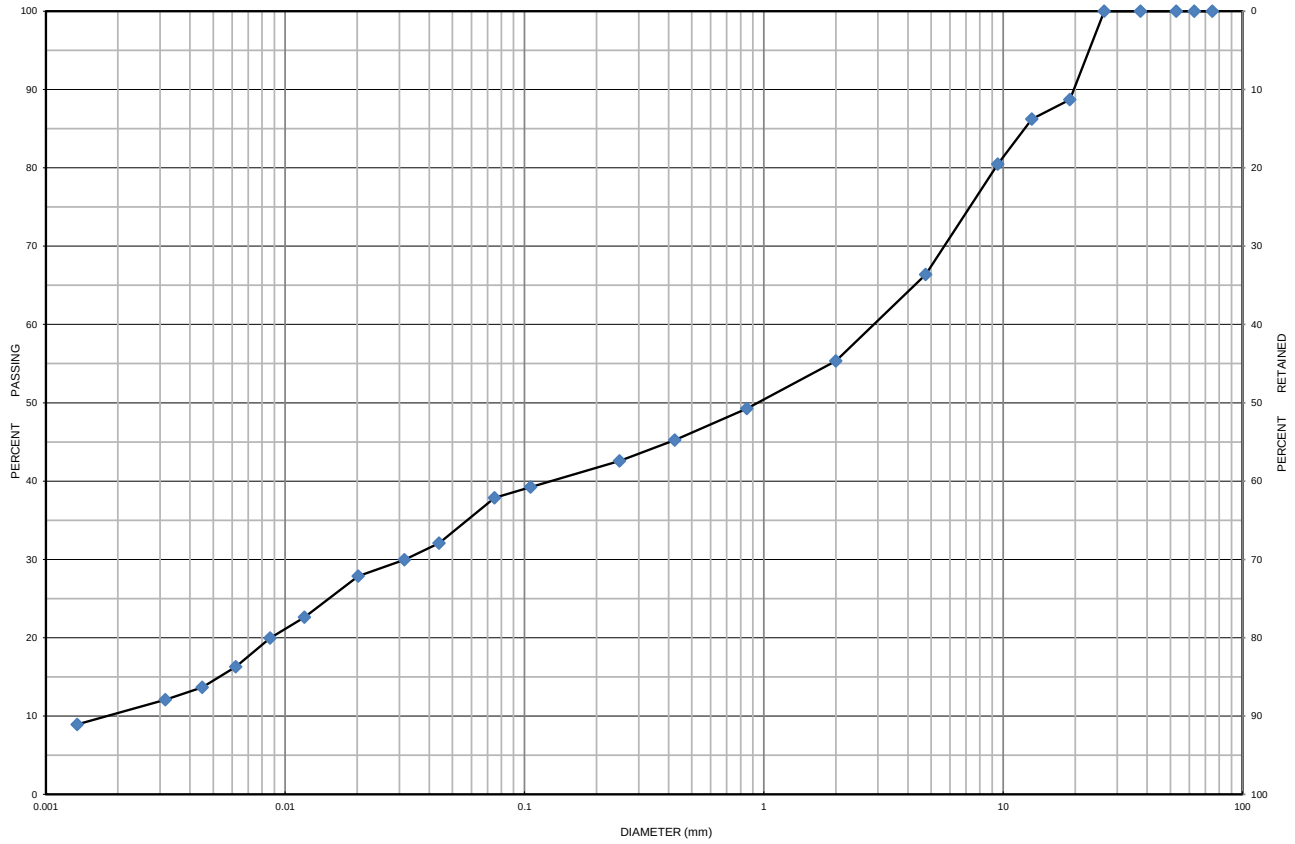
Location: *BH 112-23 SS 3* **Depth:** *1.5 m to 2.1 m* **Lab Sample No:** *S-23-1850*

Borehole No.	Sample No.	Depth	Gravel	Sand	Silt	Clay	Moisture
BH 112-23	SS 3	1.5 m to 2.1 m	34	29	26	11	6.8
