Erosion Hazard Limit Study Report

Heritage Line Residential Development

**Lot 14, Concession 6, Otonabee-
South Monaghan, ON**

D.M. Wills Project Number 21-10985

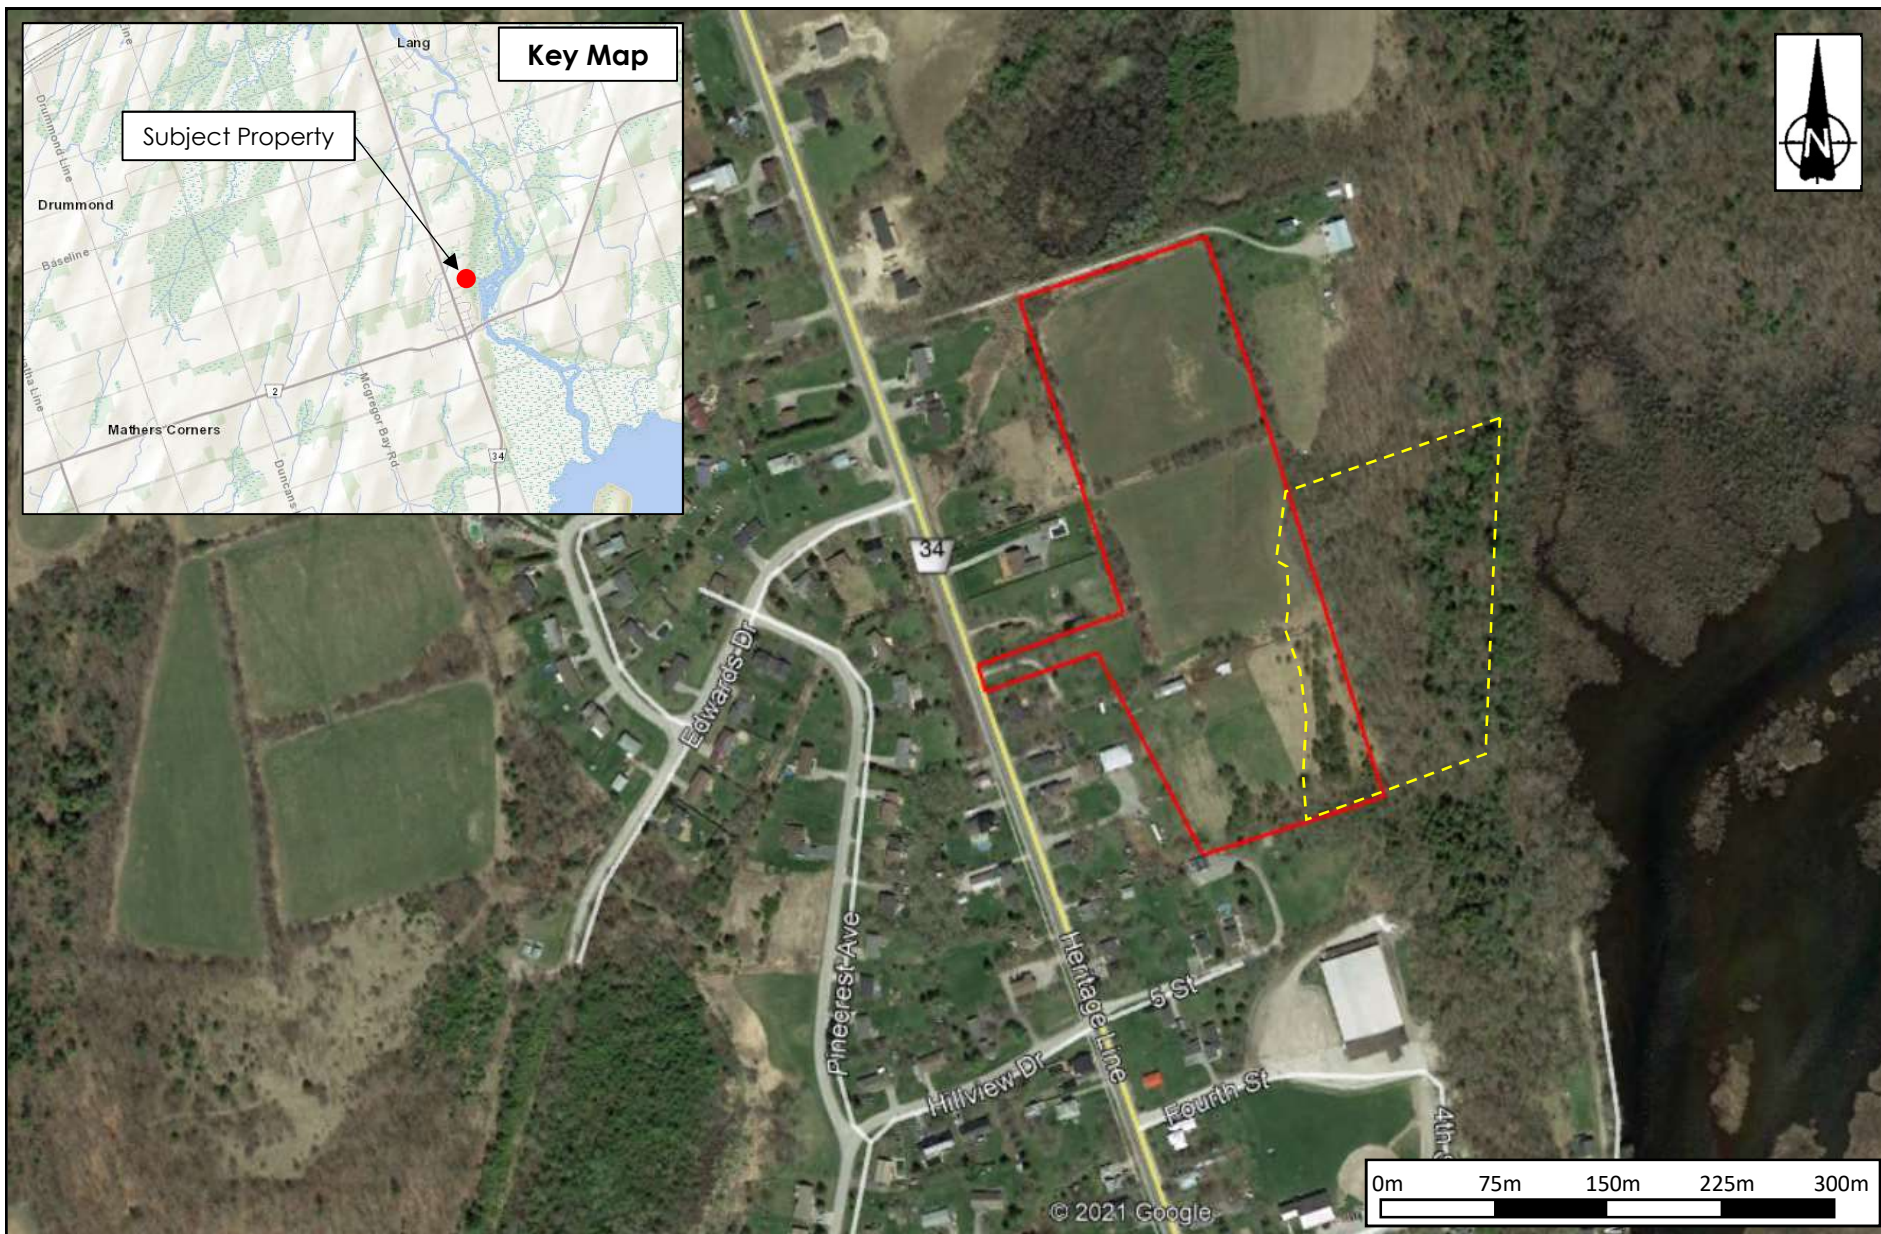
D.M. Wills Associates Limited (Wills) was retained by Alina Stewart and Shawn Elmhirst (Client) to complete an Erosion Hazard Limit Study (Study) for the property located on Lot 14, Concession 6 in the municipality of Otonabee-South Monaghan (Subject Property). A Subject Property Plan showing the approximate property boundary is included as **Figure 1**.

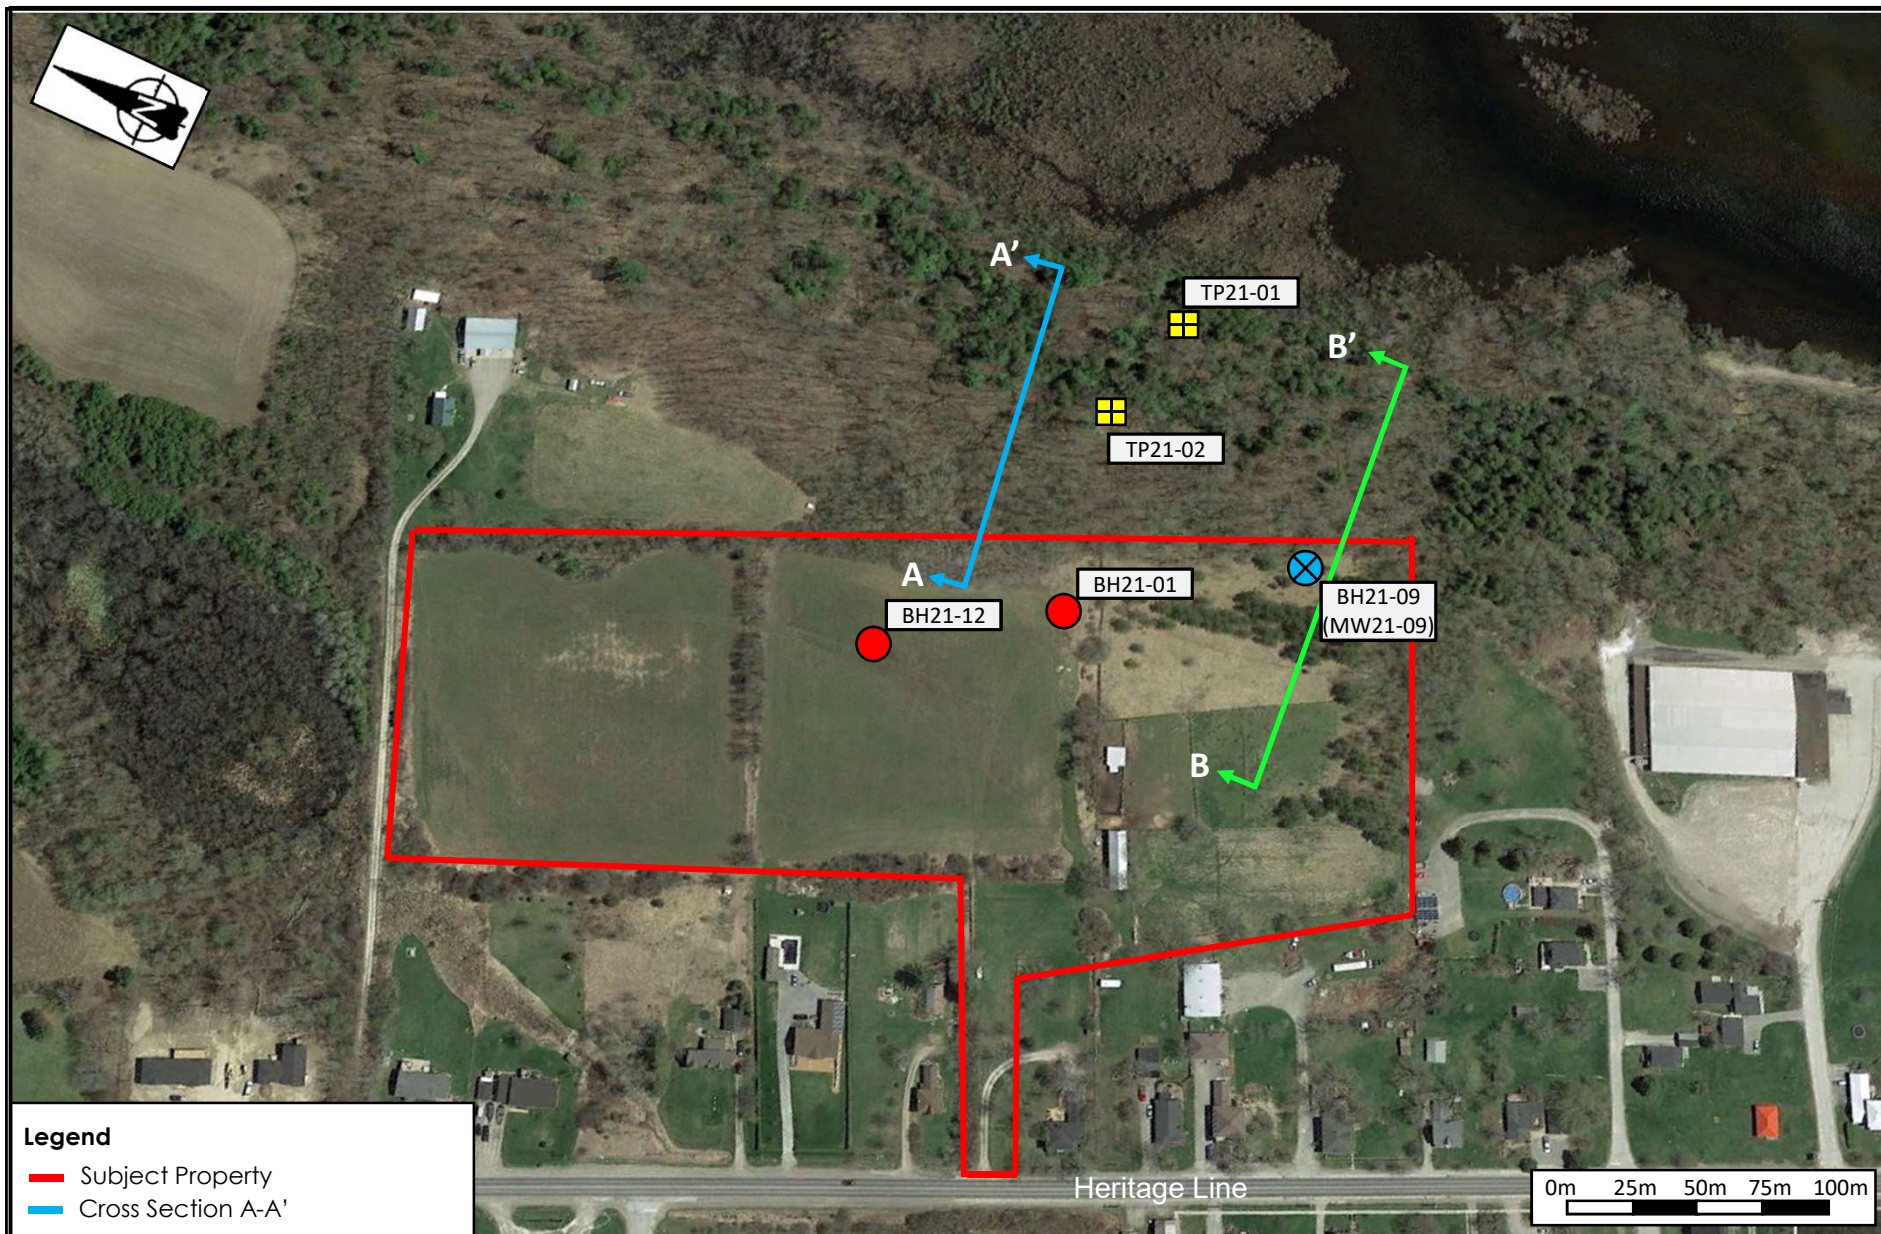
Borehole locations are shown on **Figure 2**, and the encountered subsurface conditions are summarized in **Table 2**.
