Our Ref: 11224019-03  
TBG Ref: 20697

Re: Response to Comments – 787 & 825 Fallis Line, Millbrook ON  
County File 15T-21007

GHD Limited (GHD) is pleased to present the following responses to various agency comments received regarding the geotechnical and hydrogeologic investigation reports and environmental site assessment report completed for the above noted properties located on Fallis Line in Millbrook, Ontario. GHD responses follow the respective agency comments.

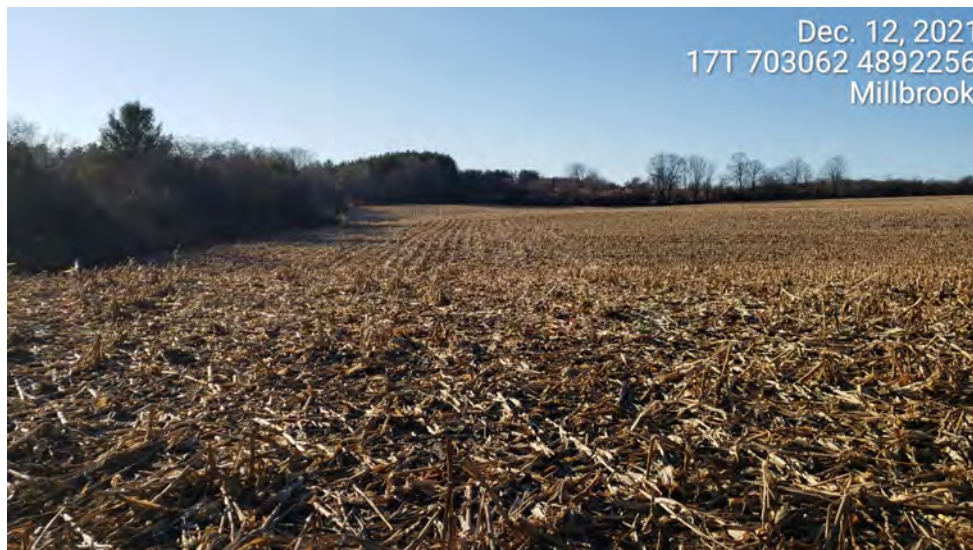
Dec. 12, 2021  
17T 703062 4892256  
Millbrook

Photo 5 - View of western agricultural field looking west.

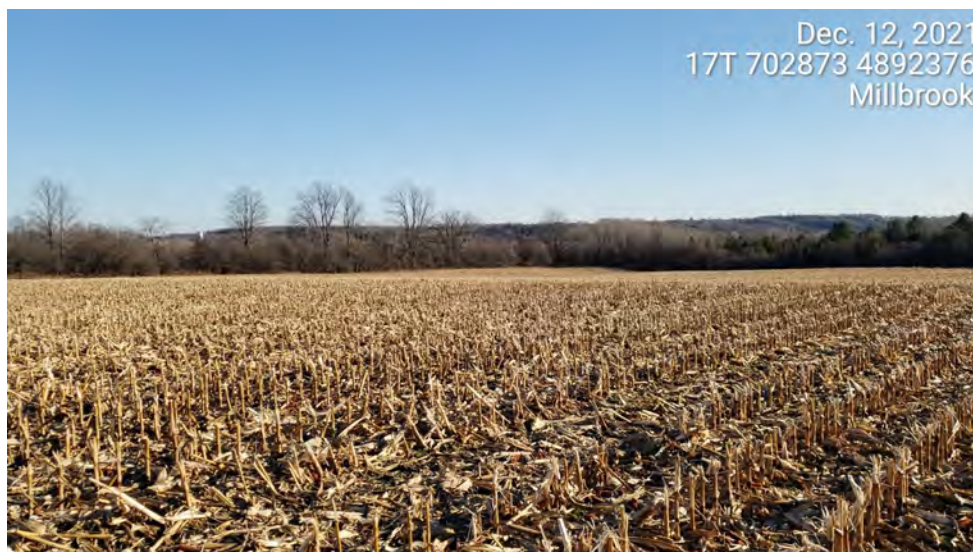
Dec. 12, 2021  
17T 702873 4892376  
Millbrook

Photo 6 - View of agricultural field looking southeast toward Village of Millbrook.

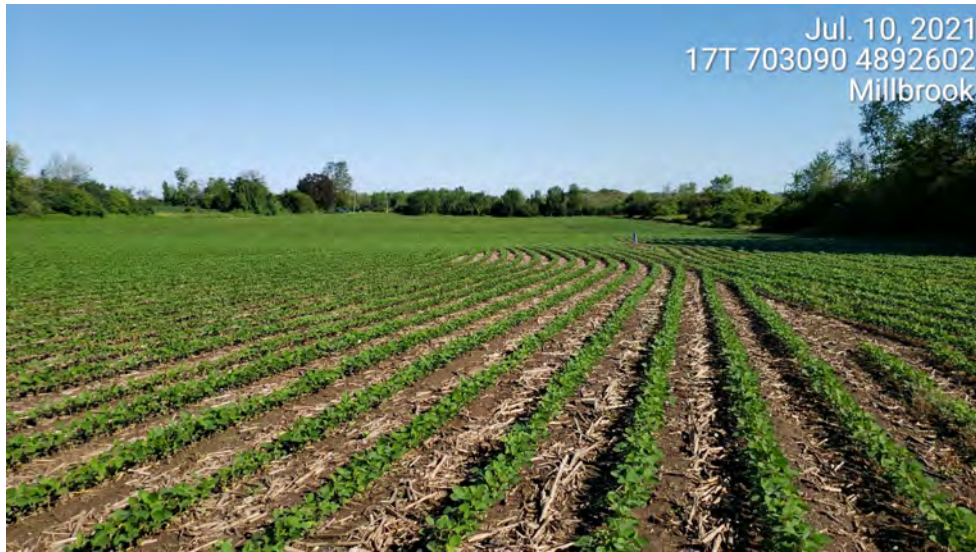
Photo 7 - View of agricultural field looking north toward Fallis Line.

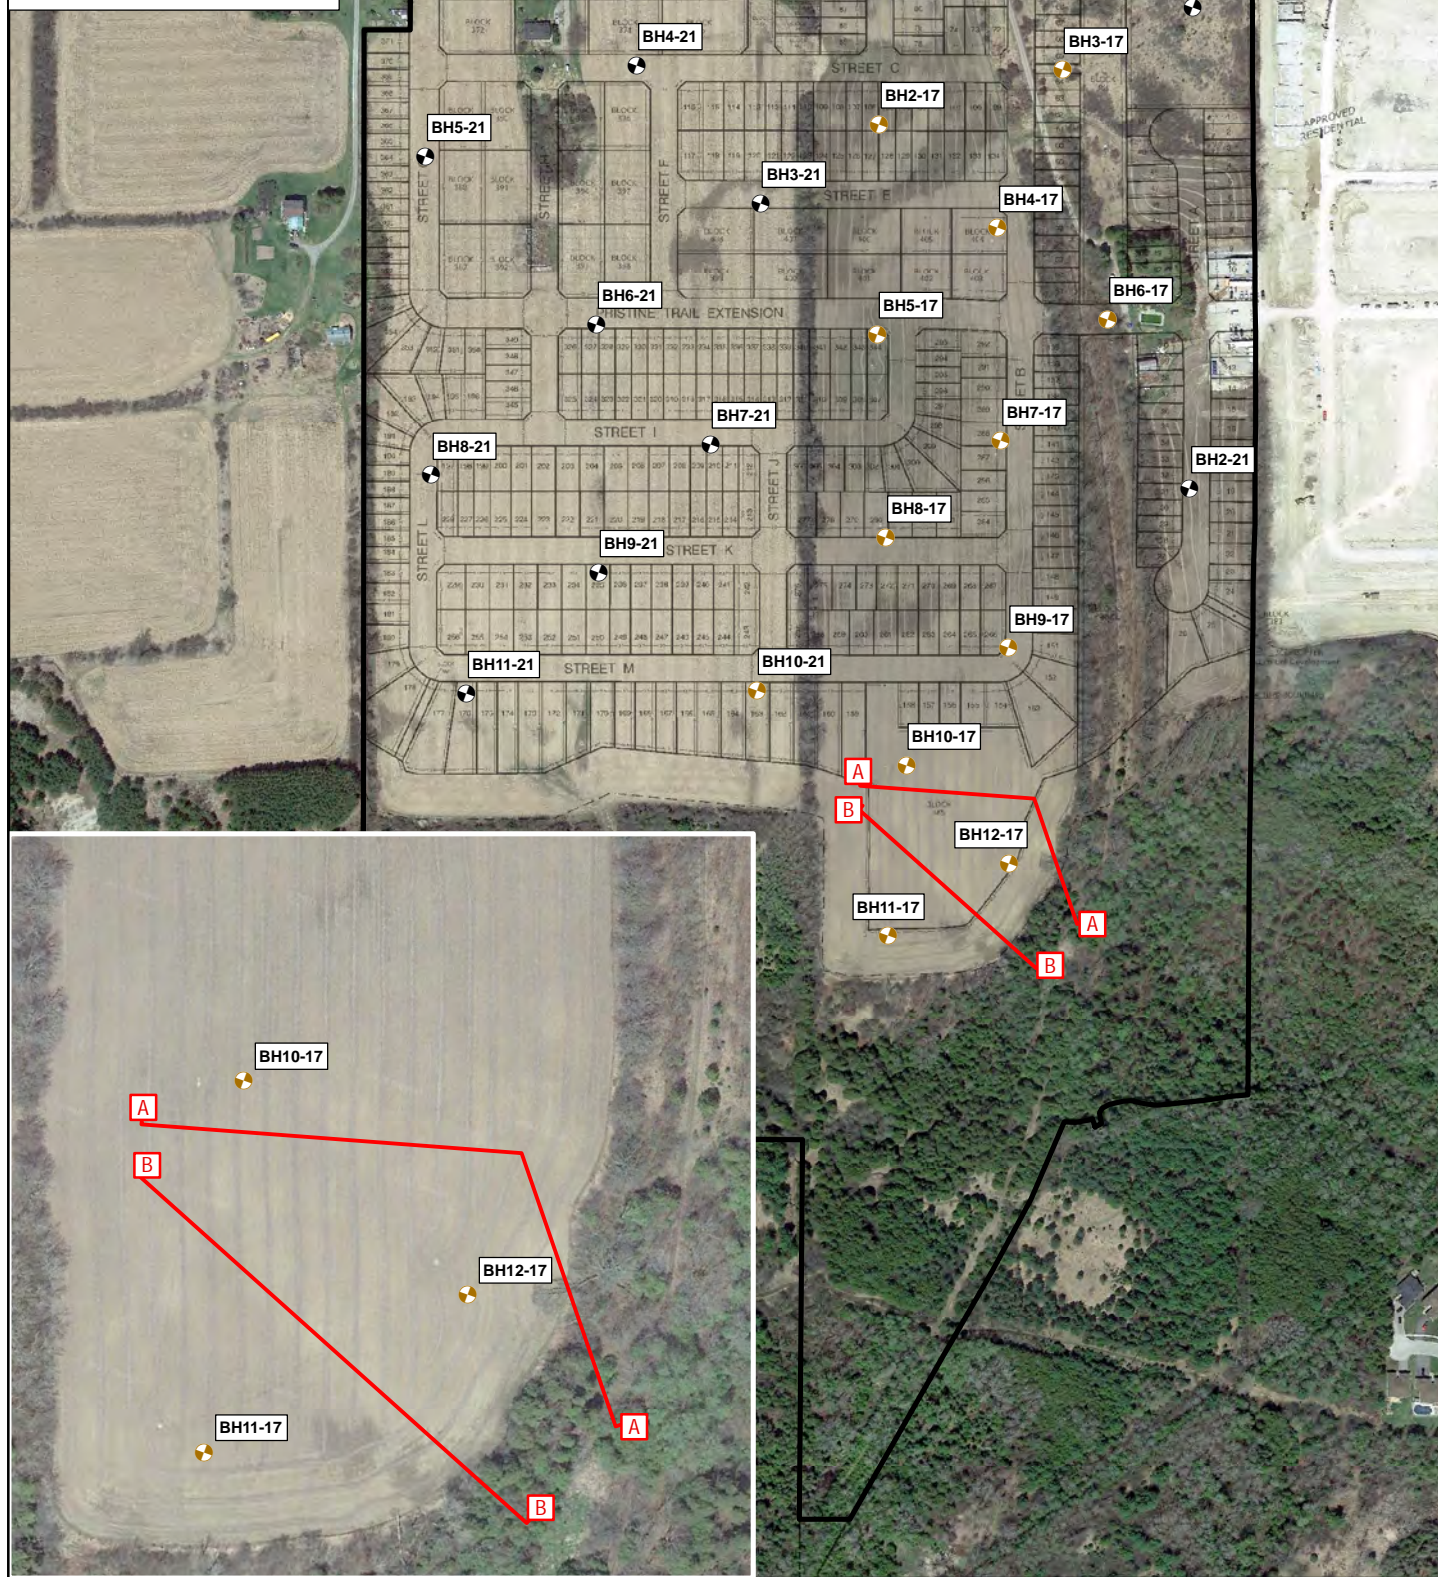
## Figure 1

The slope inclinations and height were visually assessed during the slope inspections, and verified using the topographic information provided by the Valdor. The slope inclination was assessed to be approximately 9 degrees (6H:1V) along cross-section A-A' and 6 degrees (9H:1V) along cross-section B-B' illustrated on Figure 1.

In order to determine the global stability of the slope along the representative cross-sections A-A' and B-B', illustrated in Figure 1, a global stability analysis was carried out for the existing and proposed Site conditions. Global stability refers to the potential of a slope to undergo a relatively deep seated circular failure. The subsurface stratigraphy was selected using the GHD borehole logs.

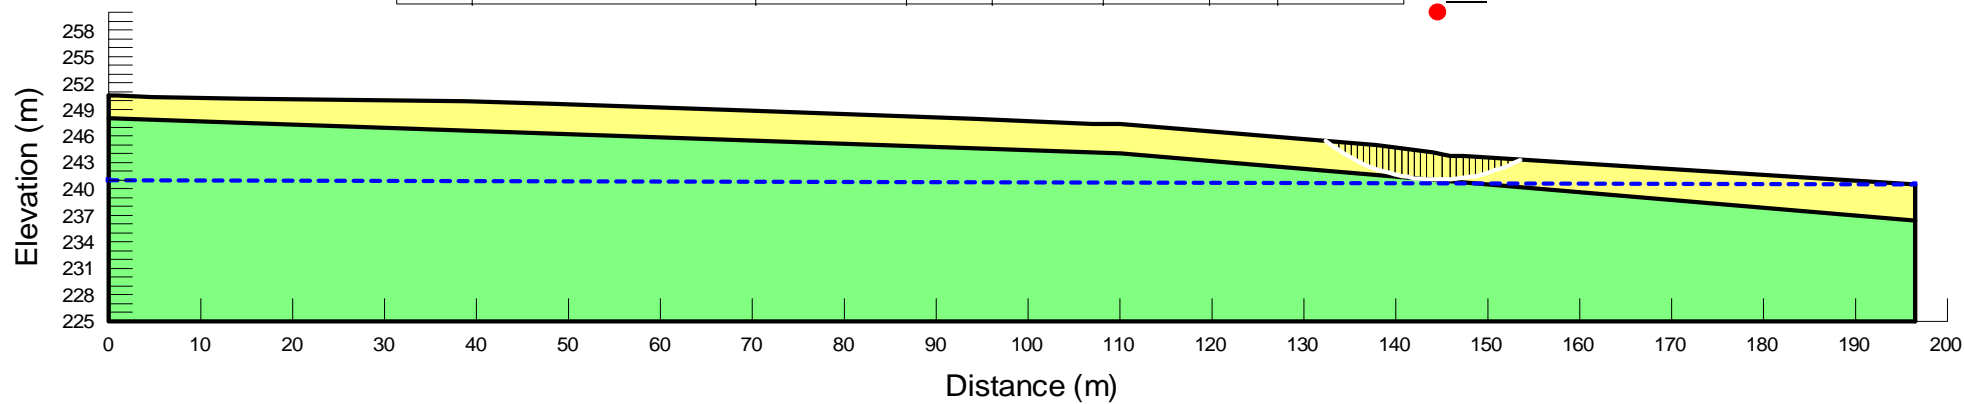
FIGURE 2

The graphical output of the slope stability analyses for the existing and proposed conditions along cross-section A-A' and B-B' are provided on Figure 2 through Figure 5. The modeled cross-sections A-A' and B-B' obtained factors of safety ranging from 2.5 and 5.9, for existing and proposed conditions.

Based on the results of the analysed cross sections and as illustrated in Figure 2 through Figure 5, it is concluded that the existing and proposed grades for the Site obtained the targeted minimum 1.5 FoS and can be considered stable.

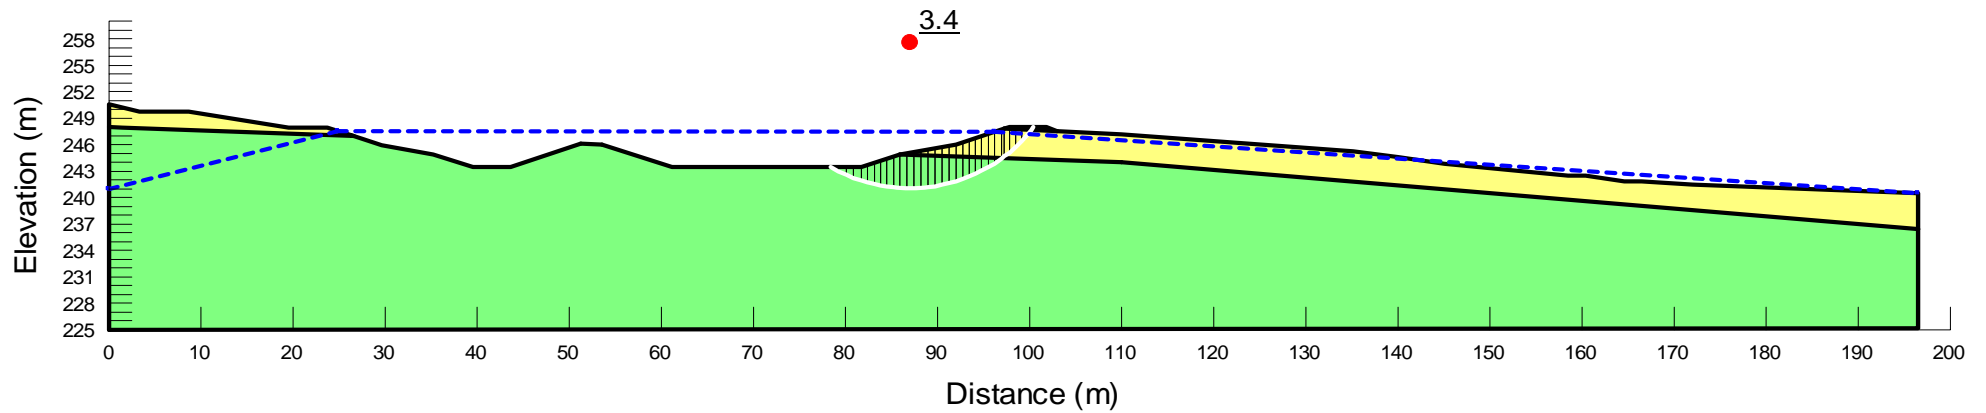
FIGURE 6

GHD also evaluated the stability of the east and west embankment of the proposed southern SWM Pond along cross-section A-A'. The SWM Pond was analysed under full weight condition (100 year storm event) and yielded a FoS of 3.4 for the east embankment (Figure 6) and 3.0 for the west embankment (Figure 7). The stability analyses performed therefore suggest the pond's design is globally stable.
