Geotechnical Investigation

Slope Stability Assessment – Proposed Residential Development, Turner Street, Millbrook, ON

Veltri and Son Limited

7 March 2023

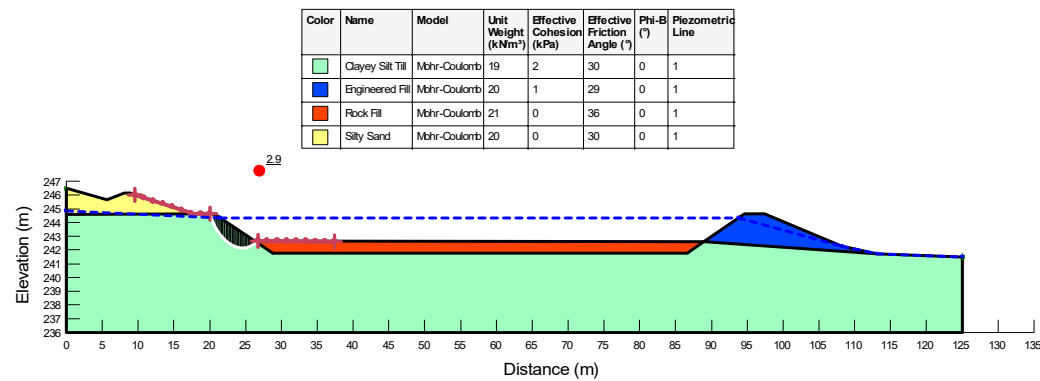
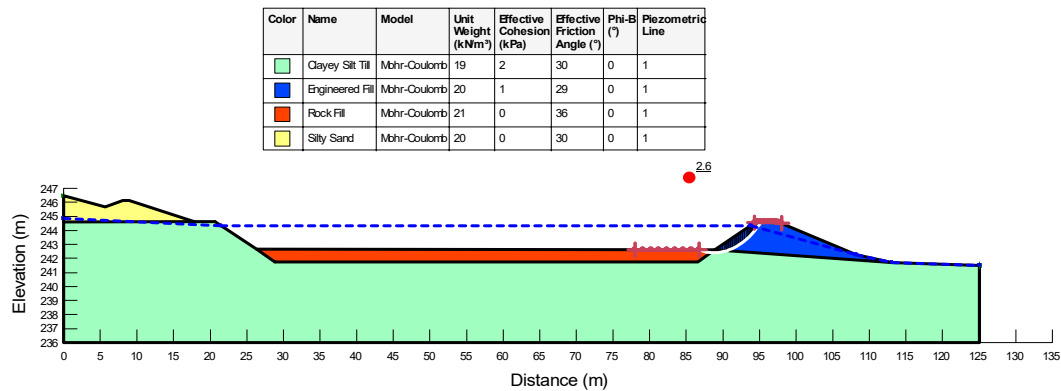
SLOPE STABILITY MODEL - CROSS SECTION A-A' - PROPOSED CONDITION, 100 YR FLOOD

Scale:
As Shown Above
2x Vertical Exaggeration

Conditions of Analysis		Factor of Safety (FoS)
Section A-A'	Existing Condition	4.2
	Proposed Condition (100 Year Flood)	2.3 to 2.9
	Proposed Condition (Dry)	2.2 to 3.0
	Proposed Condition (Seismic)	1.9
	Proposed Condition (Rapid Drawdown)	2.4
Section B-B'	Existing Condition	5.4
	Proposed Condition (100 Year Flood)	2.5 to 6.5
	Proposed Condition (Dry)	2.3 to 8.7
	Proposed Condition (Seismic)	2.0
	Proposed Condition (Rapid Drawdown)	2.3
Section C-C'	Existing Condition	5.6
	Proposed Condition (100 Year Flood)	1.9 to 2.8
	Proposed Condition (Dry)	2.3 to 3.1
	Proposed Condition (Seismic)	1.6
	Proposed Condition (Rapid Drawdown)	2.1
Section D-D'	Existing Condition	3.7
	Proposed Condition (100 Year Flood)	2.6 to 3.8
	Proposed Condition (Dry)	2.6 to 3.8
	Proposed Condition (Seismic)	2.0
	Proposed Condition (Rapid Drawdown)	2.6

The analyses for the proposed conditions yielded minimum FoS values ranging from 1.9 to 8.7 for the north SWMP and FoS values ranging from 1.6 to 3.8 for the south SWMP, all of which are above the minimum FoS of 1.3 to 1.5. The stability analyses performed therefore suggest the proposed north SWMP and south SWMP designs are globally stable.
