Geotechnical Investigation Report

Proposed Residential and Commercial Development
Part Lot 13 Concession 5
Millbrook, Ontario

Report for
Vargas Properties Inc.

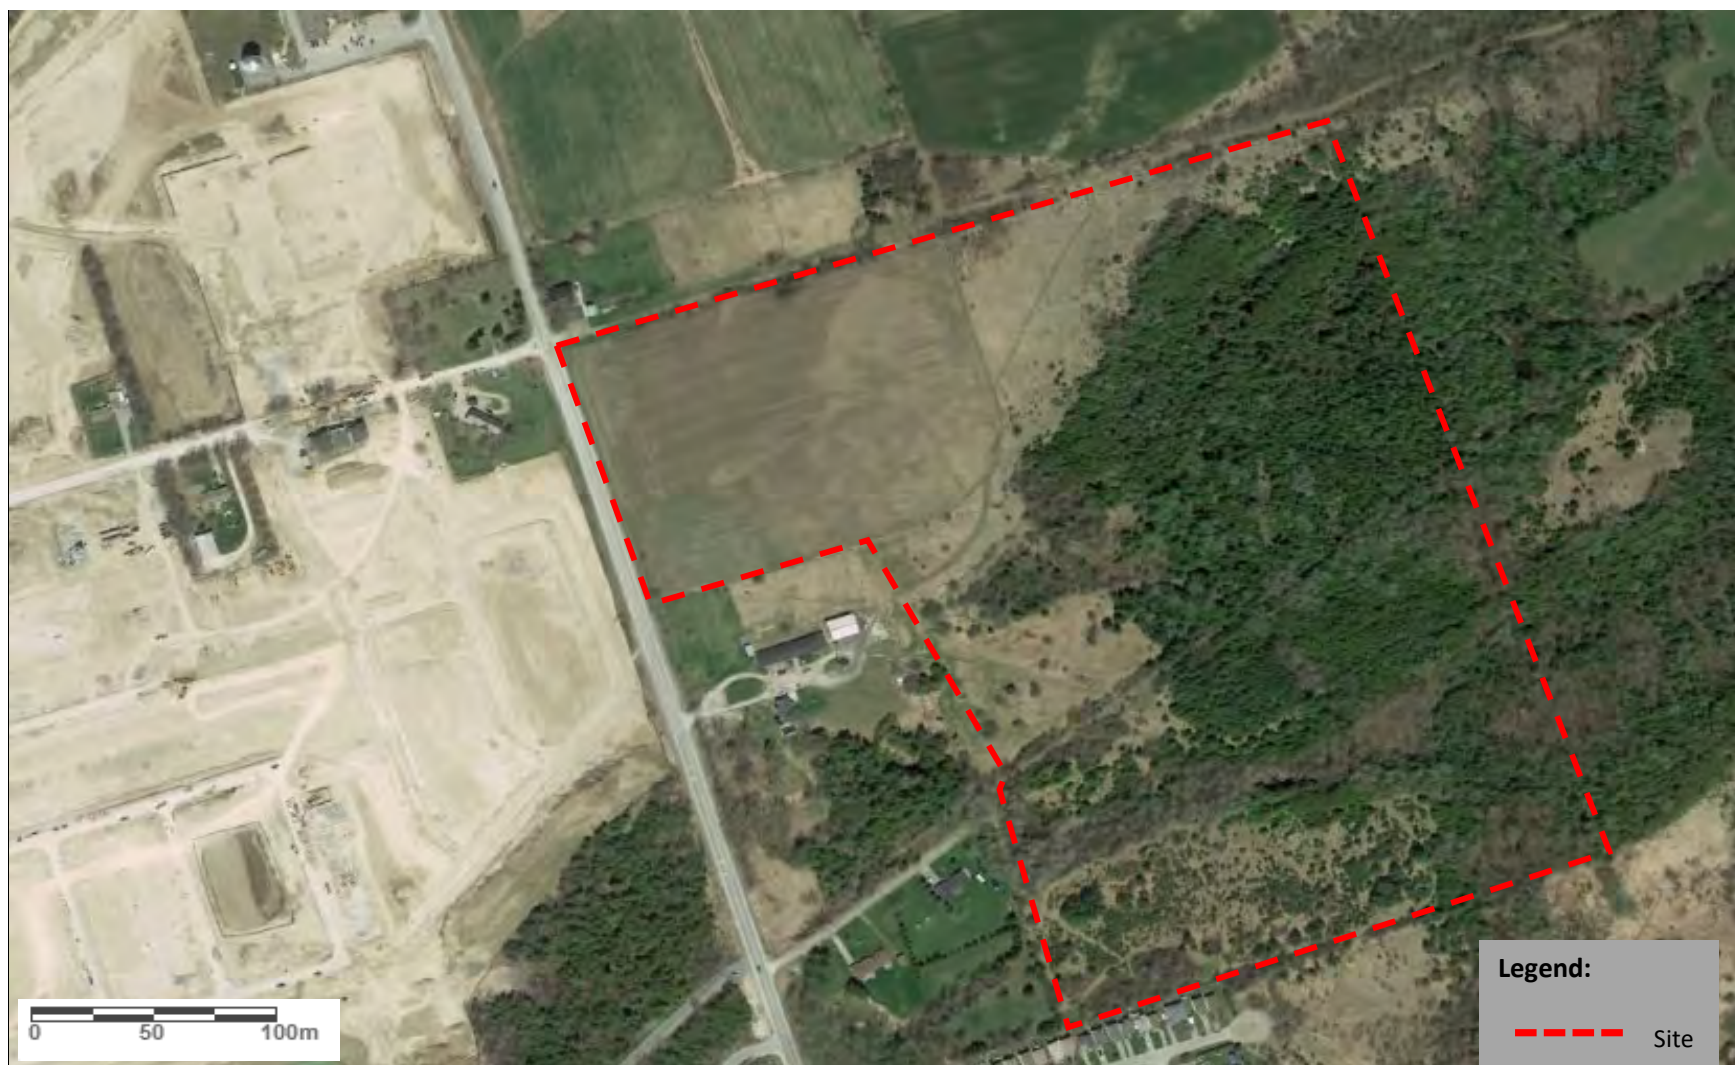
FIGURE 2

Property Plan

The general location of the Site is illustrated on the Vicinity Plan, Figure 1. The location with respect to surrounding roads and land use is depicted on the Property Plan, Figure 2. Specific details of the Site and surrounding properties based on recent aerial photography is presented on the Plot Plan, Figure 3. A current plan (by The Biglieri Group Ltd. dated February 8, 2021) depicting the proposed development layout is provided on the Concept Plan, Figure 4. The borehole and test pit locations are illustrated on the Test Hole Location Plan, Figure 5. These plans and other figures can be reviewed in the Enclosures section.

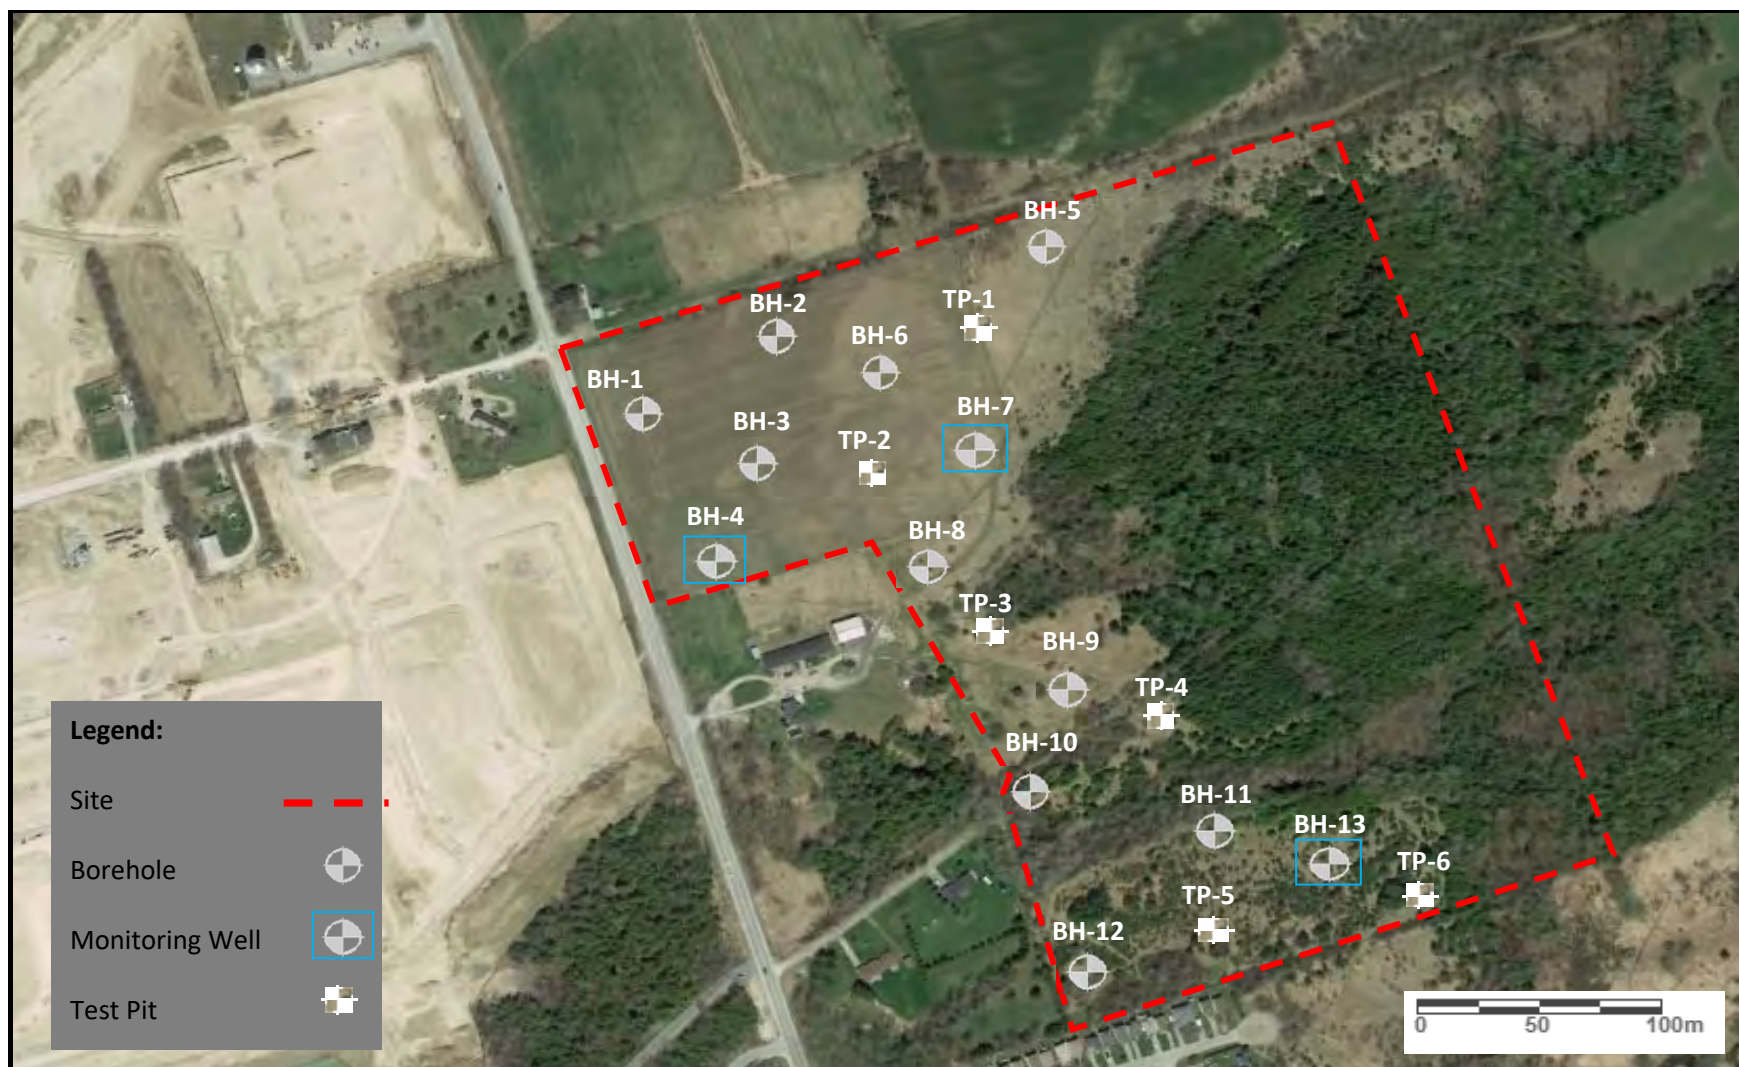
FIGURE 5

Source: Google Earth 2018, Image taken May 6, 2018. ©2018 Google

Test Hole Plan

4. The subsurface conditions were explored by advancing, sampling and logging a total of thirteen (13) boreholes and six (6) test pits. The subsurface conditions were recorded and are summarized in detail in Appendix A. The boreholes were advanced to depths ranging from 6.3 to 8.2m. The test pits were excavated to depths that varied from 3.0 to 3.5m. A monitoring well was installed in three (3) of the boreholes to facilitate water level measurements and further testing.

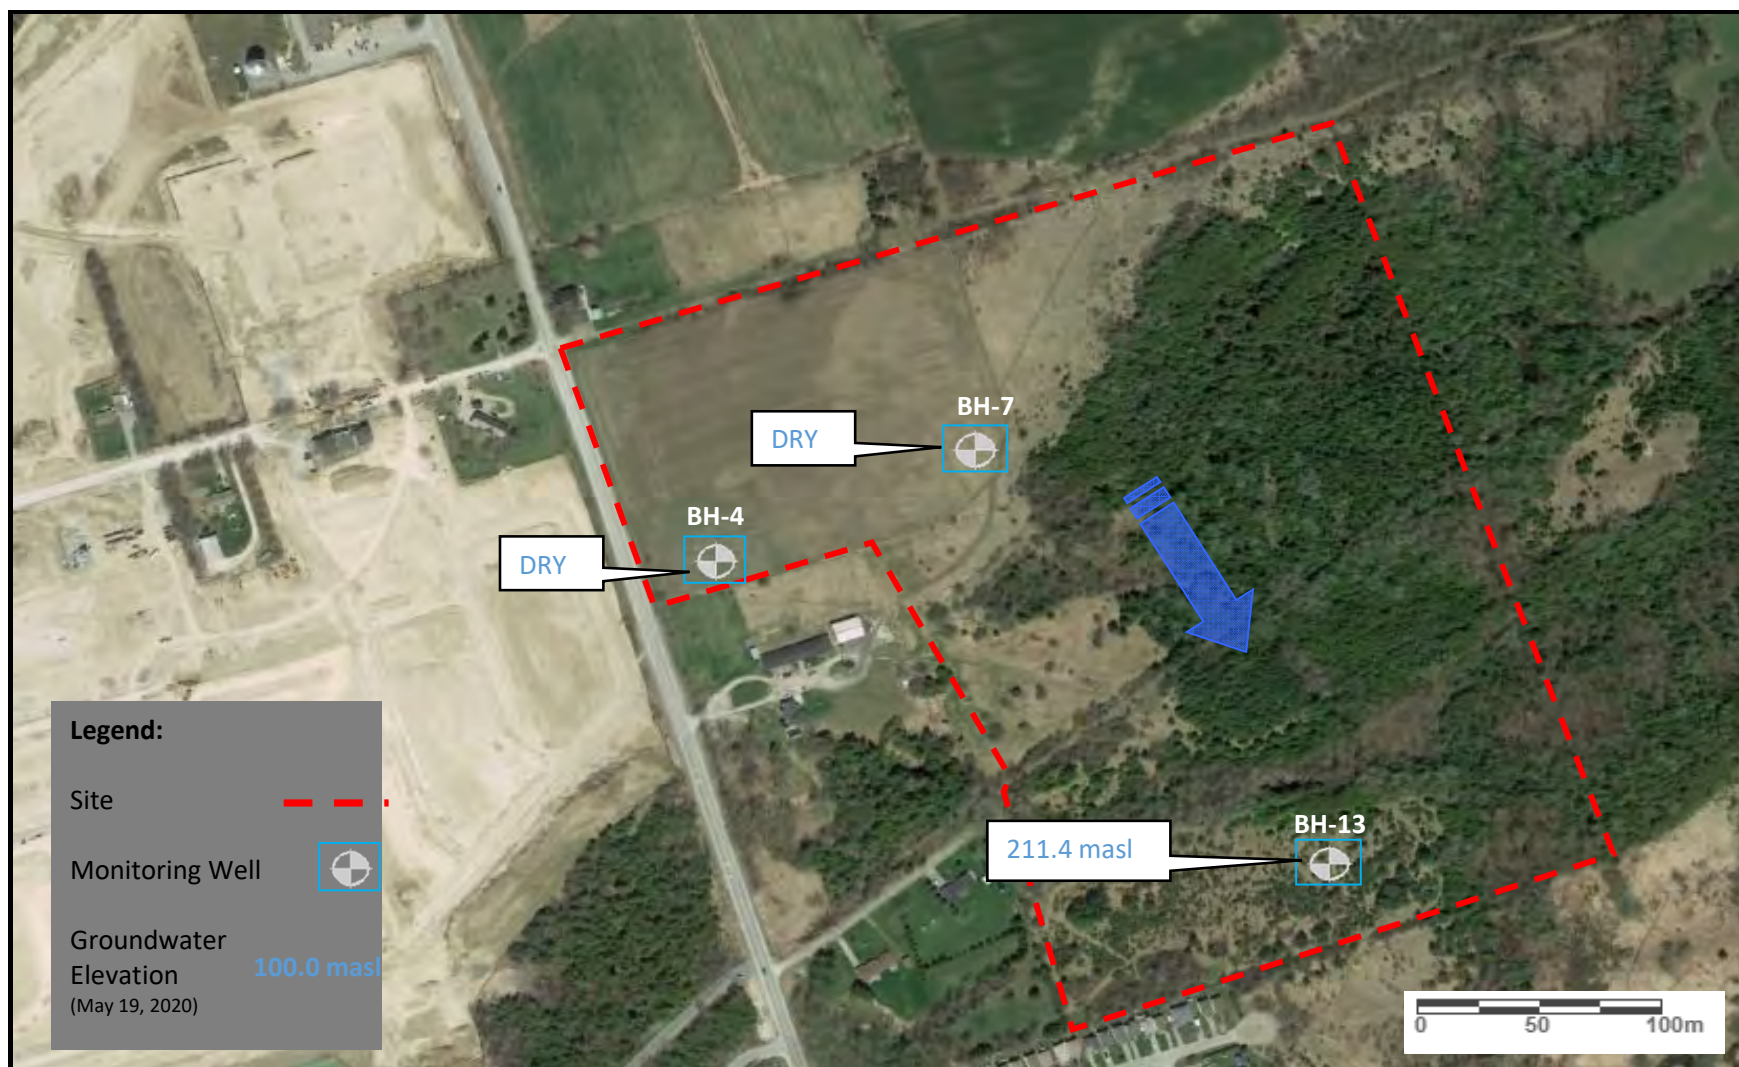
FIGURE 5

Source: Google Earth 2018, Image taken May 6, 2018. ©2018 Google. Surface elevations interpreted from topographic map.

Groundwater Elevation Plan

Based on the water level data collected and the surrounding topography, the overall shallow groundwater flow direction is to the southeast towards tributaries that lead to Baxter Creek. The direction of shallow groundwater movement is illustrated on the Groundwater Elevation plan, Figure 6. It is expected that groundwater seepage will be encountered intermittently at depths ranging from 1.8 to 4.0m (similar to what encountered during the subsurface explorations). It should be noted that groundwater levels are transient and tend to fluctuate with the seasons, periods of precipitation and temperature.
