Hydrogeological Assessment, Woodview Golf Subdivision

June 8, 2023

Prepared for:
Eric Challenger

Cambium Reference: 15101-001

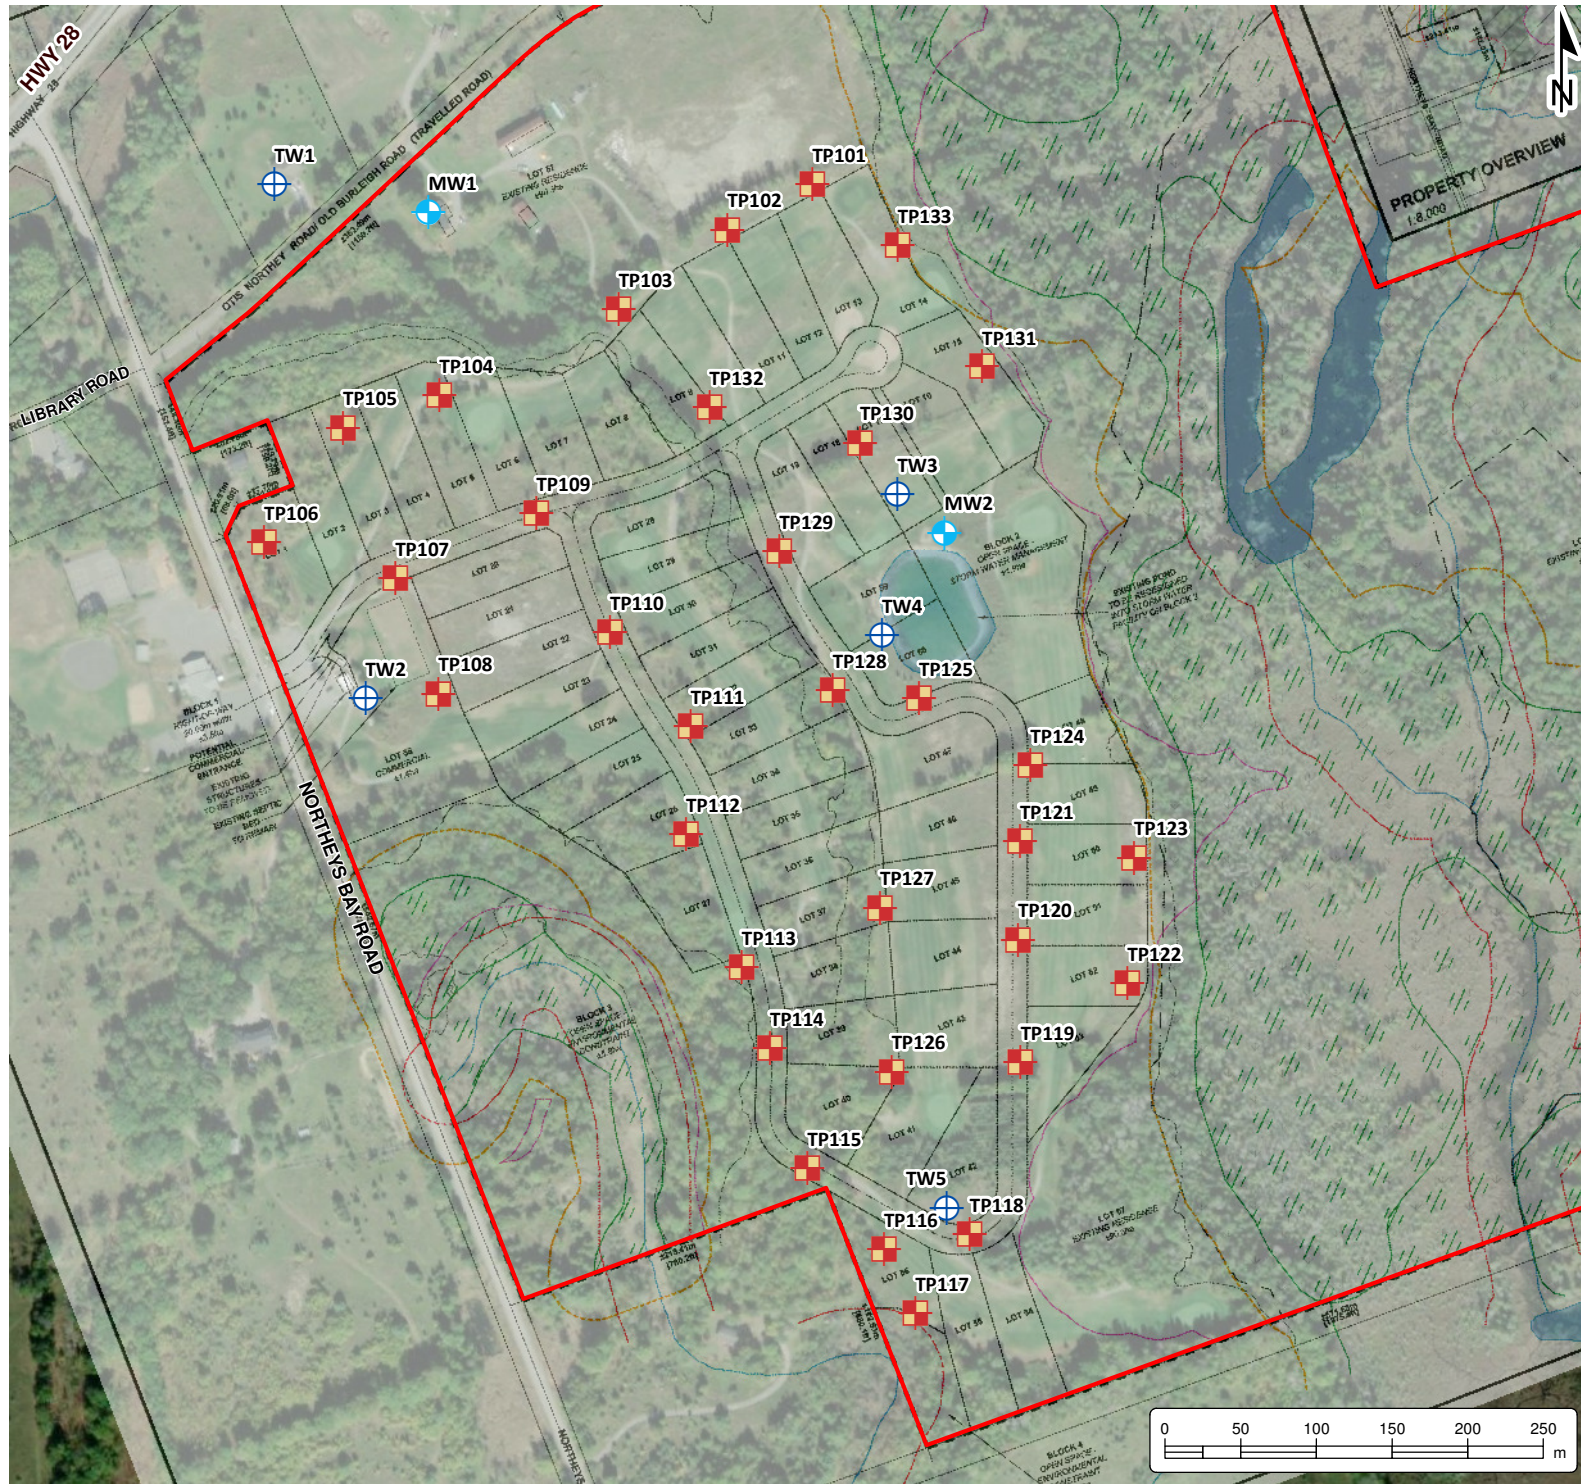
TEST PIT AND TEST WELL LOCATION PLAN

Grey, weathered and fractured limestone bedrock was encountered at all the test pit locations, ranging in depth from 0 mbgs (outcropping at ground surface) to a depth of 1.35 mbgs. Test pits that had bedrock at ground surface were localized to the northwestern and western portions of the developable area and included TP104-22–TP107-22 and TP112-22 (Figure 3).

Fissures were noted on the bedrock surface following excavation of the test pits at seven locations located along the western edge of the developable area (TP104-22 through TP107-22, TP112-22, TP114-22, and TP115-22). The fissures measured approximately 0.2 m in width, based on field observations, and may be indicative of localized karst topography.

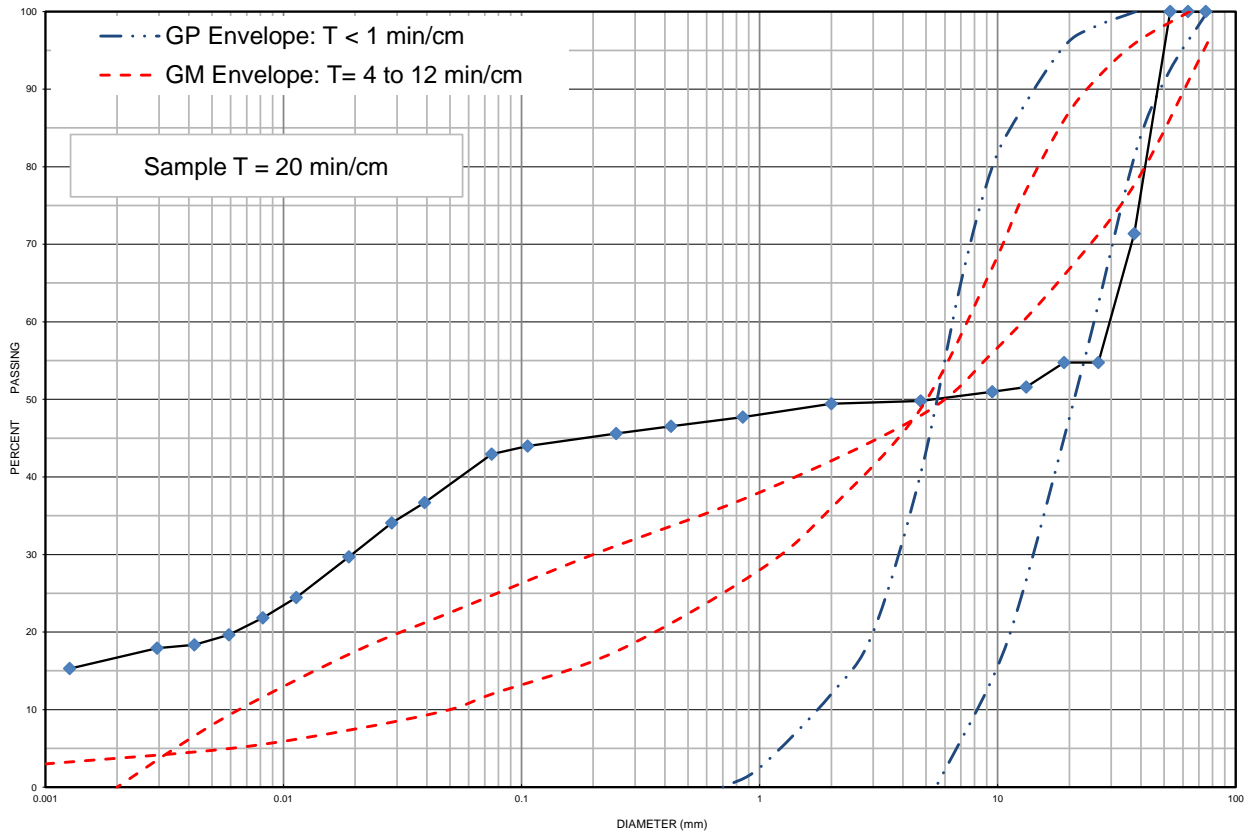
Borehole No.	Sample No.	Depth	Gravel	Sand	Silt	Clay	Moisture
TP 124-22	GS 2	25.3 m to 1.1 m	50	7	26	17	10.0
Description		Classification	D ₆₀	D ₃₀	D ₁₀	C _u	C _c
Silty Gravel some Clay trace Sand		GM	30.000	0.019	-	-	-
